"SITE INFORMATION												
*SURVEY DATE:	r 20, 2013	*ADDRESS:	*ADDRESS: 31305 465 th Ave									
*SURVEYOR:	Jim Stone	· · · · · · · · · · · · · · · · · · ·	*COUNTY:	-								
			*CITY:	Vermi	llion							
LOCATION DESCRIPTION: From Vermillion, from intersection of South Dakota Highway 50 bi-pass and												
University Road, (North) about 5 miles to intersection of University Road, 313th Street (East) and 465th Ave												
(South), turn right (South) about 200 yards, on the right (West) side.)												
LEGAL DESCRIPTION: Tract 2 Buck's Addn, NE ¼, Exc Lots 1 & 2, 30 – 93 – 51 Prairie Center Twp.												
LEGAL DESCRIPTION.	ITACL Z DUCK	S Addii, NE 74	, EXCLUIS I & Z	, 30 – 93	- 5	I FIC	allie	Cei	ilei i	wp.		
*QUARTER 1: NE 1	OWNER NAME: Hemminger Family Trust											
*QUARTER 2:		OWNER ADDRESS: 106 W. Main Street										
	Center		OWNER CITY:			Beresford						
*RANGE: 51	1	0	OWNER STATE: South Dakota

STRUCTURE DETAILS

SHPO ID:		_							
*PROPERTY NAME:									
OTHER NAME:									
CURRENT FUNCTION:	Vacant	FOUNDATION:	Poured concrete						
CURRENT CURRUNCTION	Otamana	DOOF MATERIAL.	Steel roofing over						
CURRENT SUBFUNCTION:	Storage	ROOF MATERIAL:	cedar shin

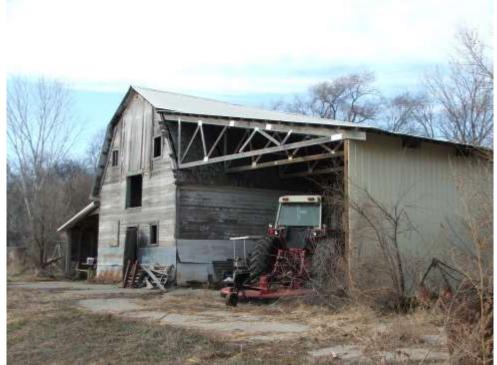
PHOTOGRAPHER: Jim Stone ROLL NUMBER: DATE OF PHOTO: November 20, 2013 PHOTO NUMBER: 2

CAMERA DIRECTION: Looking NW, SE corner

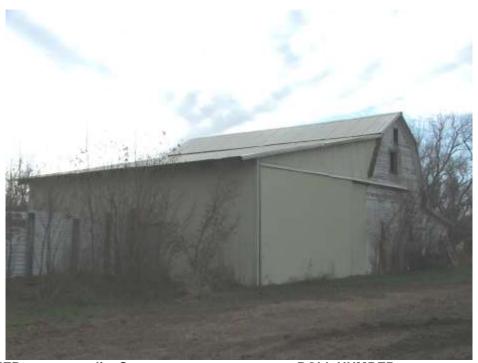
PHOTOGRAPHER: Jim Stone ROLL NUMBER: DATE OF PHOTO: November 20, 2013 PHOTO NUMBER: 3

CAMERA DIRECTION: Looking SW, NE corner

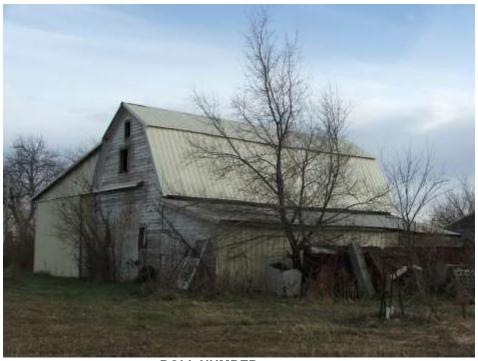
Jim Stone November 20, 2013 ROLL NUMBER:
PHOTO NUMBER:
CAMERA DIRECTION:
Looking SE, NW corner

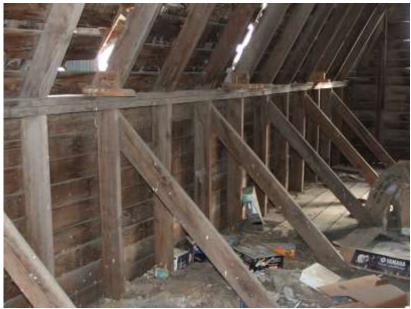
Hayloft, looking SE, 2x6 rafters, 2x6 stud wall in hayloft, 2x6 bracing from top of the wall down to hayloft floor, 4' O. C.

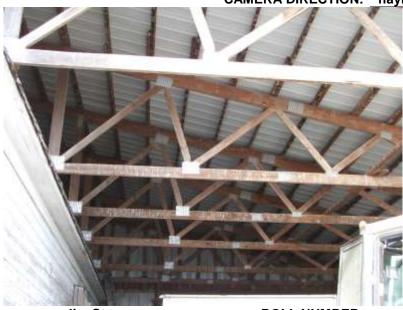
East lean-to, looking North and up, mfg. truss rafters with 2x8 top chord and 2x6 bottom chord, with 2x4 purlins,

CAMERA DIRECTION: and steel roofing.
