""SITE INFORMATION				
*SURVEY DATE: June 26, 2013	*ADDRESS: 45450 299th Street			
*SURVEYOR: Jim Stone	*COUNTY: Clay			
-	*CITY: Irene			
LOCATION DESCRIPTION: From Vermillion, the intersection of South Dakota Highway 50 bi-pass and				
South Dakota Highway 19, North 15 miles to 302 <sup>nd</sup> Street, turn left (West) about 7 miles, turn right (North)				
3 miles to 299th Street, turn left (West) about ¼ mile on the right (North) side.				
LEGAL DESCRIPTION: SE ¼, 9 – 95 – 53 Star Twp.				
*QUARTER 1: SE 1/4	OWNER NAME: Charles T. & Suzanne Stockland			
	NER ADDRESS: 45327 299th Street			
*TOWNSHIP: Star	OWNER CITY: Irene			
*RANGE: 53	OWNER STATE: South Dakota			
*SECTION: 9	OWNER ZIP: 57037			
ACRES: 163.89	QUAD NAME:			
OWNER CODE 1: P				
OWNER CODE 2:				
OWNER CODE 3:				
HISTORIC SIGNIFICANCE				
*DOE:	REGISTER NAME:			
*DOE DATE:	MULTIPLE PROPERTY NAME:			
REASON INELIGIBLE:				
MEAGON INCLIGIBLE.

#### STRUCTURE DETAILS

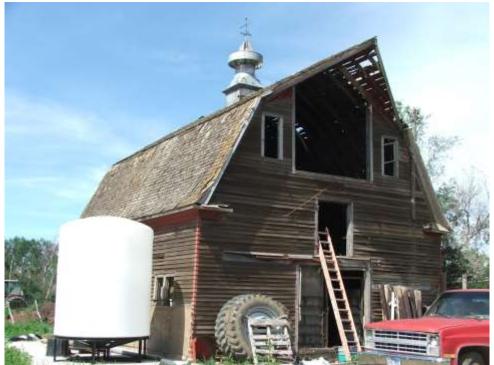
CAMERA DIRECTION: Looking NE, SW corner

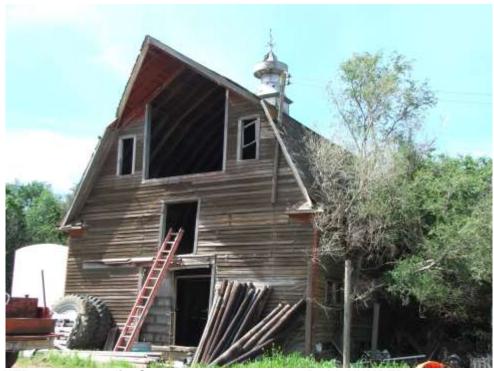
PHOTOGRAPHER: Jim Stone ROLL NUMBER: DATE OF PHOTO: June 26, 2013 PHOTO NUMBER: 2

CAMERA DIRECTION: Looking NW, SE corner

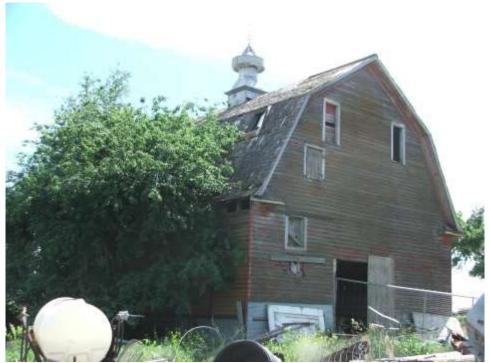
CAMERA DIRECTION: Looking SW, NE corner

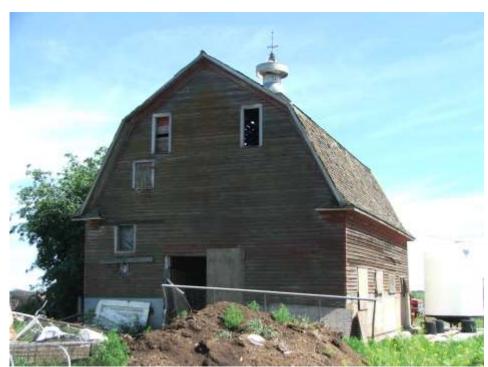
CAMERA DIRECTION: Looking SE, NW corner

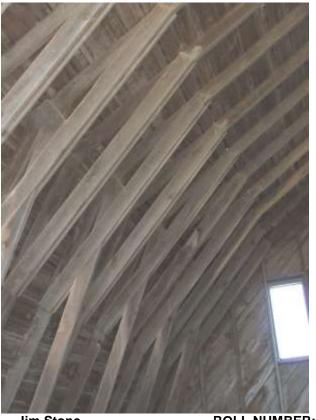
Hayloft, looking NW, 2x6 brace supporting hip, 4'

CAMERA DIRECTION: O. C.
