SITE INFORMATION

STRUCTURE DETAILS									
SHPO ID:									
*PROPERTY NAME:		•							
OTHER NAME:									
O THER TO MILE									
			Native rock						
CURRENT FUNCTION:	Vacant	FOUNDATION:	mortared						
CURRENT SUBFUNCTION:		ROOF MATERIAL:	Cedar shingles						
HISTORIC FUNCTION:	Livestock barn	ROOF SHAPE:	Gambrel						
HISTORIC SUBFUNCTION:	Hay and grain storage	STRUCTURAL SYSTEM:	Balloon framing						
		STYLE:	Gambrel roof barn						
OCCUPIED:	No	TYPE:	Livestock barn						
			2x6 & 2x10,						
400500IDI 5	Yes with	WALL 0	sheathing & ½" x						
ACCESSIBLE:	permission	WALLS:	6" cedar lap siding

•						
STORIES:		SIGNIFICANT PERSON:							
*DATE OF CONSTRUCTION:	<u>1915 to 1925</u> CU	LTURAL AFFILIATION:	?						
ALTERED/MOVED NOTES: Original site. Horse stalls and milk cow stanchions have been removed.									
INTERIOR NOTES. Contactive news Coloniate and Colonian Colonia Colonian Colonia Colonian Colonia Colonian Colonia Colo									
INTERIOR NOTES: Center two rows 6x6 posts and 6x8 beams. Outer two rows of 6x6 posts and 6x6									
beams in the North 28'. South 46' has four rows 6x6 posts and (4) 2x10's laminated for beams.									
2x6 wall with solid diagonal sheathing di

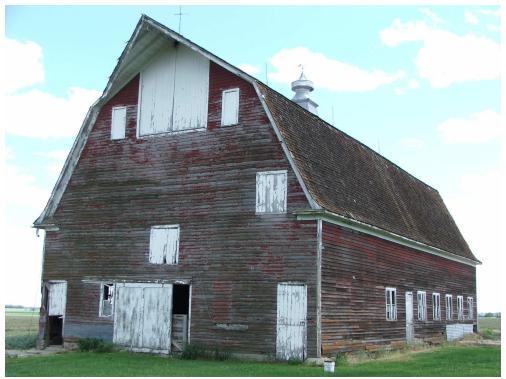
DATE OF PHOTO: March 7, 2012 PHOTO NUMBER: 1

CAMERA DIRECTION: Looking SE, NW corner

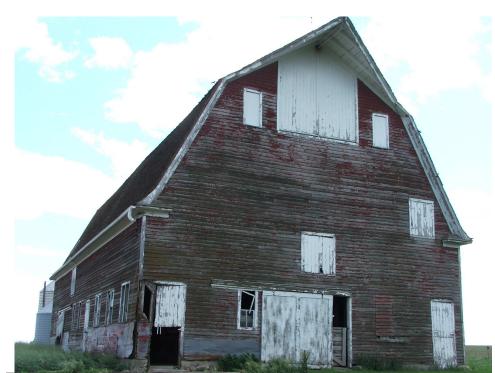
PHOTOGRAPHER: Jim Stone ROLL NUMBER: DATE OF PHOTO: March 7, 2012 PHOTO NUMBER: 2
CAMERA DIRECTION: Looking SW, NE corner

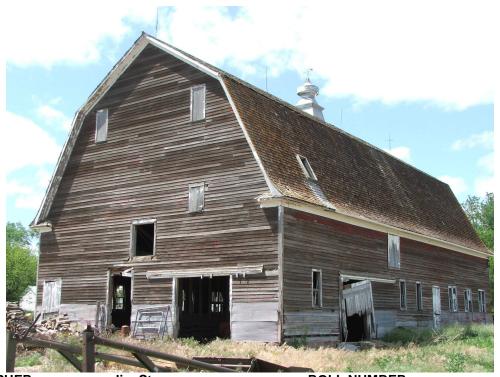
CAMERA DIRECTION: Looking NW, SE corner

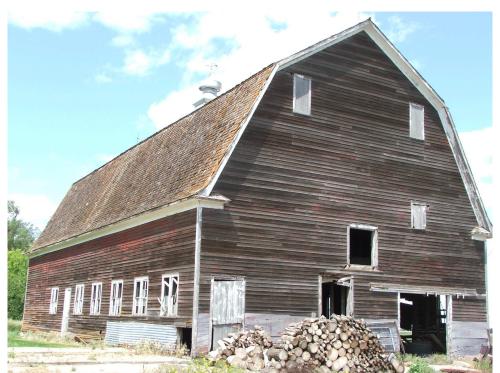
CAMERA DIRECTION: Looking NE, SW corner

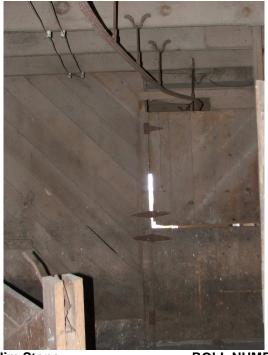
First floor, looking

South, dividing wall &

CAMERA DIRECTION: curved manure track

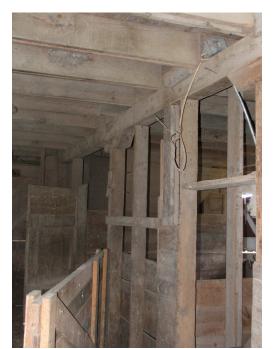
CAMERA DIRECTION: _post and beam & granary

First floor, looking SE,

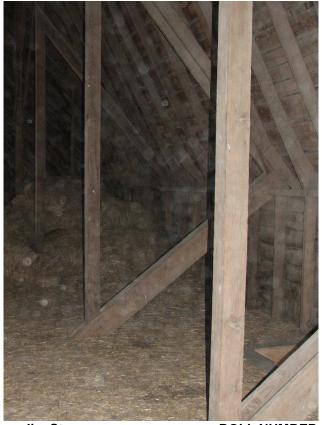
11 Hayloft, looking South, 2x10's bracing at bottom

of 6x6 post up to 6x6

CAMERA DIRECTION: rafter
