**SOUTH DAKOTA STATE HISTORIC PRESERVATION OFFICE
HISTORIC SITES SURVEY STRUCTURE FORM**

CURRENT FUNCTION: <u>Storage</u>	FOUNDATION: <u>Poured concrete</u>	
CURRENT SUBFUNCTION: <u>Raises pheasants</u>	ROOF MATERIAL: <u>Steel over cedar shingles</u>	
HISTORIC FUNCTION: <u>Livestock barn</u>	ROOF SHAPE: <u>Gambrel</u>	
HISTORIC SUBFUNCTION: <u>Hay storage</u>	STRUCTURAL SYSTEM: <u>Balloon framing</u>	
	STYLE: <u>Gambrel roof barn</u>	
OCCUPIED: <u>Yes</u>	TYPE: <u>Livestock barn</u>	
	<u>Yes with</u>	WALLS: <u>2x6, sheathing,</u>
ACCESSIBLE: <u>permission</u>		<u>steel roofing</u>

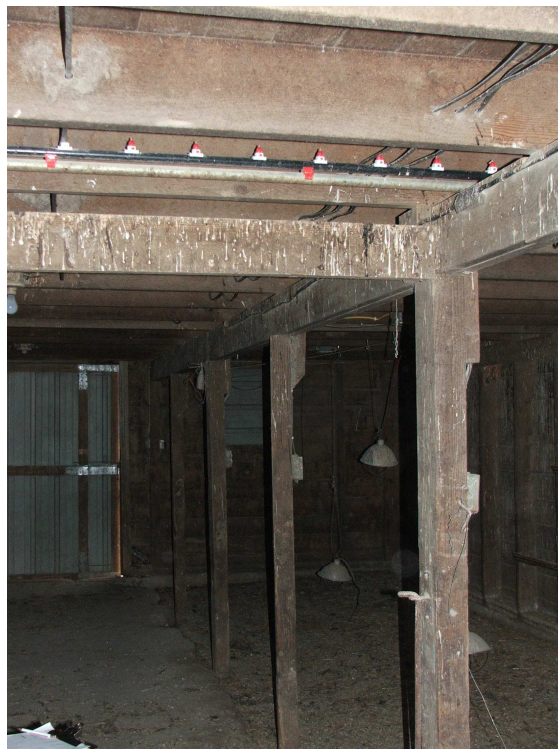
ROLL NUMBER: _____
PHOTO NUMBER: 4
CAMERA DIRECTION: First floor, looking West,
4x6 posts, (2) 2x8's
beam, 2x8 floor joists

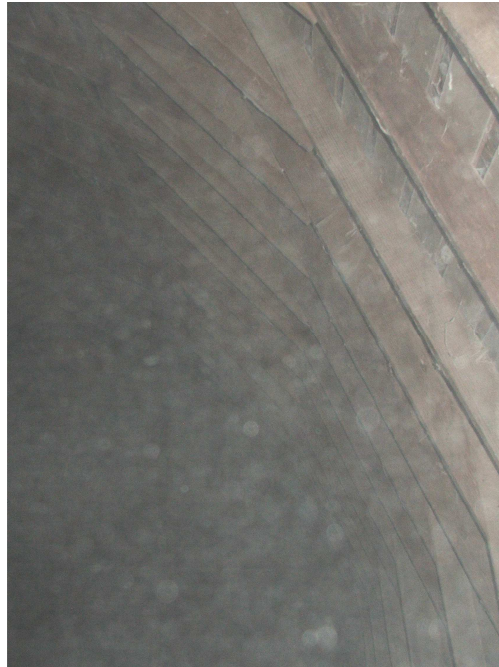
ROLL NUMBER: 5
PHOTO NUMBER: 5

CAMERA DIRECTION: Hayloft, looking West,
1x12 bracing on hip, 2x6
lower bracing

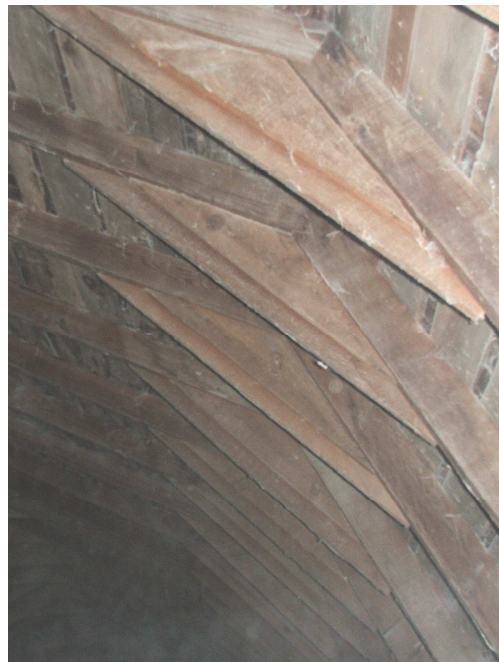
ROLL NUMBER: 6
PHOTO NUMBER: 6

CAMERA DIRECTION: Hayloft, looking West,
1x12 hip bracing
