**SOUTH DAKOTA STATE HISTORIC PRESERVATION OFFICE
HISTORIC SITES SURVEY STRUCTURE FORM**

*SURVEY DATE: July 8, 2013 *ADDRESS: 29721 456th Ave.
*SURVEYOR: Jim Stone *COUNTY: Clay
*CITY: Wakonda

CURRENT FUNCTION:	<u>Calving barn</u>	FOUNDATION:	<u>Poured concrete</u>
CURRENT SUBFUNCTION:	<u>Storage</u>	ROOF MATERIAL:	<u>Steel roofing over cedar shingles</u>
HISTORIC FUNCTION:	<u>Livestock barn</u>	ROOF SHAPE:	<u>Gable roof</u>
HISTORIC SUBFUNCTION:	<u>Hay storage</u>	STRUCTURAL SYSTEM:	<u>Balloon framing</u>
OCCUPIED:	<u>Yes</u>	STYLE:	<u>Gable roof barn</u>
ACCESSIBLE:	<u>Yes with permission</u>	WALLS:	<u>2x6 studs, 1x6 # 106 drop siding and steel roofing.</u>
STORIES:	<u>2</u>	SIGNIFICANT PERSON:	<u>Michael Young</u>
*DATE OF CONSTRUCTION:	<u>Early 1900's</u>	CULTURAL AFFILIATION:	<u>Irish</u>

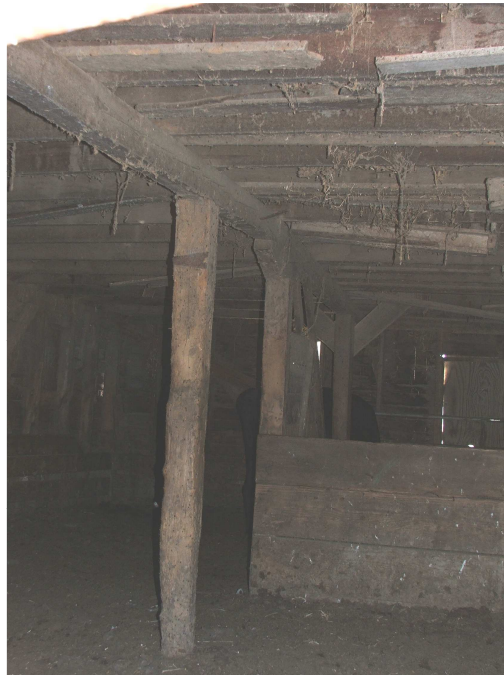
ROLL NUMBER: _____
PHOTO NUMBER: 5

INTERIOR NOTES: Two rows of 6x6 posts, and 6x6 beam support the 2x8 joists for the hayloft floor.

CAMERA DIRECTION: First floor, looking SW,
6x6 post, 6x6 beam, 2x8
joists.

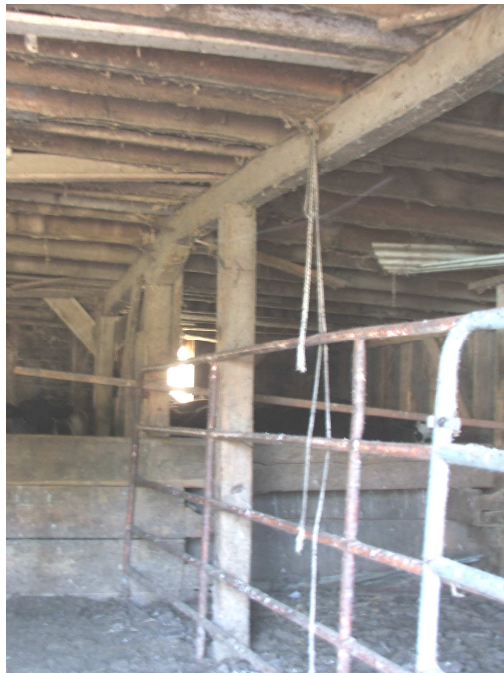
ROLL NUMBER: _____
PHOTO NUMBER: 6

CAMERA DIRECTION: First floor, looking NW,
6x6 posts, 6x6 beam &
2x8 floor joists

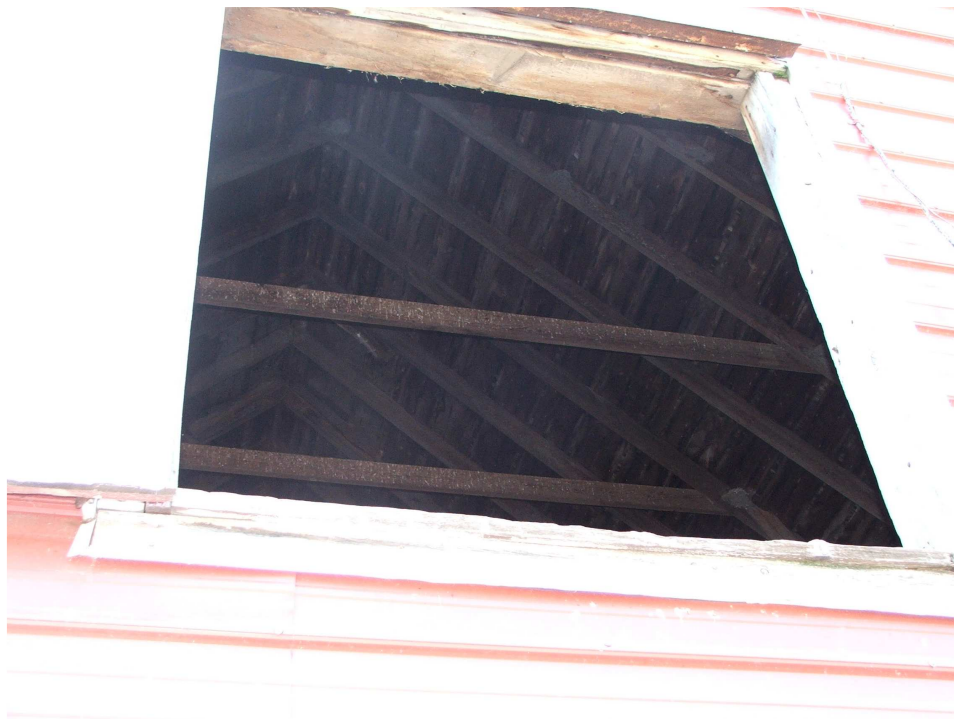
ROLL NUMBER: _____
PHOTO NUMBER: 7

OTHER NOTES: 2x6 stud walls with 1x6 #106 drop siding and horizontal steel roofing. Rafters 2x6's with a 2x6 horizontal brace 4' O. C. Windows are 9" x 12" four light, but most of them are covered with corrugated fiberglass material.

CAMERA DIRECTION: Hayloft, looking up & NW, 2x6 rafters & 2x6 horizontal bracing 4' O. C.
