""SITE INFORMATION				
*SURVEY DATE: June11, 2013	*ADDRESS: 45757 S D 46			
*SURVEYOR: Jim Stone	*COUNTY: Clay			
-	*CITY: Centerville			
LOCATION DESCRIPTION: From Vermillion, the intersection of South Dakota Highway 50 bi-pass and				
South Dakota Highway 19, North 20 miles to South Dakota Highway 46, turn left (West) about 4 – 1/2 miles				
, on the left (South) side.				
LEGAL DESCRIPTION: N ½, NE ¼, 1–95 – 53 Star Twp.				
*QUARTER 1: NE 1/4	OWNER NAME: E. Dale & Betty Jo Johnson			
	NER ADDRESS: 45757 S D 46			
*TOWNSHIP: Star	OWNER CITY: Centerville			
	DWNER STATE: South Dakota			
*SECTION: 1	OWNER ZIP: 57014			
ACRES: 76.11	QUAD NAME:			
OWNER CODE 1: P				
OWNER CODE 2:				
OWNER CODE 3:				
HISTORIC SIGNIFICANCE				
HISTORIC SIGNII ICANCE				
*DOE:	REGISTER NAME:			
*DOE DATE:	MULTIPLE PROPERTY NAME:			
REASON INELIGIBLE:	-			
	CATEGORY:			
NOMINATION STATUS:	SIGNIFICANCE LEVEL 1: N S L			
DATE LISTED:	SIGNIFICANCE LEVEL 2: N S L

#### STRUCTURE DETAILS

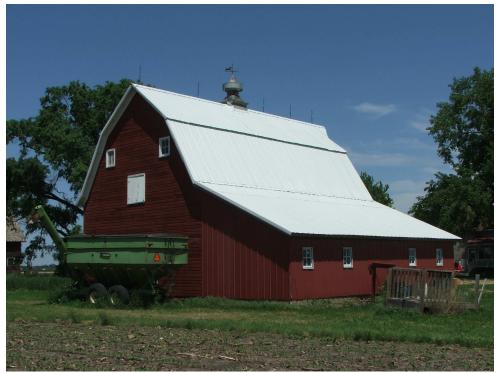
CAMERA DIRECTION: Looking NE, SW corner

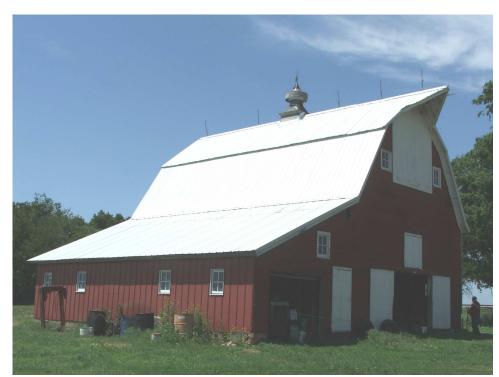
2

CAMERA DIRECTION: Looking NW, SE corner

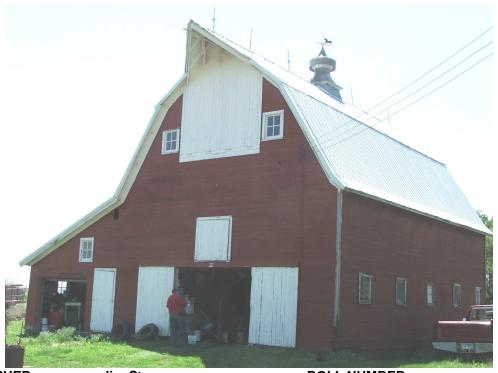
PHOTO NUMBER: 3

CAMERA DIRECTION: Looking SW, NE corner

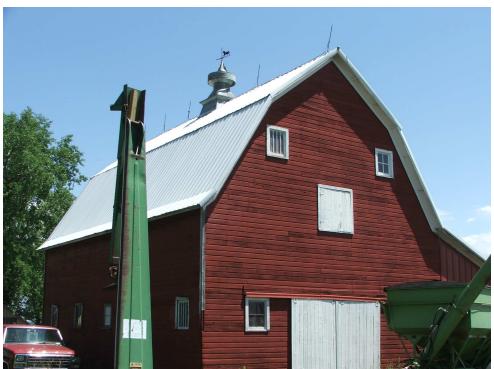
PHOTOGRAPHER: Jim Stone ROLL NUMBER:
DATE OF PHOTO: June 11, 2013 PHOTO NUMBER: 4
CAMERA DIRECTION: Looking SE, NW corner

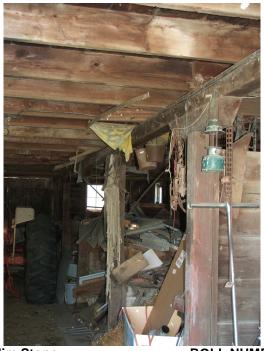
First floor, looking NW, 4x6 post, 4x6 beam, 2x8 joists, horse stalls still in CAMERA DIRECTION: place on North wall.

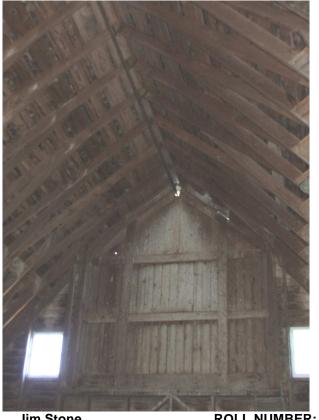
Hayloft, looking NE, wall and top over stairs to keep hay from falling

CAMERA DIRECTION: down on stairs.
