<b>"SITE INFORMATION</b>								
*SURVEY DATE: July 30, 2013		ADDRESS:	: 30635 456 <sup>th</sup> Ave.					
	Stone	*COUNTY:	Clay					
		*CITY:	Volin					
LOCATION DESCRIPTION: From	m Vermillion, intersectio	n of South D	akota Hig	hway	50 b	i-pas	s an	d
South Dakota Highway 19, North								
turn left, (South) about ¼ mile, on								
LEGAL DESCRIPTION: N 704' C	of S 1,200' of E 898', NE 1	l/4, 22 <b>–</b> 94 -	- 53 Beth	el Tw <sub>l</sub>	<b>)</b> .			
*QUARTER 1: NE 1/4		ER NAME:	Krishna K. Mastel & Christopher A Meyer					
*QUARTER 1: NE 1/4		ADDRESS:	30635 45	6 <sup>th</sup> Δν	Δ			
*TOWNSHIP: Bethel		-	Volin	<u> </u>	<u>.                                    </u>			
*RANGE: 53		ER STATE:	South Da	kota				
*SECTION: 22		-	57072					
ACRES: 13.68		AD NAME:	0.0					
OWNER CODE 1: P		· · · · · · · · · · · ·						
OWNER CODE 2:								
OWNER CODE 3:								
HISTORIC SIGNIFICANCE								
*DOE:	RE	GISTER NA	ME:

#### STRUCTURE DETAILS

***************************************							
*PHYSICAL NOTES: Barn is	in fair condition.		*RESTRICTE	D: Y o	r N		
*UTM EASTING:

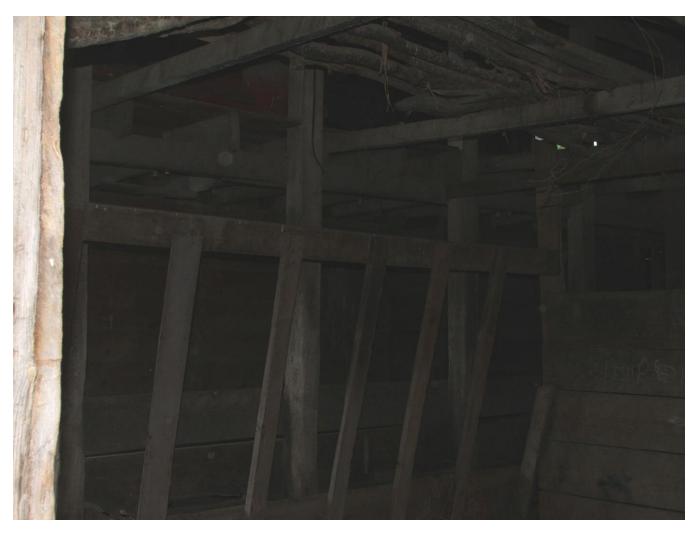
First floor, looking NW, in East lean-to, hay feed rack, 4x4 open stud wall

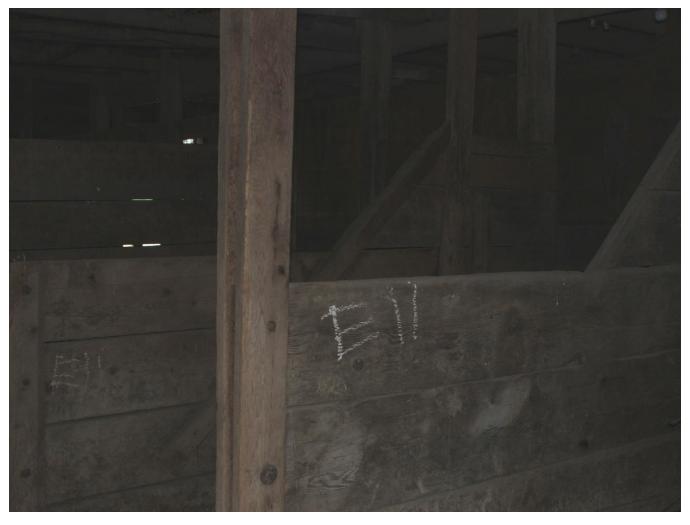
First floor, looking SW, East lean-to, single horse stalls still in place

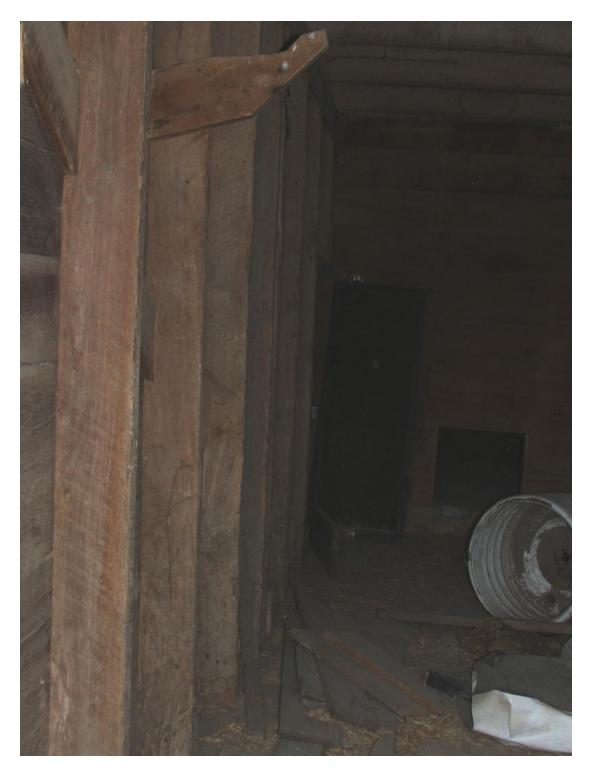
First floor, looking NW into 18'x12' granary, 2x6

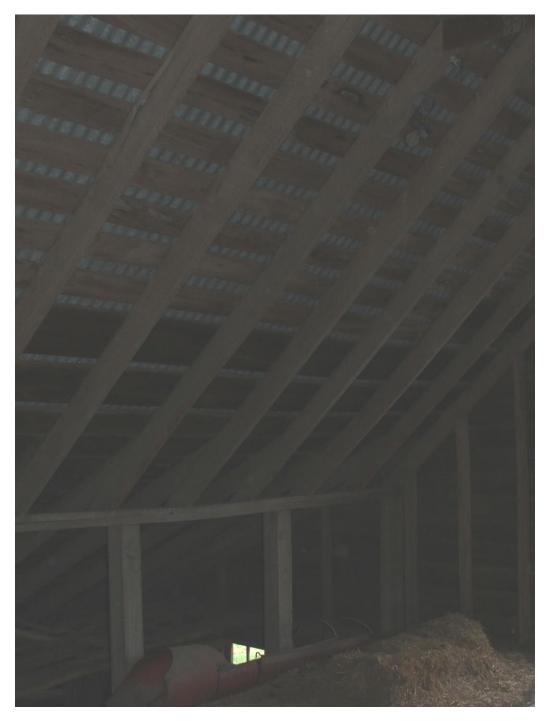
Hayloft. looking SE, open

4x4 stud wall, 2x6

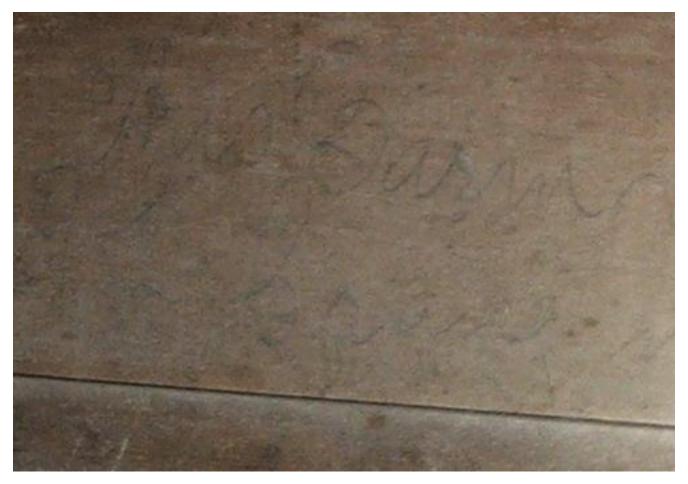
Penciled note on side of granary, " Hans barn" can not read second line,

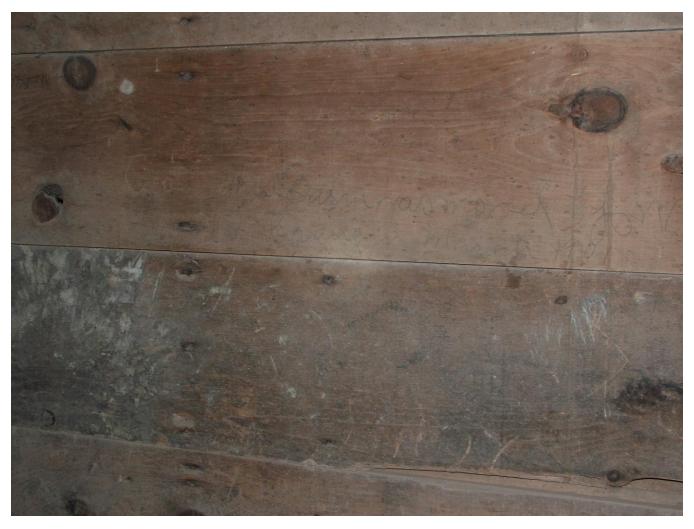
Penciled note on side of granary "moved \_\_\_\_-CAMERA DIRECTION: March, 1901"
