SITE INFORMATION

*SURVEY DATE: Jult 2, 2012 *SURVEYOR: Jim Stone *ADDRESS: 45702 Jetly Park Street

STRUCTURE DETAILS			
		-	
*PROPERTY NAME: OTHER NAME:			
	Farm machinery		
CURRENT FUNCTION:	storage	FOUNDATION:	Poured concrete Asphalt over cedar
CURRENT SUBFUNCTION:	Shop	ROOF MATERIAL:	•
HISTORIC FUNCTION:	Livestock barn	ROOF SHAPE:	Gable
HISTORIC SUBFUNCTION:	Hay and grain storage	STRUCTURAL SYSTEM:	Balloon framing
		STYLE:	Gable roof barn
OCCUPIED:	Yes	TYPE:	Livestock barn
ACCESSIBLE:	Yes with permission	WALLS:	2x6, 1x6 #106 drop siding
STORIES:	2	SIGNIFICANT PERSON:	Nels Larson
*DATE OF CONSTRUCTION:			Norwegian

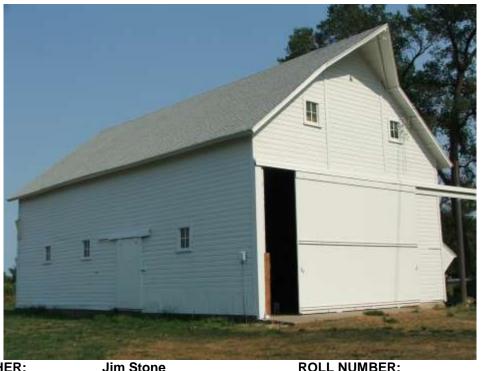
DATE OF PHOTO:
 July 2, 2012
 PHOTO NUMBER:
 4

CAMERA DIRECTION:
 Looking SW, NE corner
