**SOUTH DAKOTA STATE HISTORIC PRESERVATION OFFICE
HISTORIC SITES SURVEY STRUCTURE FORM**

*SURVEY DATE: April 3, 2013 *ADDRESS: 46669 298th Street
*SURVEYOR: Jim Stone *COUNTY: Clay
*CITY: Beresford

CURRENT FUNCTION: Cattle barn FOUNDATION: Poured concrete
Steel over cedar

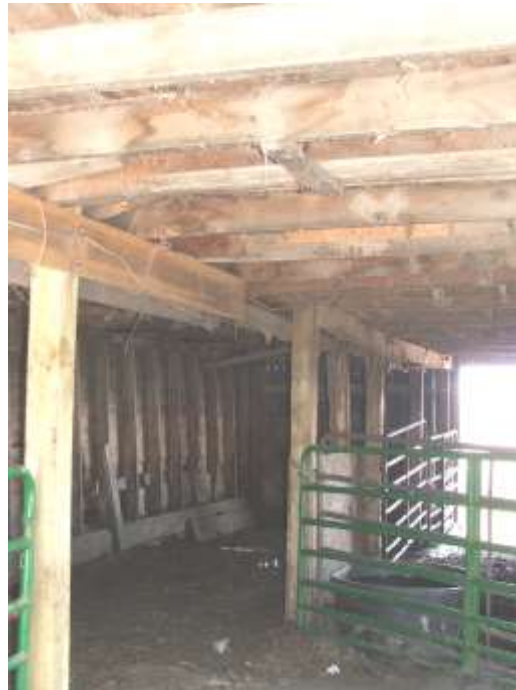
ROLL NUMBER: _____
PHOTO NUMBER: 5

ALTERED/MOVED NOTES: Original site. Any evidence of horse stalls and milk cow stanchions has been removed. Roof has been covered with steel roofing, except the South side, which is cedar shingles. Most of the walls have been covered with 1-1/4" x 26" galvanized corrugated steel was applied vertically. North 14'x 48' lean-to added later. South 16' x 48' lean-to added later, snow caved the roof in and the lean-to was removed. Posts in the main barn have rotted off and have been replaced with treated 6x6's

**First floor, looking East,
6x6 posts (2) 2x6's for a
beam and 2x6 floor
joists.**

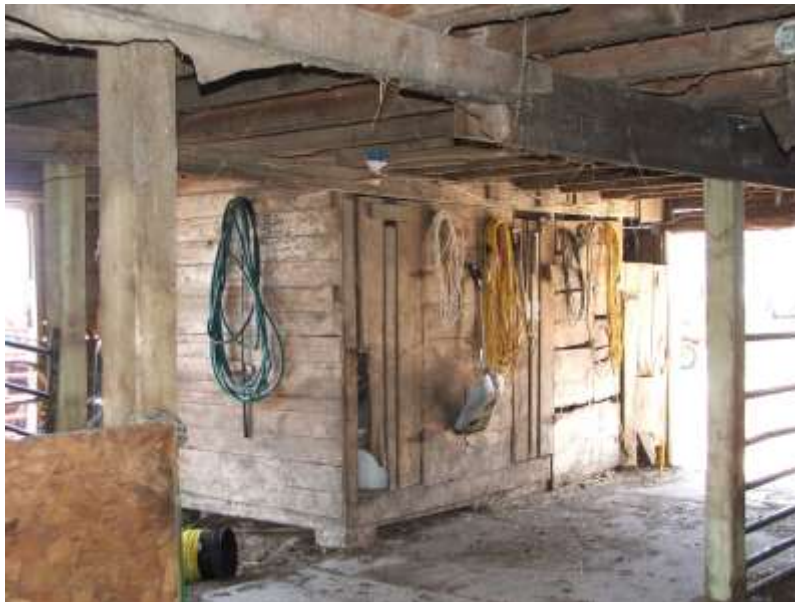
ROLL NUMBER: _____
PHOTO NUMBER: 6

**First floor, looking SW,
two granaries still in SW
corner.**

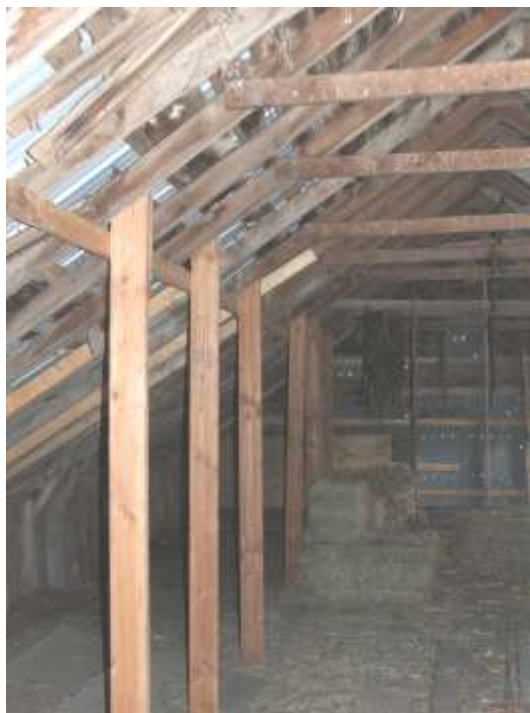
ROLL NUMBER: _____
PHOTO NUMBER: 7

CAMERA DIRECTION: Hayloft, looking East,
2x6 posts 4' O. C.
supporting rafters.
