SITE INFORMATION

STRUCTURE DETAILS

SHPO ID:										
*PROPERTY NAME:										
OTHER NAME:										
CURRENT FUNCTION:	Cattle and calving barn	FOUNDATION:	Poured concrete foundation							
CURRENT SUBFUNCTION:	Storage	ROOF MATERIAL:	Steel roofing over cedar shingles							
HISTORIC FUNCTION:	Livestock barn	ROOF SHAPE:	Gambrel							
HISTORIC SUBFUNCTION:	Hay storage	STRUCTURAL SYSTEM:	Balloon framing							
		 STYLE:	Gambrel roof barn							
OCCUPIED:	Yes	TYPE:	Livestock barn							
ACCESSIBLE:	Yes with permission	WALLS:	2x6 studs & 2x8 studs with sheathing and ½"x6" cedar drop siding

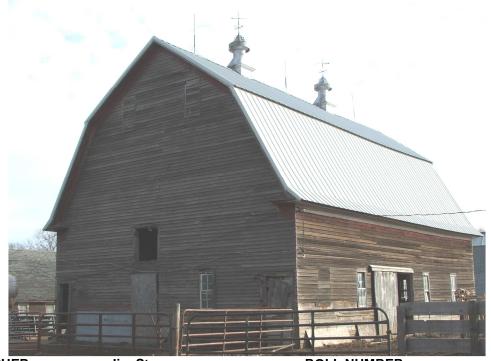
DATE OF PHOTO: November 17, 2012 PHOTO NUMBER: 2

CAMERA DIRECTION: Looking NW, SE corner

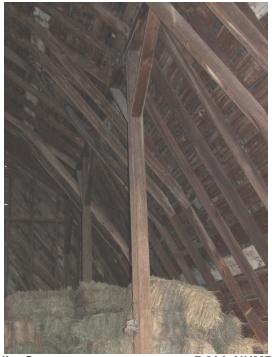
Hayloft, looking North, 4x6 posts & 6x6 beam

CAMERA DIRECTION: supporting hip

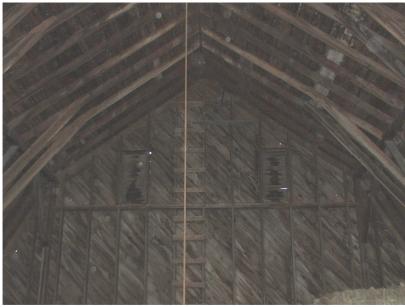
Hayloft, looking North, 4x6 posts 6x6 beam & (2)

CAMERA DIRECTION: 1x6 bracing on hip
