**SOUTH DAKOTA STATE HISTORIC PRESERVATION OFFICE
HISTORIC SITES SURVEY STRUCTURE FORM**

*SURVEY DATE: April 30, 2013 *ADDRESS: 29917 University Road
*SURVEYOR: Jim Stone *COUNTY: Clay
*CITY: Beresford

CURRENT FUNCTION: Horse barn FOUNDATION: Poured concrete
Steel roofing over

HISTORIC FUNCTION: Livestock barn ROOF SHAPE: Gable

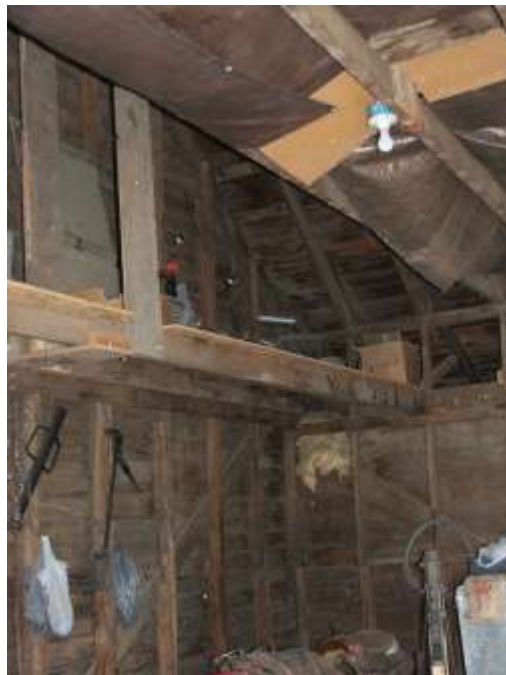
ROLL NUMBER: _____
PHOTO NUMBER: 4
CAMERA DIRECTION: First floor, looking NW,
2x6 stud walls , 4' of
hayloft floor on West
wall

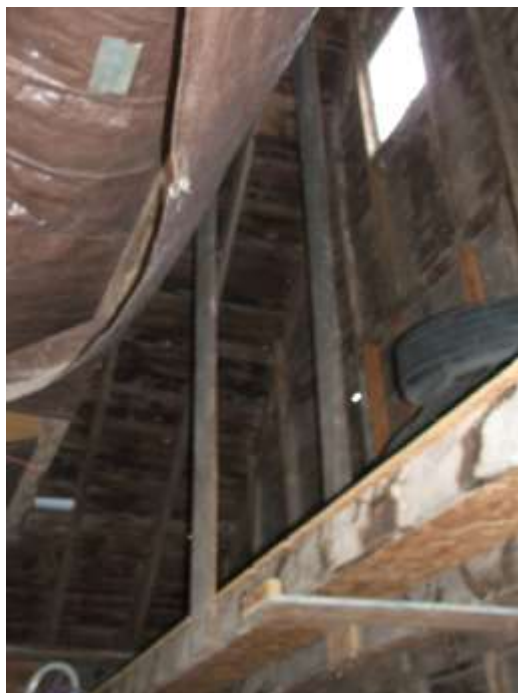
ROLL NUMBER: _____
PHOTO NUMBER: 5

CAMERA DIRECTION: First floor, looking NE. 4' hayloft floor on East wall.
