```SITE INFORMATION

*ADDRESS: 30520 458th Ave. *COUNTY: Clay *CITY: Wakonda

SHPO ID:			
*PROPERTY NAME:			
OTHER NAME:			
CURRENT FUNCTION:	Machinery storage	FOUNDATION:	Poured concrete
CURRENT SUBFUNCTION:	Calving barn	ROOF MATERIAL:	Steel roofing over cedar shingles
HISTORIC FUNCTION:	Livestock barn	ROOF SHAPE:	Gable roof
HISTORIC SUBFUNCTION:	Hay storage	STRUCTURAL SYSTEM:	Balloon framing
		STYLE:	Western feeder barn barn
OCCUPIED:	Yes	TYPE:	Livestock barn
ACCESSIBLE:	Yes with permission	WALLS:	2x6 studs, and 1x6 #106 drop siding
STORIES:	2	SIGNIFICANT PERSON:	Olaf Skonhovd
*DATE OF CONSTRUCTION:	1915 - 1920	CULTURAL AFFILIATION:	?

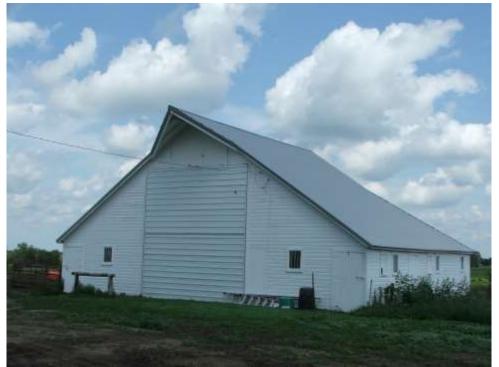
1

CAMERA DIRECTION: Looking NE, SW corner

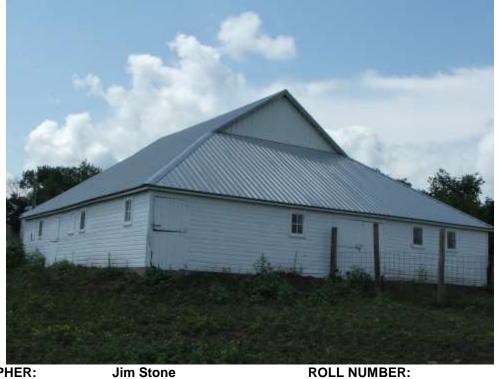
ROLL NUMBER: 2 PHOTO NUMBER: CAMERA DIRECTION: Looking NW, SE corner

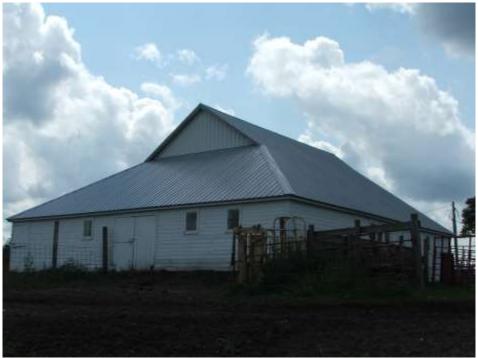
DATE OF PHOTO:
 August 12, 2013
 PHOTO NUMBER:
 3

CAMERA DIRECTION:
 Looking SW, NE corner

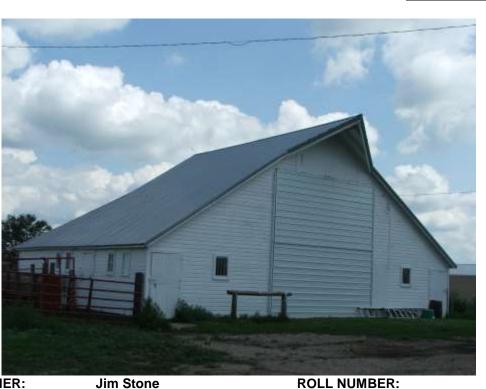
PHOTOGRAPHER:	Jim Stone	ROLL NUMBER:	
DATE OF PHOTO:	August 12, 2013	PHOTO NUMBER:	4
		CAMERA DIRECTION:	Looking SE, NW corner

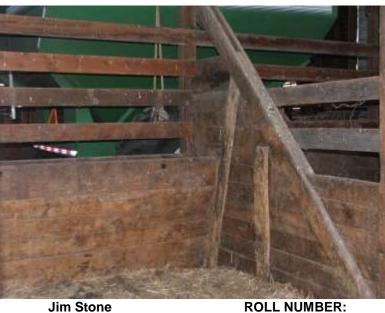
PHOTO NUMBER: 6 First floor, looking SE in original barn horse stall CAMERA DIRECTION: on North side.

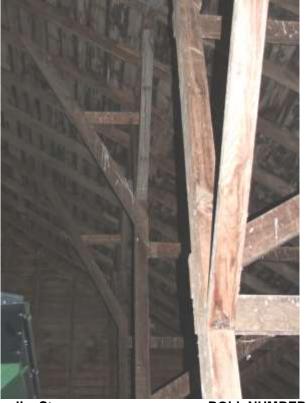
7
 looki

First floor, looking SE, 4x6 posts 8' O. C.,1x6 bracing supporting rafters.
