**SOUTH DAKOTA STATE HISTORIC PRESERVATION OFFICE
HISTORIC SITES SURVEY STRUCTURE FORM**

*SURVEY DATE: May 29, 2013 *ADDRESS: 46125 311th Street
*SURVEYOR: Jim Stone *COUNTY: Clay
*CITY: Vermillion

CURRENT FUNCTION: Storage FOUNDATION: Poured concrete
 CURRENT SUBFUNCTION: Storage ROOF MATERIAL: Cedar shingles
 HISTORIC FUNCTION: Livestock barn ROOF SHAPE: Gable
 HISTORIC SUBFUNCTION: Hay and grain storage STRUCTURAL SYSTEM: Balloon framing
 OCCUPIED: Yes STYLE: Gable roof barn
 TYPE: Livestock barn
2x6 studs, 1x8 diagonal sheathing, 1/2"x6" cedar lap siding

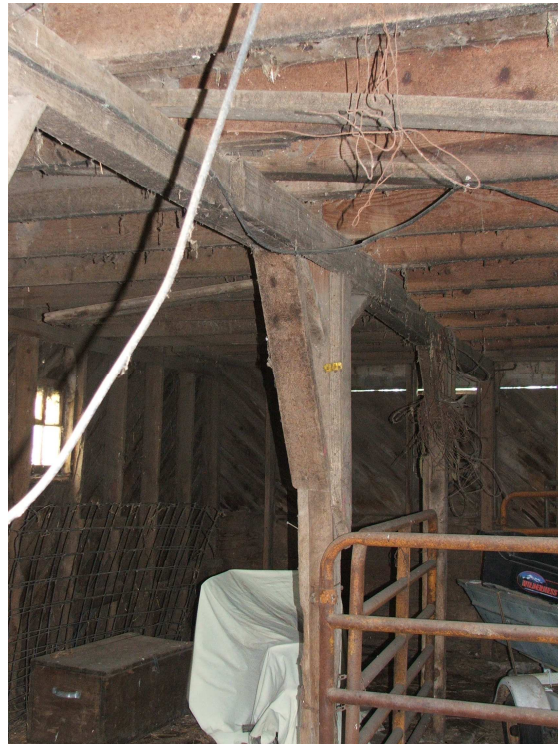
ROLL NUMBER: 5
PHOTO NUMBER: 5

*PHYSICAL NOTES: Barn is in good condition. The diagonal sheathing keeps the barn plumb and straight.

CAMERA DIRECTION: First floor, looking NW,
4x6 post, 4x6 beam, 2x8
joists, note diagonal
sheathing on wall.

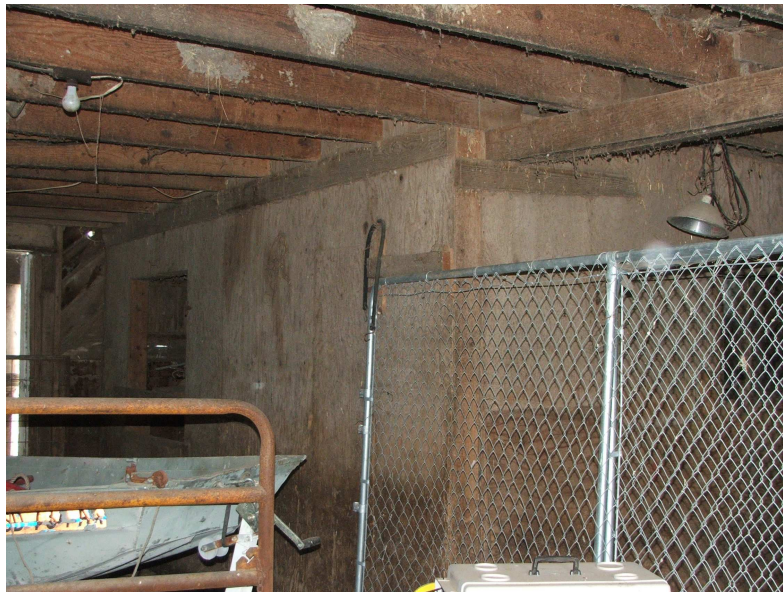
ROLL NUMBER: 6
PHOTO NUMBER: 6

INTERIOR NOTES: Two rows of 4x6 posts and 4x6 beams. 2x8 floor joists for hayloft floor. 8' x 16' granary in the NE corner, may have been added later. All evidence of horse stalls or milk cow stanchions has been removed.

CAMERA DIRECTION: First floor, looking NE,
granary in NE corner.

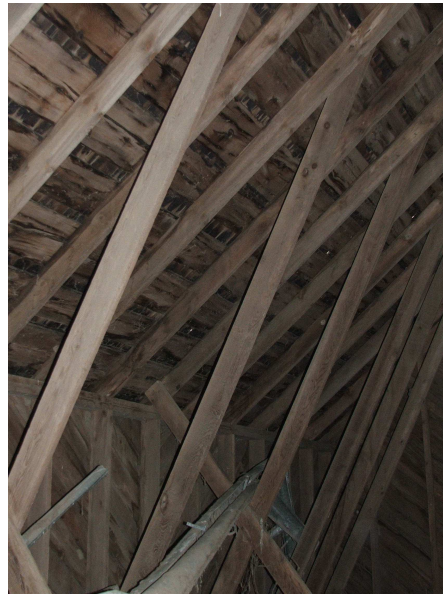
ROLL NUMBER: _____
PHOTO NUMBER: 7

**Hayloft, looking NW, 2x6
rafters with 2x6 brace
from center of rafters
down to the floor and
2x6 brace from top of
wall out to floor, both 4'
O.C.**

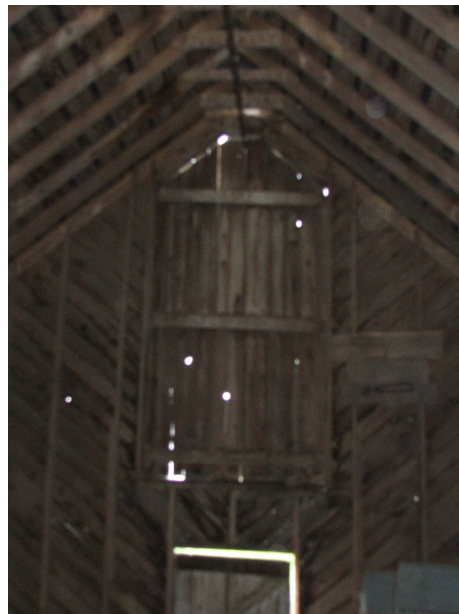
ROLL NUMBER: _____
PHOTO NUMBER: 8

**Hayloft, looking South,
double out swing doors
for hayloft doors.**
