**SOUTH DAKOTA STATE HISTORIC PRESERVATION OFFICE
HISTORIC SITES SURVEY STRUCTURE FORM**

*SURVEY DATE: Aug. 2, 2012 *ADDRESS: 31229 Greenfield Road
*SURVEYOR: Jim Stone *COUNTY: Clay
*CITY: Vermillion

CURRENT FUNCTION:	<u>Cattle barn</u>	FOUNDATION:	<u>Poured concrete</u>
CURRENT SUBFUNCTION:	<u>Straw storage</u>	ROOF MATERIAL:	<u>Steel over cedar shingles</u>
HISTORIC FUNCTION:	<u>Livestock barn</u>	ROOF SHAPE:	<u>Gambrel</u>
HISTORIC SUBFUNCTION:	<u>Hay and grain storage</u>	STRUCTURAL SYSTEM:	<u>Balloon framing</u>
		STYLE:	<u>Gambrel roof barn</u>
OCCUPIED:	<u>Yes</u>	TYPE:	<u>Livestock barn</u>
	<u>Yes with</u>		<u>2x6, 1x6 #106 drop</u>
ACCESSIBLE:	<u>permission</u>	WALLS:	<u>siding</u>

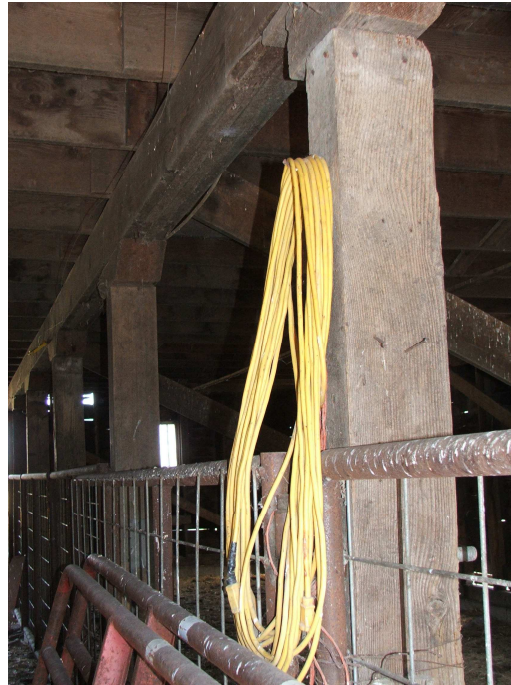
ROLL NUMBER: _____
PHOTO NUMBER: 5

INTERIOR NOTES: Has two rows 6x8 posts and (4) 2x8's for a beam. 2x10 floor joists. Has two massive 6"x 10" timbers used as bracing for the West hayloft gable end wall. These timbers are attached to the wall about 10' above the hayloft floor and down through the floor and are attached to the beams that support the hayloft floor. Has three double 2x6's for posts to support the hip on each side.

CAMERA DIRECTION: First floor, looking East,
6x8 posts and (4) 2x8's
for a beam

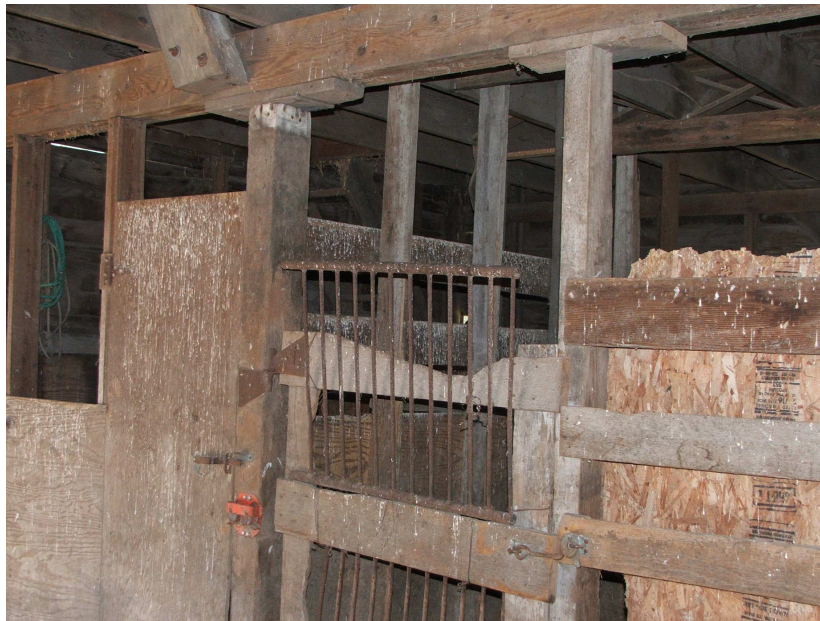
ROLL NUMBER: _____
PHOTO NUMBER: 6

ALTERED/MOVED NOTES: Original site. All but one horse stall, calf pen and stairs have been removed. Roof re-roofed with steel roofing.

CAMERA DIRECTION: First floor, looking NW,
horse pen/stall and feed
room in the NW corner

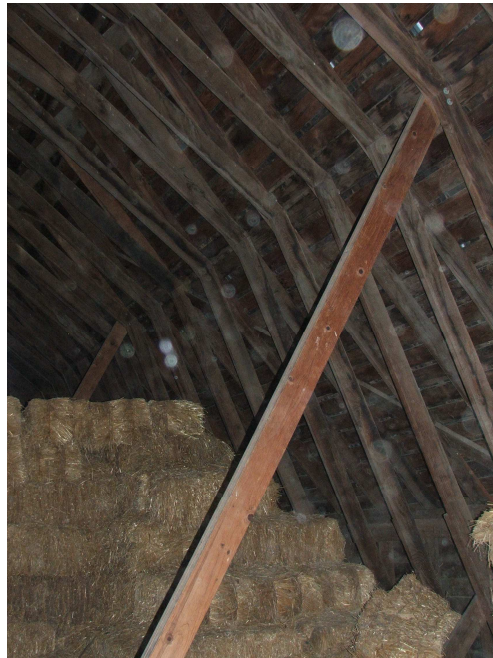
ROLL NUMBER: _____
PHOTO NUMBER: 7

CAMERA DIRECTION: Hayloft, looking East, (2)
2x6's for post to support
hip

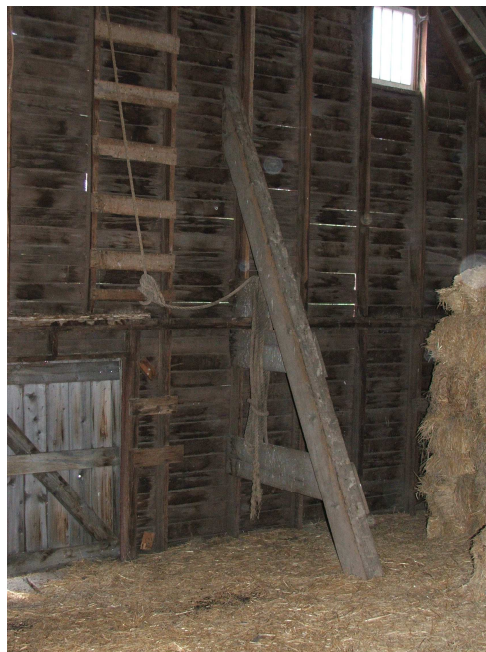
ROLL NUMBER: _____
PHOTO NUMBER: 8

CAMERA DIRECTION: Hayloft, looking West,
one of two massive
6"x10" timbers to brace
the West gable end wall
