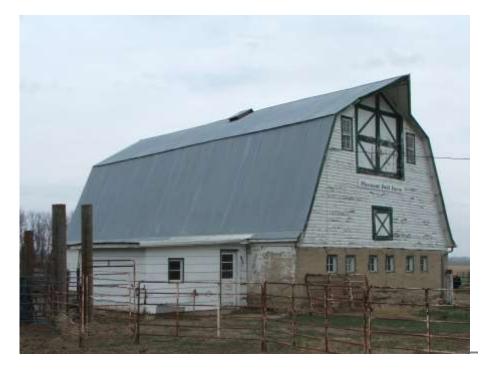
PHOTOGRAPHER: Jim Stone ROLL NUMBER: DATE OF PHOTO: April 7, 2013 PHOTO NUMBER: 1

CAMERA DIRECTION: Looking NE, SW corner

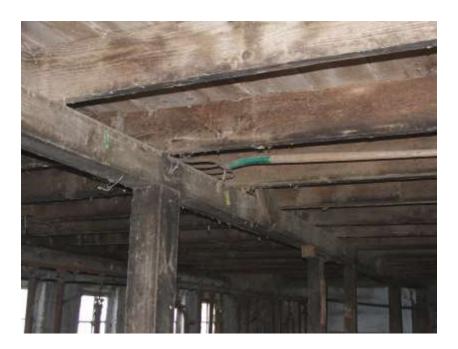
PHOTOGRAPHER: Jim Stone ROLL NUMBER: DATE OF PHOTO: April 7, 2013 PHOTO NUMBER: 4

CAMERA DIRECTION: Looking SE, NW corner

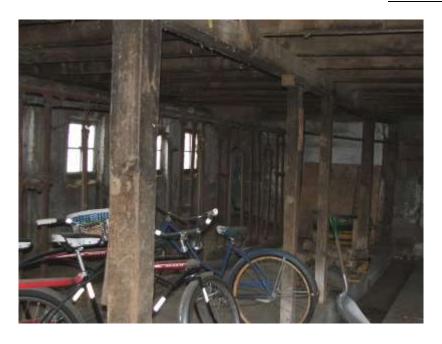
First floor, looking SW, 6x6 posts, 6x6 beam and 2x8 floor joists, running

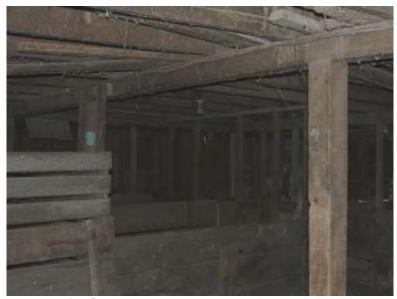
PHOTO NUMBER: 6

First floor, looking SW, (9) milk cow stanchions

CAMERA DIRECTION: on South wall

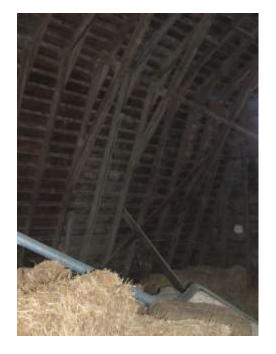
8

Hayloft, looking NW, double 1x6' bracing on hip, note 2x6 diagonal

CAMERA DIRECTION: bracing.
