**SOUTH DAKOTA STATE HISTORIC PRESERVATION OFFICE
HISTORIC SITES SURVEY STRUCTURE FORM**

*SURVEY DATE: February 5, 2013 *ADDRESS: 30239 463rd Ave.
*SURVEYOR: Jim Stone *COUNTY: Clay
*CITY: Centerville

CURRENT FUNCTION: Shop FOUNDATION: Native stone
CURRENT SUBFUNCTION: Storage ROOF MATERIAL: Cedar shingles
HISTORIC FUNCTION: Livestock barn ROOF SHAPE: Gable
HISTORIC SUBFUNCTION: Hay storage STRUCTURAL SYSTEM: Balloon framing
STYLE: Gable roof barn
OCCUPIED: No TYPE: Livestock barn
2x4 studs, 1x6 #106 drop siding & 1/2"x6" cedar lap siding

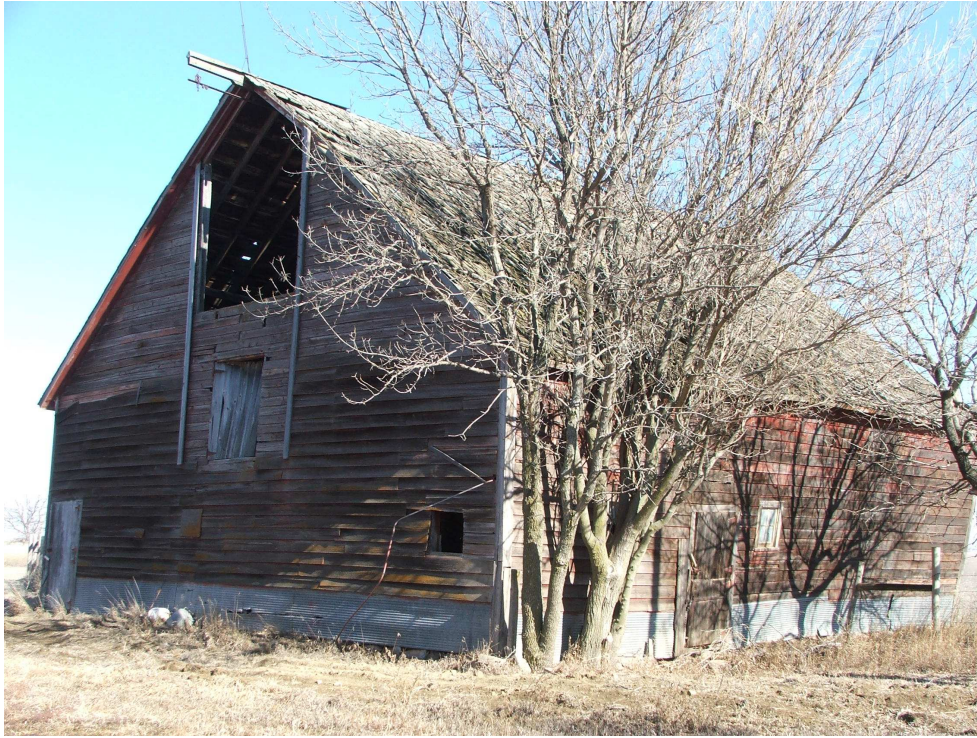
ROLL NUMBER: _____
PHOTO NUMBER: 1
CAMERA DIRECTION: Looking NE, SW corner

*PHYSICAL NOTES: Barn is in very poor condition. Barn is off the concrete foundation on the North side and is leaning to the South as per pictures. Roof is leaking very bad. Wooden cupola has fallen over and is laying on the South side of the roof.

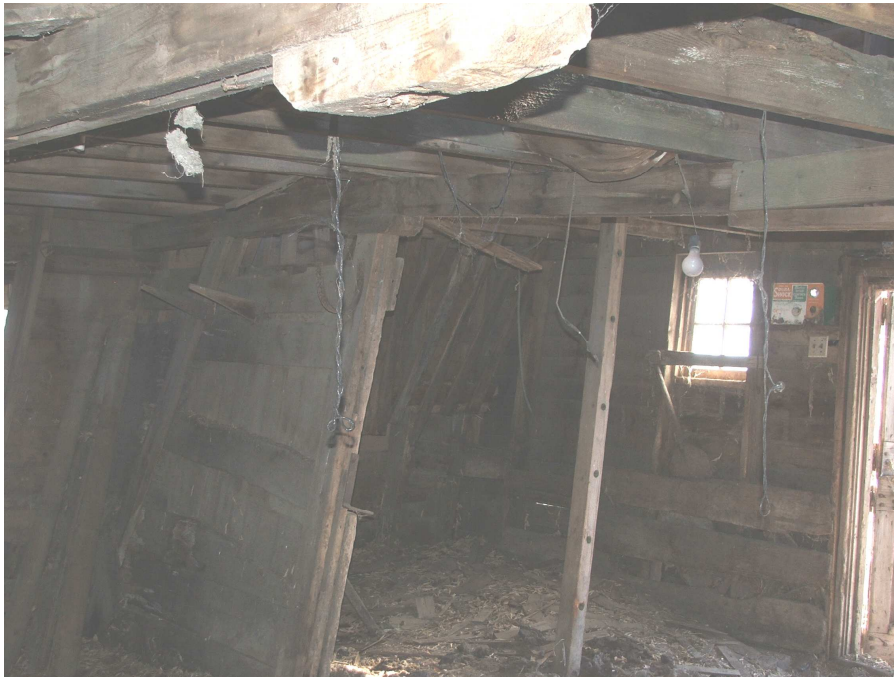
ROLL NUMBER: _____
PHOTO NUMBER: 5
CAMERA DIRECTION: First floor, looking SE,
double horse stalls

INTERIOR NOTES: Has two rows of 4x6 posts, with (2) 2x6's for a beam and a 2x6 solid wall in 12' from the North wall. Floor joists are 2x8's. parts of the three double horse stalls are still in place. 4' x 9' granary is still in the SW corner.

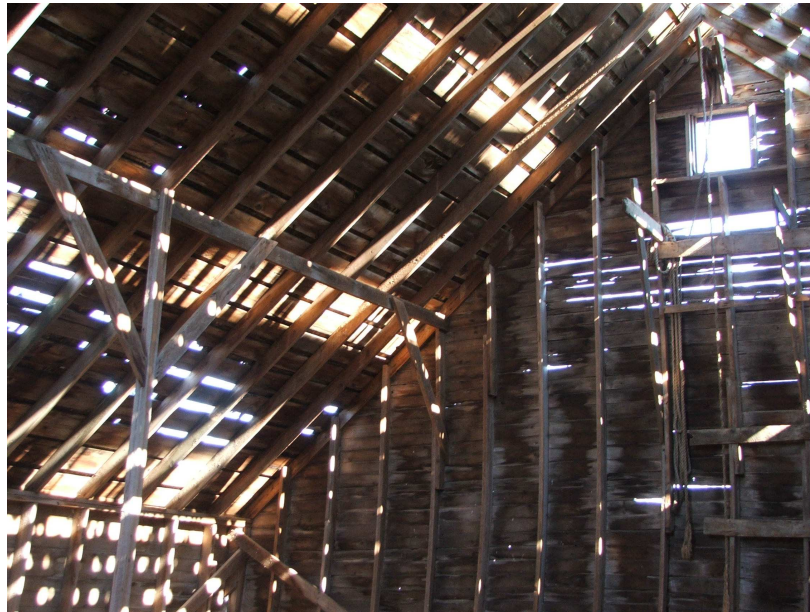
ROLL NUMBER: _____
PHOTO NUMBER: 7

Hayloft, looking SE, 4x4 post with 2x6 beam and bracing supporting rafters.

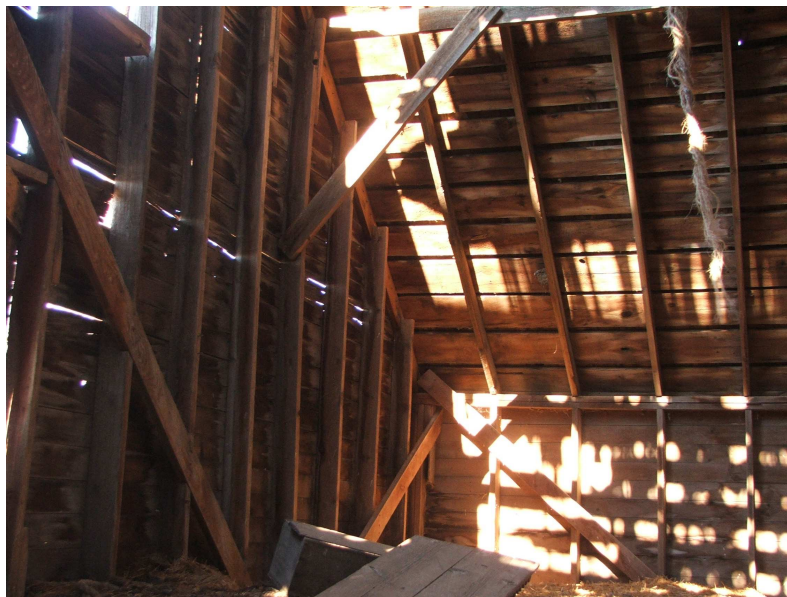
ROLL NUMBER: _____
PHOTO NUMBER: 8

Hayloft, looking NW, 4' - 8" wall in Hayloft and bracing on gable end wall
