SITE INFORMATION

STRUCTURE DETAILS

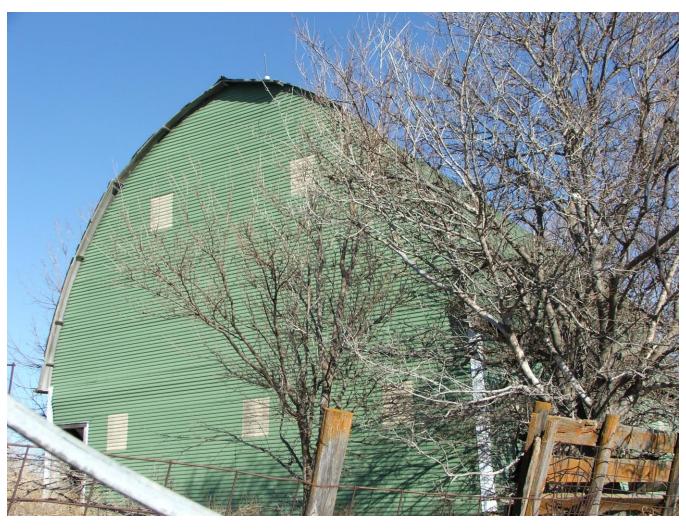
PHOTOGRAPHER: Jim Stone ROLL NUMBER: DATE OF PHOTO: February 12, 2013 PHOTO NUMBER: 1
CAMERA DIRECTION: Looking NE, SW corner

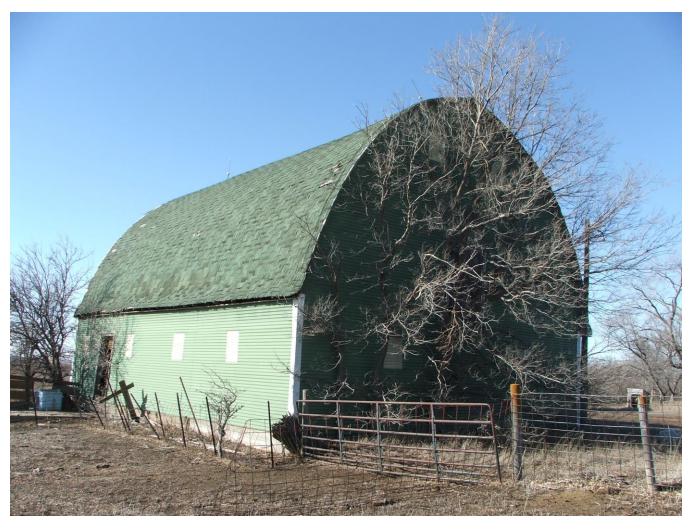
PHOTOGRAPHER: Jim Stone ROLL NUMBER: DATE OF PHOTO: February 12, 2013 PHOTO NUMBER: 2
CAMERA DIRECTION: Looking NW, SE corner

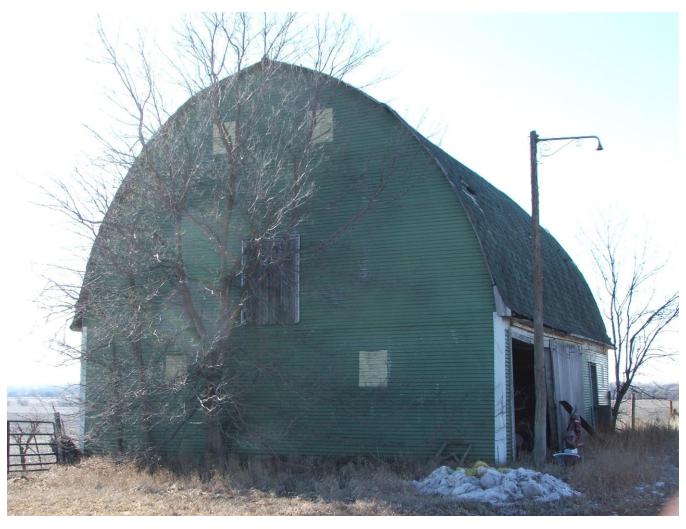
PHOTOGRAPHER: Jim Stone ROLL NUMBER: DATE OF PHOTO: February 12, 2013 PHOTO NUMBER: 3
CAMERA DIRECTION: Looking SW, NE corner

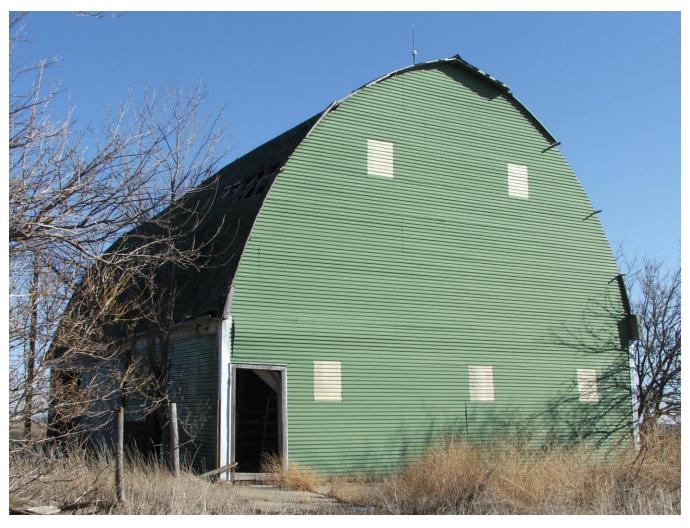
PHOTOGRAPHER: Jim Stone ROLL NUMBER: DATE OF PHOTO: February 12, 2013 PHOTO NUMBER: 4
CAMERA DIRECTION: Looking SE, NW corner

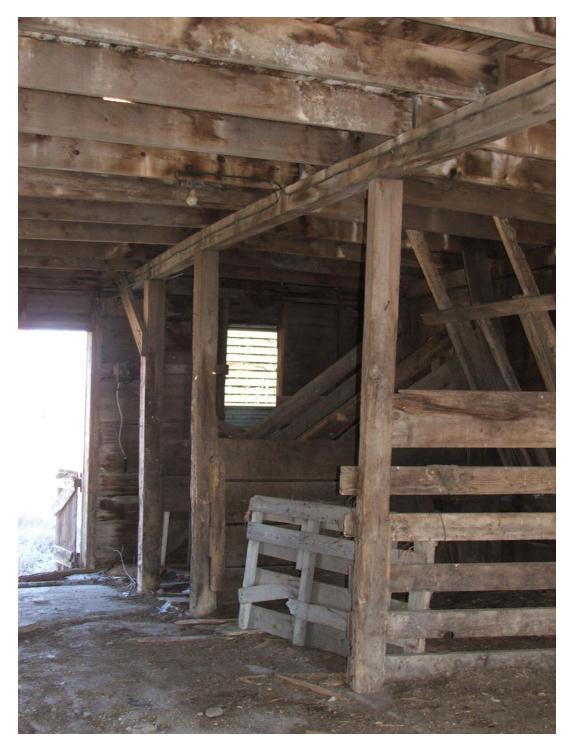
First floor, West side,

looking NE, two horse Stalls still in West side

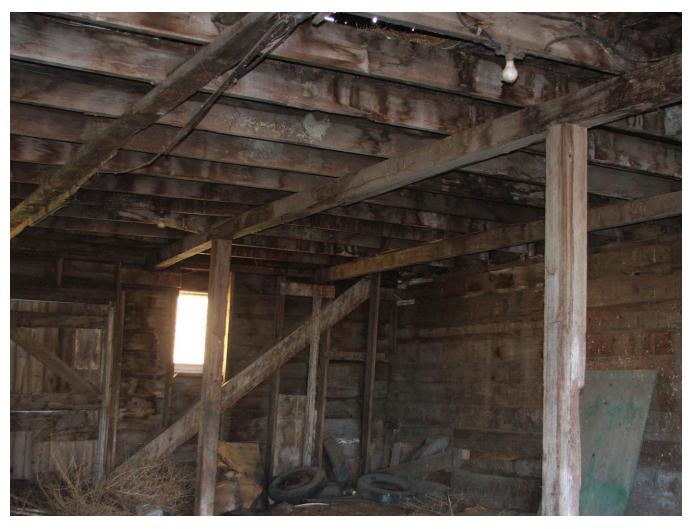
6

First floor, East side, looking SW, posts and beam, (2) 2x6 beam and 2x6 solid wall, note

CAMERA DIRECTION: missing posts.

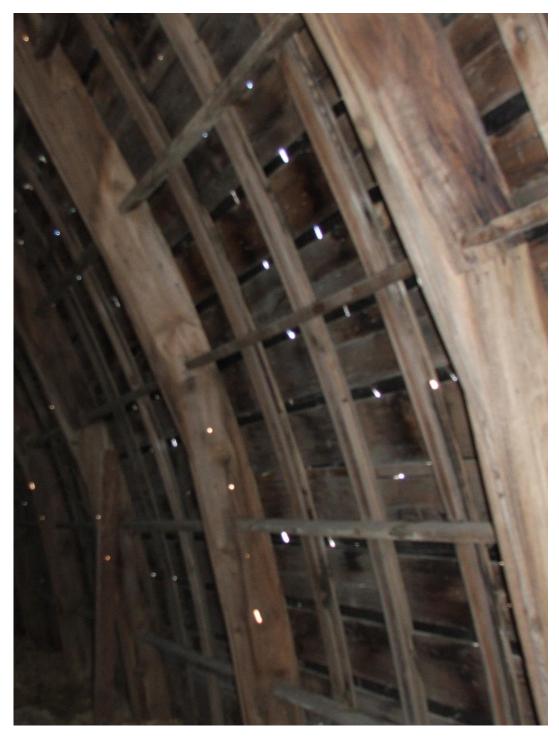
Hayloft, looking SE, 1x12 rafters 8' O.C., 2x4 horizontal purlins 2'O. C. and vertical three ply

CAMERA DIRECTION: rafters 2. O. C.

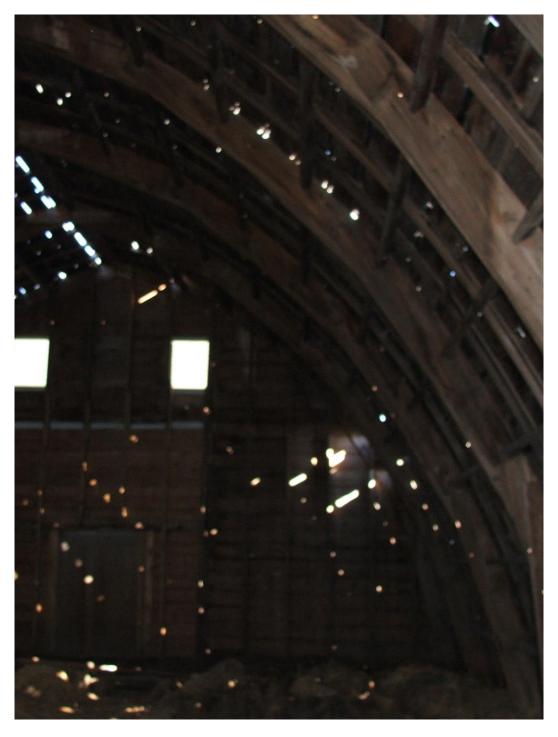
Hayloft, looking East, rafters and East gable

CAMERA DIRECTION: end

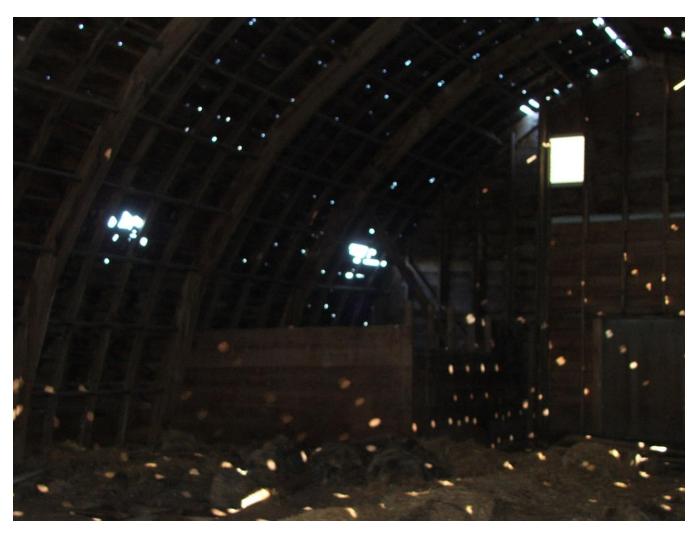
9

Hayloft, looking NE, 12' x 14' granary in the NE corner of hayloft

CAMERA DIRECTION: corner of hayloft.

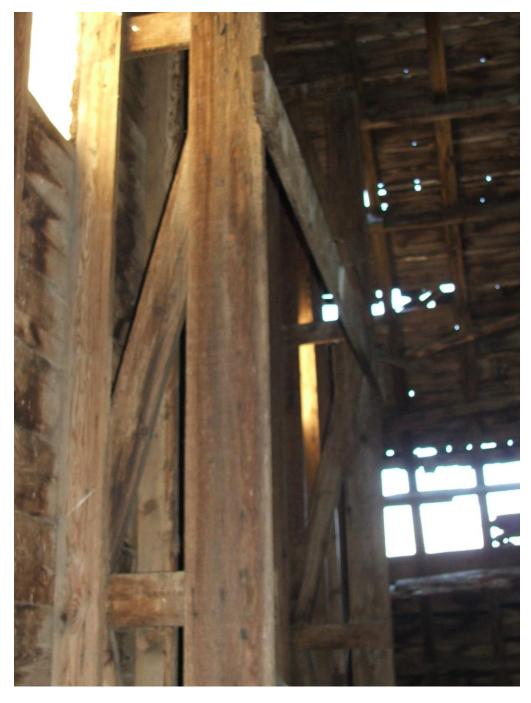
10

Hayloft, looking North, 2x10 vertical bracing, 10' O. C., strengthening the

CAMERA DIRECTION: gable ends.
