**SOUTH DAKOTA STATE HISTORIC PRESERVATION OFFICE
HISTORIC SITES SURVEY STRUCTURE FORM**

*SURVEY DATE: March 28, 2014 *ADDRESS: 29728 SD 19
*SURVEYOR: Jim Stone *COUNTY: Clay
*CITY: Centerville

CURRENT FUNCTION: Vacant FOUNDATION: Poured concrete
 CURRENT SUBFUNCTION: Vacant ROOF MATERIAL: Asphalt shingles over cedar shingles
 HISTORIC FUNCTION: Livestock barn ROOF SHAPE: Gothic round roof
 HISTORIC SUBFUNCTION: Hay and grain storage STRUCTURAL SYSTEM: Balloon framing
 OCCUPIED: Yes STYLE: Gothic round roof barn
 TYPE: Livestock barn
2x6 studs, 1x8 shiplap, 1/2"x 6" cedar lap siding and steel roofing on North wall only

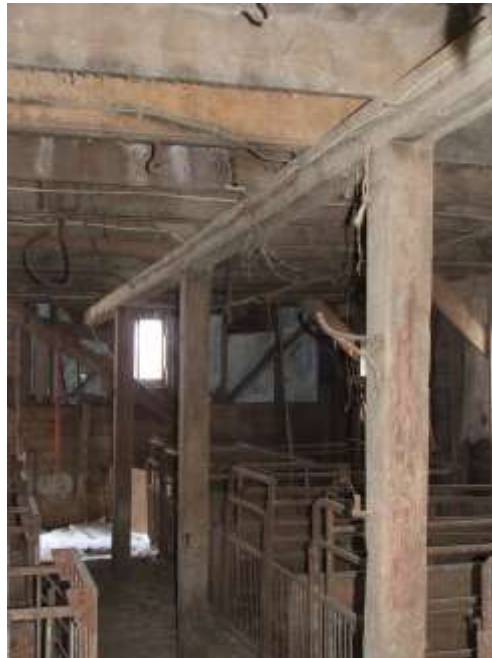
ROLL NUMBER: _____
PHOTO NUMBER: 5

**First floor, looking NE,
6x6 posts, 6x6 beams
and 2x8 floor joists,
posts are 10' O.C.**

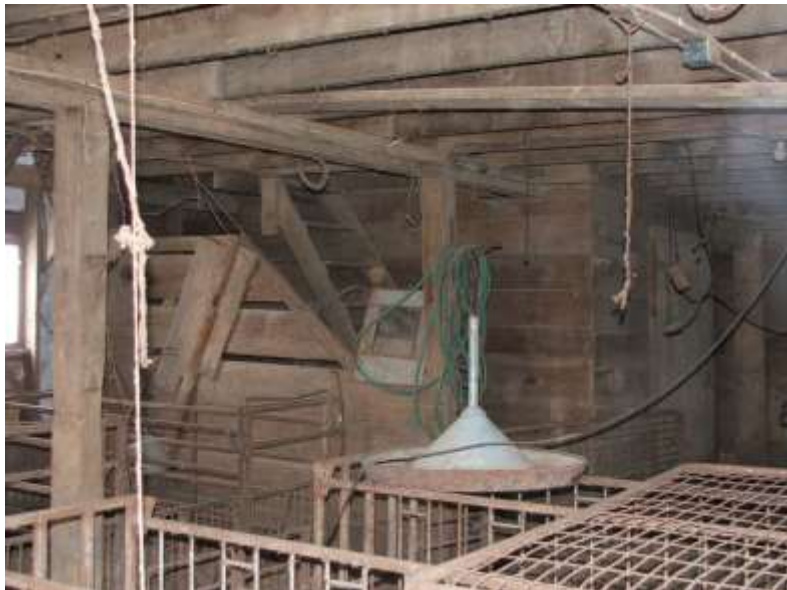
ROLL NUMBER: _____
PHOTO NUMBER: 6

**First floor, looking SE,
6x6 posts, 6x6 beam and
2x8 floor joists, granary
and stairs in the SE
corner of original barn.**

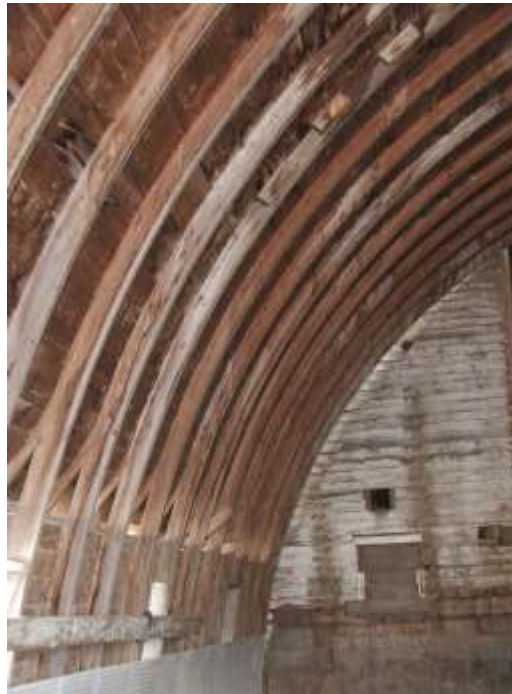
ROLL NUMBER: _____
PHOTO NUMBER: 7

CAMERA DIRECTION: Looking NW, in addition, laminated rafters with (3) courses of 8" concrete blocks for a wall.

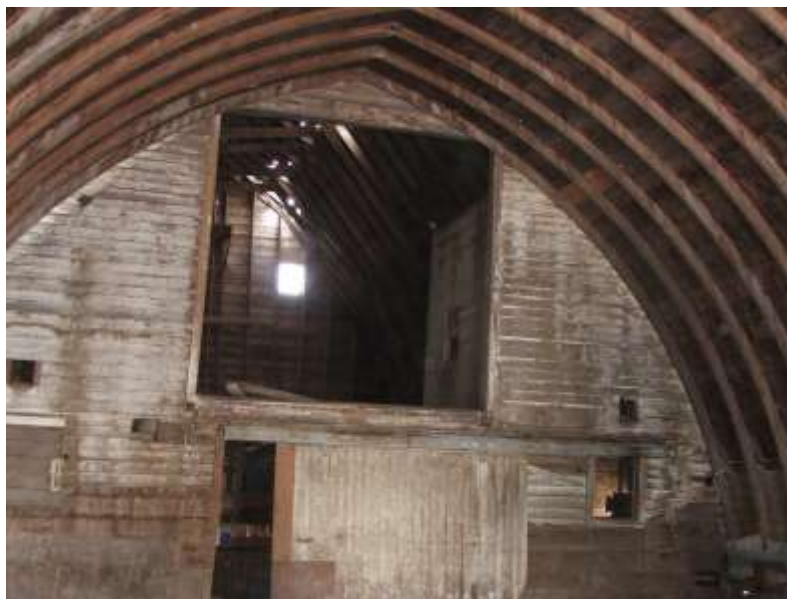
ROLL NUMBER: _____
PHOTO NUMBER: 8

CAMERA DIRECTION: Looking North, at South side of original barn from inside the addition.

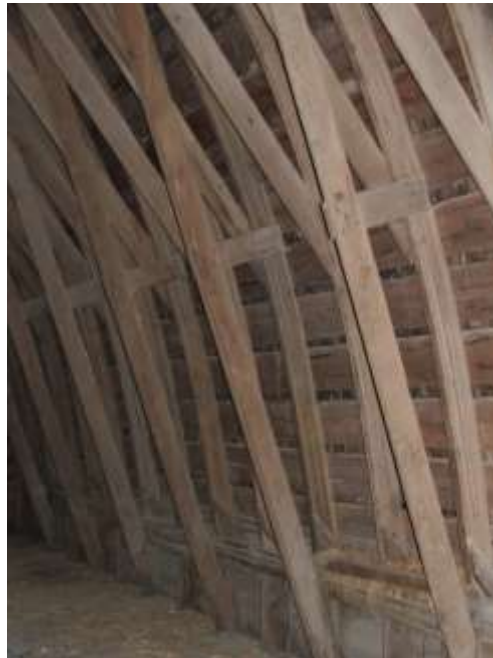
ROLL NUMBER: _____
PHOTO NUMBER: 9

**Hayloft, looking NE,
laminated rafters with
1x6 bracing 4' O. C.**

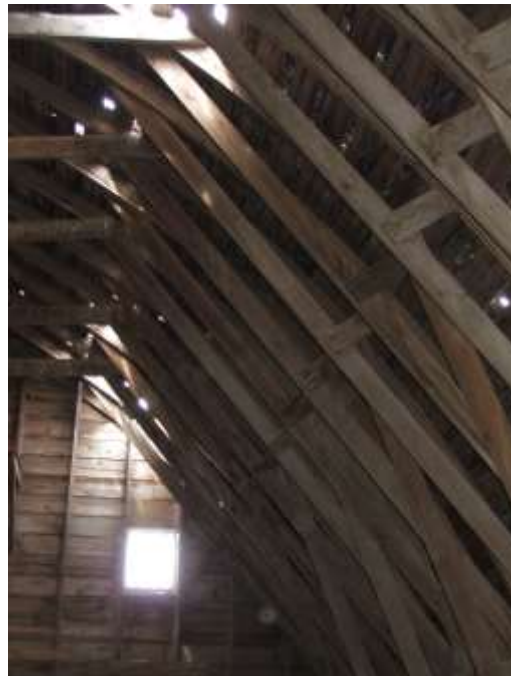
ROLL NUMBER: _____
PHOTO NUMBER: 10

**Hayloft, looking NE,
laminated rafters with
1x6 bracing 4' O. C.**

CAMERA DIRECTION: upper part of rafters.

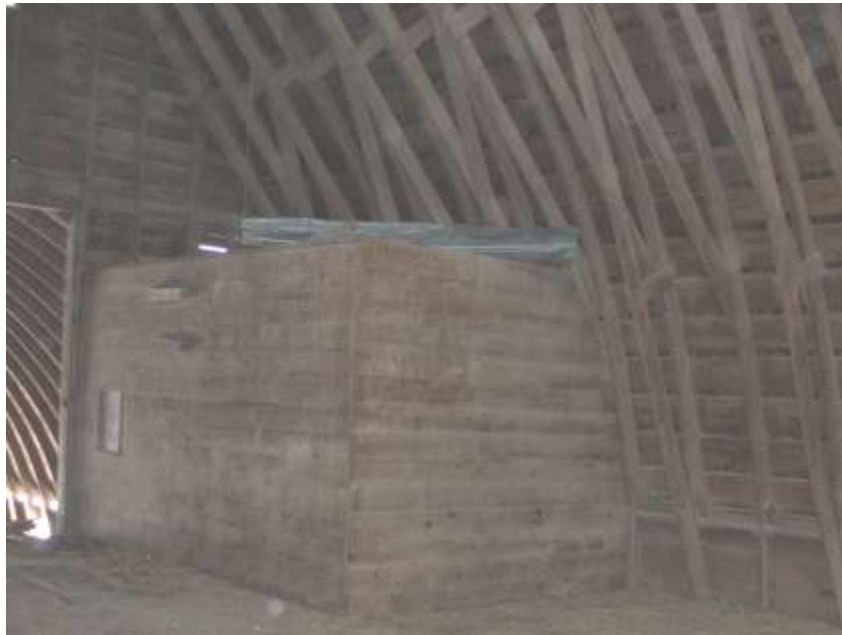
ROLL NUMBER: _____
PHOTO NUMBER: 11

CAMERA DIRECTION: Hayloft, looking at 10' x 14' granaries extended into hayloft in SW corner

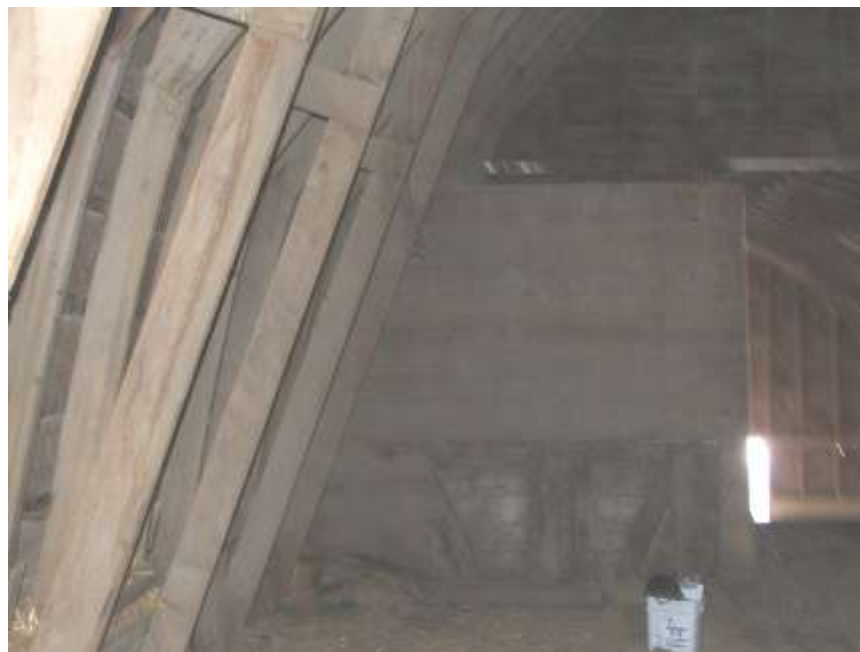
ROLL NUMBER: _____
PHOTO NUMBER: 12

CAMERA DIRECTION: Hayloft, looking SE at 8' x 10' granary extended up into hayloft in the SE corner.
