**SOUTH DAKOTA STATE HISTORIC PRESERVATION OFFICE
HISTORIC SITES SURVEY STRUCTURE FORM**

*SURVEY DATE: March 15, 2013 *ADDRESS: 46823 298th Street
*SURVEYOR: Jim Stone *COUNTY: Clay
*CITY: Beresford

CURRENT FUNCTION: Boer (meat) goats FOUNDATION: Poured concrete
 CURRENT SUBFUNCTION: Hay storage ROOF MATERIAL: Steel over cedar shingles
 HISTORIC FUNCTION: Horse barn ROOF SHAPE: Gambrel
 HISTORIC SUBFUNCTION: Hay, grain and carriage storage STRUCTURAL SYSTEM: Poured concrete walls
 OCCUPIED: Yes STYLE: Gambrel roof barn
 TYPE: Horse barn
8" x 9' poured concrete, 2x6 studs and 1x8 sheathing on gable ends, embossed steel siding

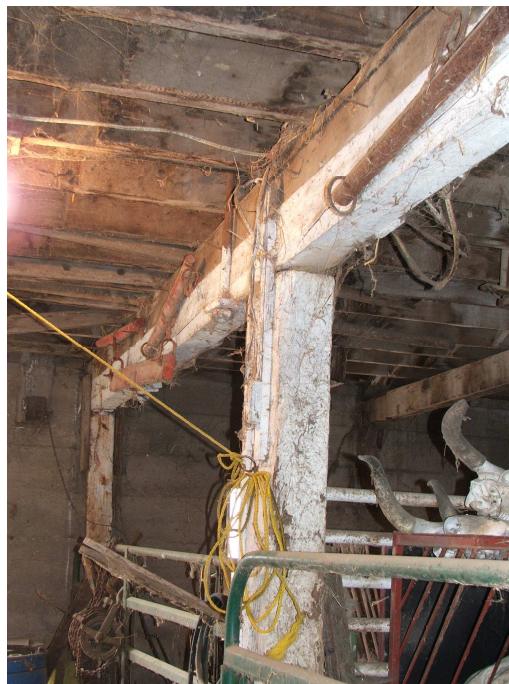
ROLL NUMBER: _____
PHOTO NUMBER: 4
CAMERA DIRECTION: First floor, West side, looking NW, 6x6 post, double 6x8 beam and 2x10 floor joists 16" O. C.

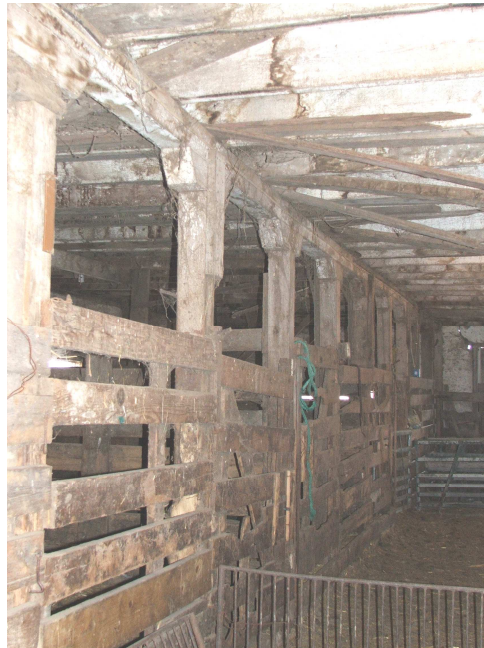
ROLL NUMBER: _____
PHOTO NUMBER: 5

**First floor, East side,
looking NE, 6x6 posts,
6x8 beam, 2x10 floor
joists 24" O. C. Eleven
single horse stalls on
this North side.**

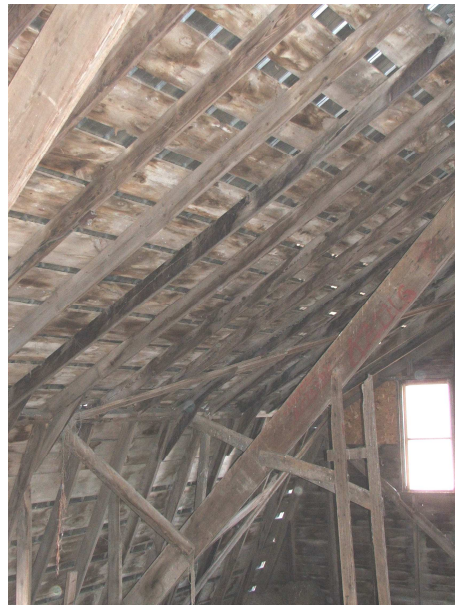
ROLL NUMBER: _____
PHOTO NUMBER: 6

**Hayloft, looking SE, 2x6
rafters, 2x6 brace at the
hip, (3) 1x12's brace 14'
O. C.**

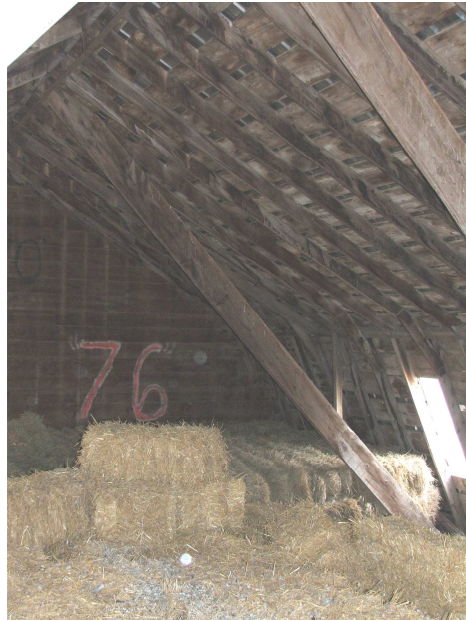
ROLL NUMBER: _____
PHOTO NUMBER: 7

**Hayloft, looking NE, 2x6
rafters, 2x6 brace at the
hip, (3) 1x12's brace 14'
O. C.**

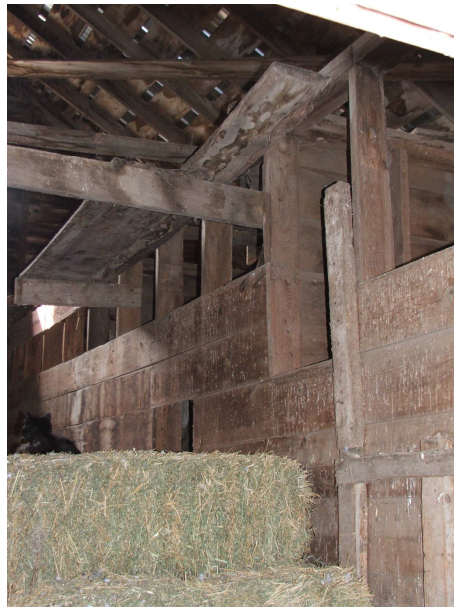
ROLL NUMBER: _____
PHOTO NUMBER: 8

**Hayloft, looking NW in
the West 24', (3) 8' x 14'
granaries on each side,
with hayloft in the center
12'.**
