**SOUTH DAKOTA STATE HISTORIC PRESERVATION OFFICE
HISTORIC SITES SURVEY STRUCTURE FORM**

CURRENT FUNCTION: <u>Vacant</u>	FOUNDATION: <u>Poured concrete</u>		
CURRENT SUBFUNCTION: <u>Storage</u>	ROOF MATERIAL: <u>Steel</u>		
HISTORIC FUNCTION: <u>Livestock barn</u>	ROOF SHAPE: <u>Gambrel</u>		
HISTORIC SUBFUNCTION: <u>Hay and grain storage</u>	STRUCTURAL SYSTEM: <u>Balloon framing</u>		
	STYLE: <u>Gambrel roof barn</u>		
OCCUPIED: <u>Yes</u>	TYPE: <u>Livestock</u>		
	<u>Yes with</u>		
ACCESSIBLE: <u>permission</u>	WALLS: <u>2x6, sheathing and steel</u>		
STORIES: <u>2</u>	SIGNIFICANT PERSON: <u>Patrick Donahue</u>		
*DATE OF CONSTRUCTION: <u>1915 to 1925</u>	CULTURAL AFFILIATION: <u>?</u>

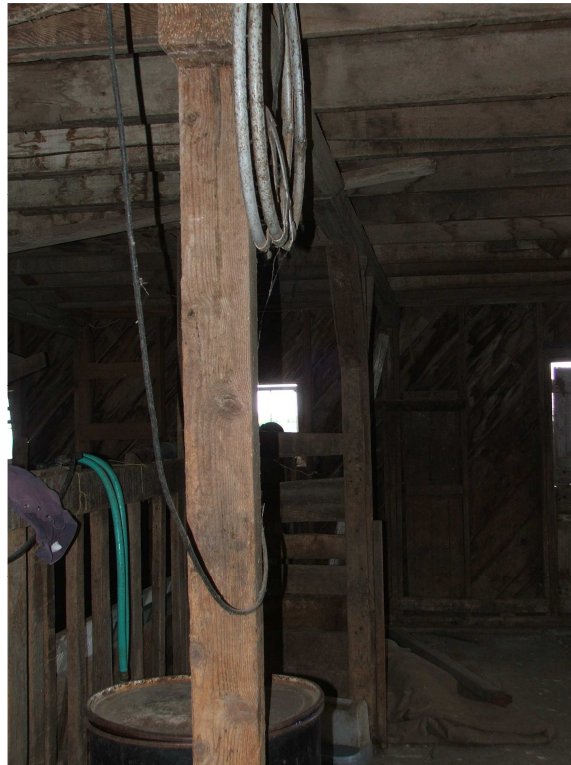
ROLL NUMBER: _____
PHOTO NUMBER: 5
CAMERA DIRECTION: First floor, looking South, post & beam

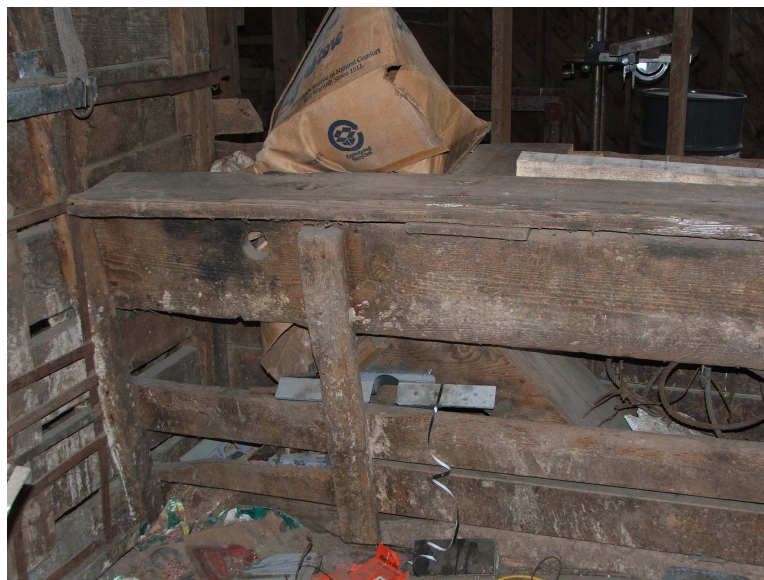
ROLL NUMBER: _____
PHOTO NUMBER: 6
CAMERA DIRECTION: First floor, looking West, manager & horse stall

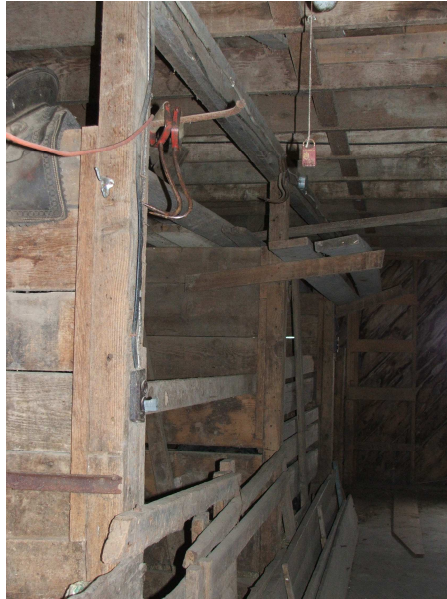
ROLL NUMBER: _____
PHOTO NUMBER: 7

INTERIOR NOTES: Three rows of 6x6 posts and 4x6 beams. 2x8 floor joists. Horse stalls are still in place. Floor joists have bridging to keep joists from tipping over. Used in homes, but I have not seen This in a barn before.

CAMERA DIRECTION: First floor, looking South, posts & beam, note bridging between joists

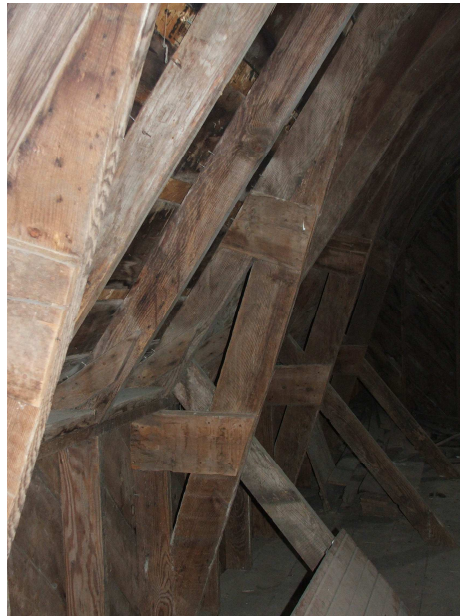
ROLL NUMBER: _____
PHOTO NUMBER: 8

CAMERA DIRECTION: Hayloft, looking North, lower rafter bracing

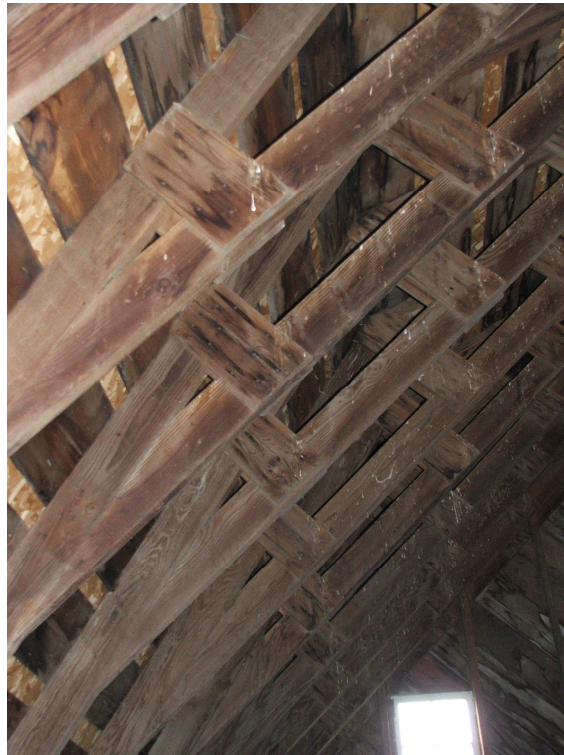
ROLL NUMBER: _____
PHOTO NUMBER: 9
CAMERA DIRECTION: Hayloft, looking North.
upper rafter bracing

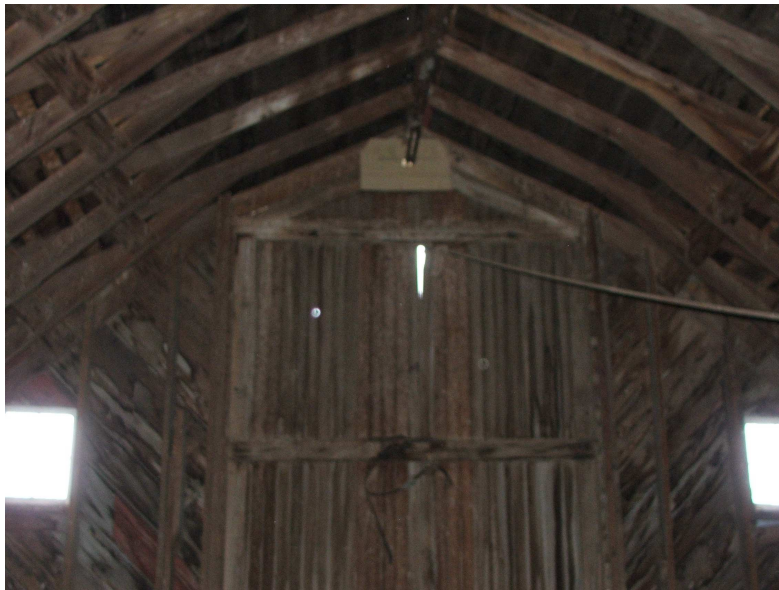
ROLL NUMBER: _____
PHOTO NUMBER: 10
CAMERA DIRECTION: Hayloft, looking North,
hay door in peak
