SITE INFORMATION					
*SURVEY DATE: August 16, 20	13 *ADDRESS: 45668 305 th Street				
*SURVEYOR: Jim Stone	*COUNTY: Clay				
	*CITY: Wakonda				
LOCATION DESCRIPTION: From Vermillion, intersection of South Dakota Highway 50 bi-pass and					
South Dakota Highway 19, North about 12 miles to 305 th Street, turn left (West) about 5-1/4 miles, on the					
right (North) side.					
LEGAL DESCRIPTION: W ½, SE ¼, NE 1/4, 11 – 94 – 53 Bethel Twp.					
*QUARTER 1: SE 1/4	OWNER NAME: Toby J. Harvey				
*QUARTER 2:	OWNER ADDRESS: 45668 305 th Street				
*TOWNSHIP: Bethel	OWNER CITY: Wakonda				
*RANGE: <u>53</u>	OWNER STATE: South Dakota				
*SECTION:11	OWNER ZIP: <u>57073</u>				
ACRES: <u>10.44</u>	QUAD NAME:				
OWNER CODE 1: P					
OWNER CODE 2:					
OWNER CODE 3:					
HISTORIC SIGNIFICANCE					
HISTORIC SIGNIFICANCE					
	REGISTER NAME:				
*DOE DATE: MULTIPLE PROPERTY NAME:					
REASON INELIGIBLE:					
	CATEGORY:

STRUCTURE DETAILS

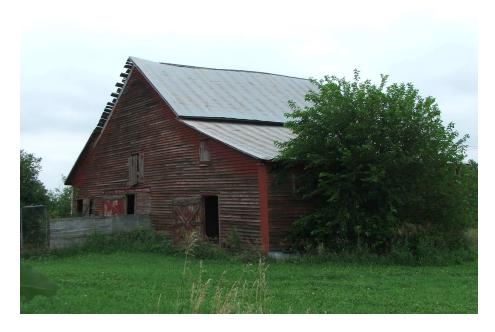
PHOTOGRAPHER: Jim Stone ROLL NUMBER: DATE OF PHOTO: August 16, 2013 PHOTO NUMBER: 1

CAMERA DIRECTION: Looking NE, SW corner

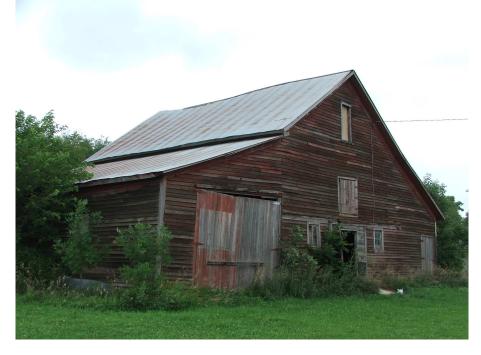
PHOTOGRAPHER: Jim Stone ROLL NUMBER: DATE OF PHOTO: August 16, 2013 PHOTO NUMBER: 2
CAMERA DIRECTION: Looking NW, SE corner

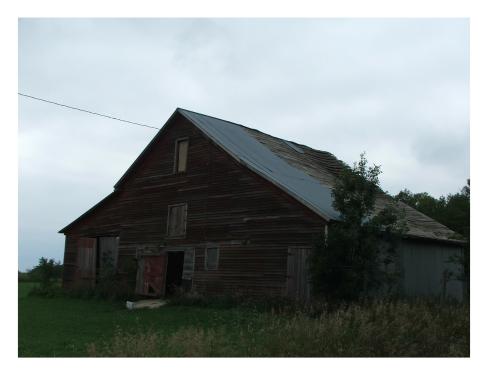
PHOTOGRAPHER: Jim Stone ROLL NUMBER: DATE OF PHOTO: August 16, 2013 PHOTO NUMBER: 3

CAMERA DIRECTION: Looking SW, NE corner

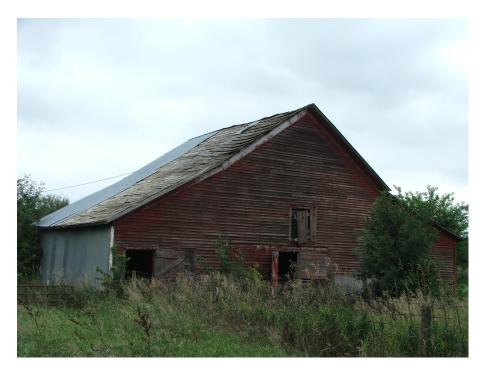
PHOTOGRAPHER: Jim Stone ROLL NUMBER: DATE OF PHOTO: August 16, 2013 PHOTO NUMBER: 4
CAMERA DIRECTION: Looking SE, NW corner
