#### **SITE INFORMATION**

STRUCTURE DETAILS									
SHPO ID:									
*PROPERTY NAME:	Ron Hesla harn								
OTHER NAME:	Non riesia barri								
OTHER HAME.									
CURRENT FUNCTION:	Machinery storage	FOUNDATION:	Poured concrete						
	macrimory crorage		Asphalt shingles						
			over cedar						
CURRENT SUBFUNCTION:	Storage	ROOF MATERIAL:							
HISTORIC FUNCTION:	Livestock barn	ROOF SHAPE:	Gothic round						
HISTORIC SUBFUNCTION:	Hay and grain storage	STRUCTURAL SYSTEM:	Balloon framing						
		STYLE:	Gothic round roof						
OCCUPIED:	Yes	TYPE:	Livestock barn						
	<b>Y</b> 1.1		2x6 and 2x8 with						
ACCESSIBLE:	Yes with permission	WALLS	sheathing and ½" x 6" cedar siding						
ACCESSIBLE.	permission	WALLS.	o cedar sidilig						
STORIES:	2 S	IGNIFICANT PERSON:	Peter S. Hesla						
*DATE OF CONSTRUCTION:			-						
DATE OF CONSTRUCTION:	1920 to 1930 COI	_TURAL AFFILIATION:	Norwegian						
ALTERED/MOVED NOTES: Original site. Horse stalls and stanchions removed. About ½ of the South end of hayloft has been removed. All of the posts and beams have been removed except the last two rows at the North end.

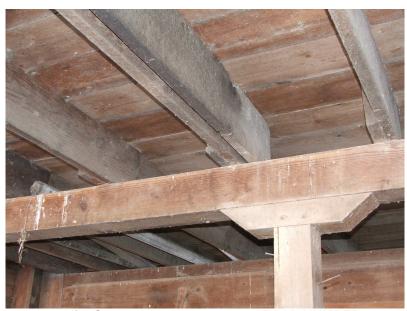
First floor looking South, note floor joists run

CAMERA DIRECTION: length of barn

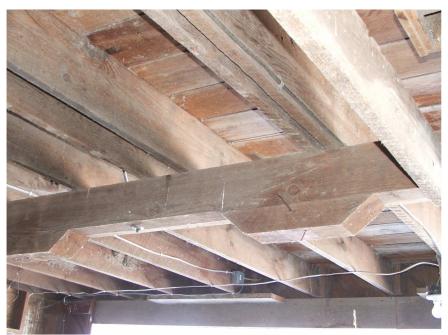
First floor looking North.

Note scarf joint on 6x6

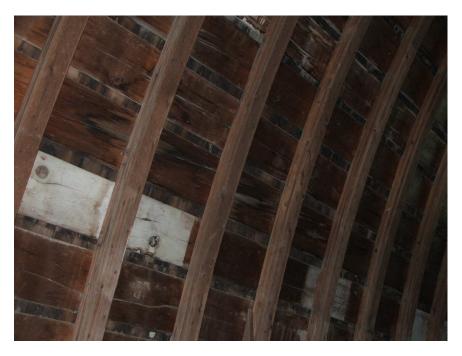
CAMERA DIRECTION: \_five ply round rafter

Hayloft, 3/4" x full 4"

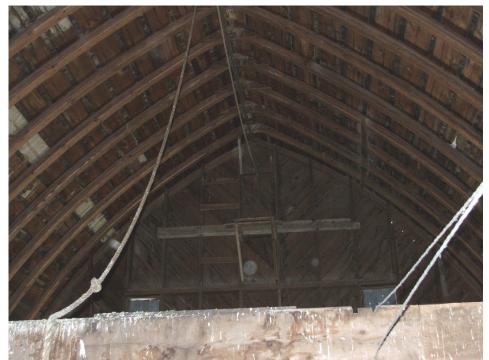
CAMERA DIRECTION: Hayloft looking South

*PHYSICAL NOTES: Barn is in very good condition. Some bracing is required on the South end where									
where the hayloft floor has be	een removed. 2 or 3 cable	es running from the East to We	est walls with a turn-						
buckle would solve the proble	em.
