SITE INFORMATION

STRUCTURE DETAILS

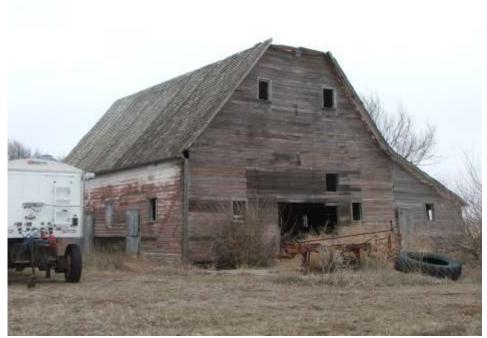
Looking NE, SW corner,

CAMERA DIRECTION: note flat roof at the peak

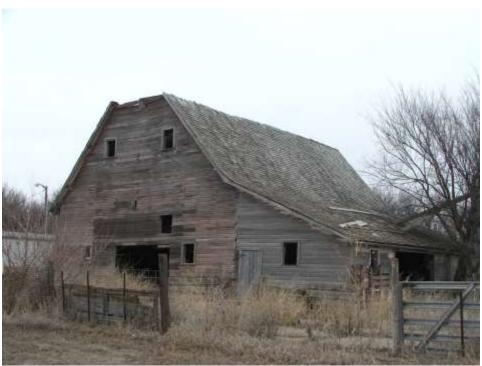
CAMERA DIRECTION: Looking NW, SE corner

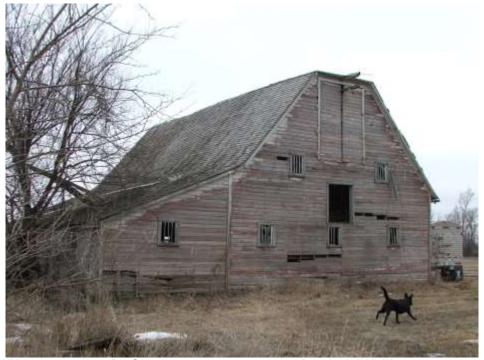
CAMERA DIRECTION: Looking SW, NE corner

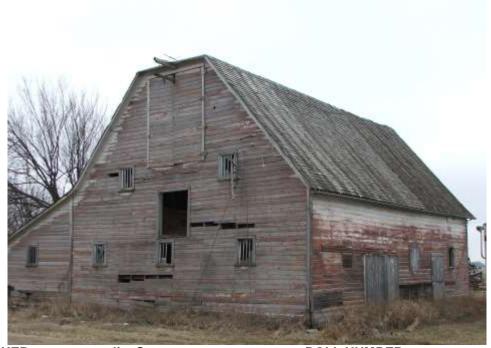
CAMERA DIRECTION: Looking SE, NW corner

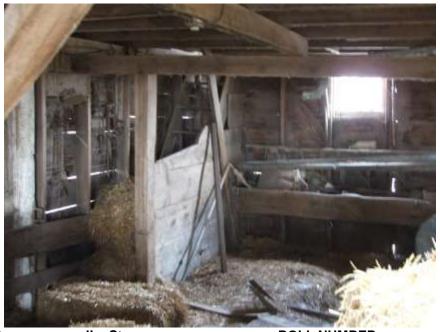
5

First floor, looking NW, 4x6 beams under 4x6 beams, tack room, stairs

CAMERA DIRECTION: and double horse stall

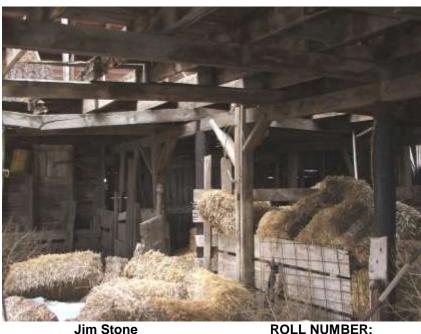
6

First floor, looking NW, 4x6 beam under 4x6

CAMERA DIRECTION: beams, 2x8 floor joists
