**SOUTH DAKOTA STATE HISTORIC PRESERVATION OFFICE
HISTORIC SITES SURVEY STRUCTURE FORM**

*SURVEY DATE: July 20, 2012 *ADDRESS: 30624 470th Ave.
*SURVEYOR: Jim Stone *COUNTY: Union
*CITY: Beresford

CURRENT FUNCTION: Livestock barn FOUNDATION: Poured concrete
Steel over cedar

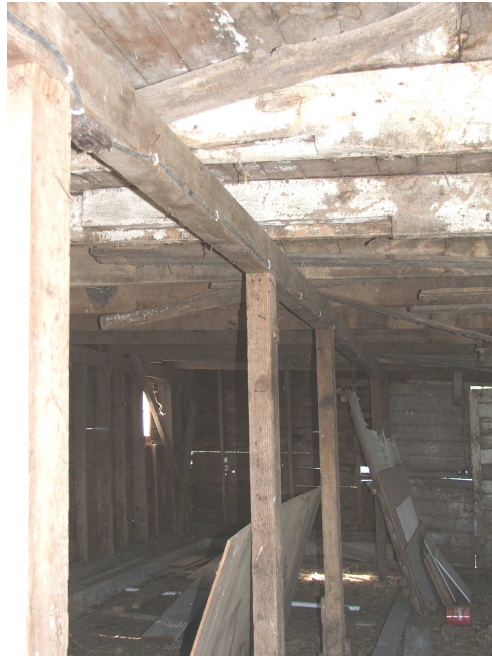
ROLL NUMBER: _____
PHOTO NUMBER: 5

First floor. Looking
North, 4x6 post, 4x6
beam and 2x8 rough
sawn cottonwood

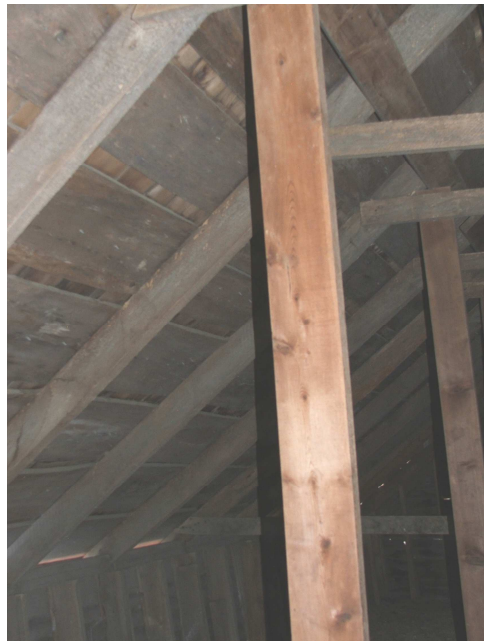
ROLL NUMBER: _____
PHOTO NUMBER: 6

Hayloft, looking North,
2x6 rafter support

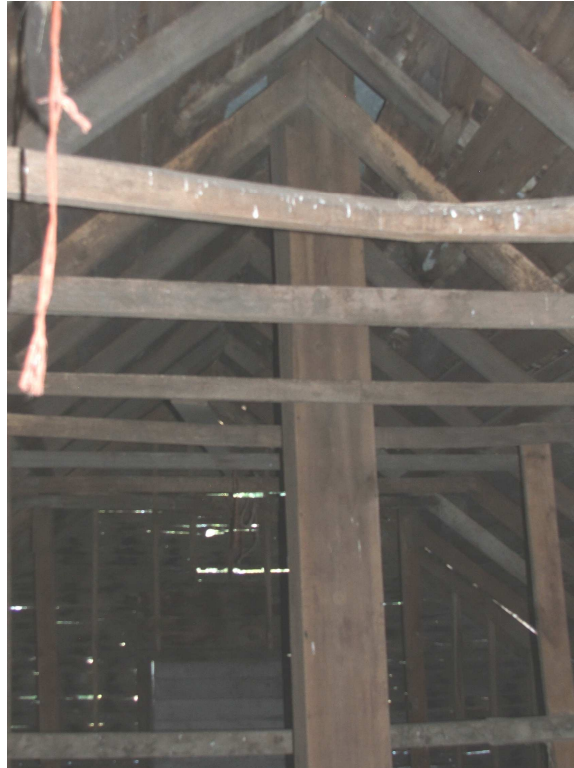
ROLL NUMBER: _____
PHOTO NUMBER: 7

CAMERA DIRECTION: Hayloft, looking North,
3x4 rough sawn
cottonwood rafters ties.
