**SOUTH DAKOTA STATE HISTORIC PRESERVATION OFFICE  
HISTORIC SITES SURVEY STRUCTURE FORM**

\*SURVEY DATE: December 27, 2013 \*ADDRESS: 30722 464<sup>th</sup> Ave.  
\*SURVEYOR: Jim Stone \*COUNTY: Clay  
\*CITY: Vermillion

CURRENT FUNCTION: Vacant FOUNDATION: Poured concrete  
 CURRENT SUBFUNCTION: Vacant ROOF MATERIAL: Steel roofing over cedar shingles  
 HISTORIC FUNCTION: Livestock barn ROOF SHAPE: Gable roof  
 HISTORIC SUBFUNCTION: Hay and grain storage STRUCTURAL SYSTEM: Balloon framing  
 OCCUPIED: No STYLE: Gable roof barn  
 ACCESSIBLE: Yes with permission TYPE: Livestock barn  
 WALLS: 2x4 studs, and 1x10 shiplap & 1/2" x 6" cedar lap siding

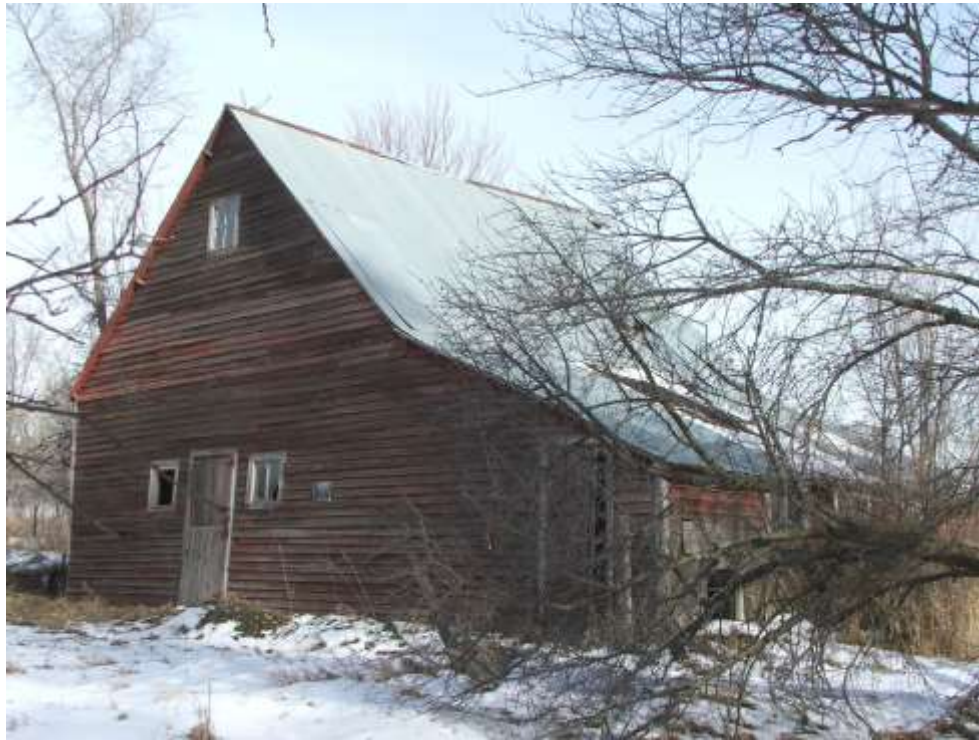
**ROLL NUMBER:** \_\_\_\_\_  
**PHOTO NUMBER:** 1  
**CAMERA DIRECTION:** Looking NE, SW corner

\*PHYSICAL NOTES: Barn is in fair condition. \*RESTRICTED: Y or N  
 \*UTM EASTING: \_\_\_\_\_  
 \*UTM NORTHING: \_\_\_\_\_

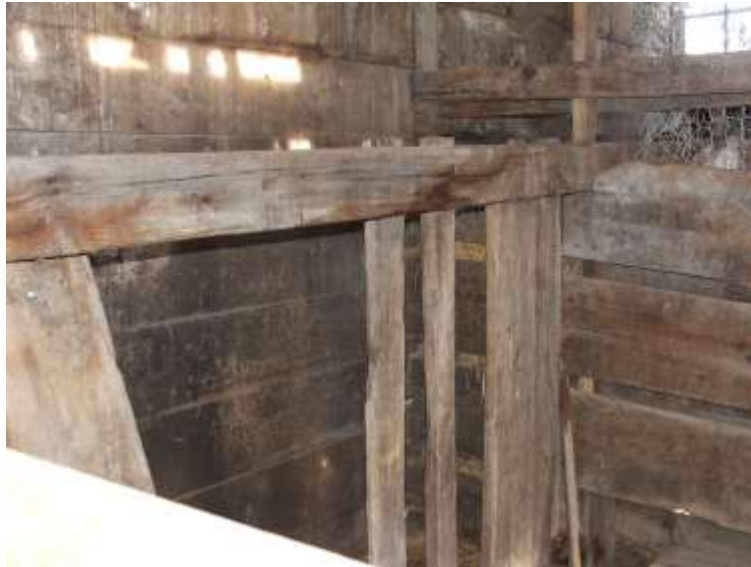
**ROLL NUMBER:** \_\_\_\_\_  
**PHOTO NUMBER:** 5

INTERIOR NOTES: Milk cow stanchions are still in place in the South lean-to and it has a concrete floor with a gutter. 6' x 8' granary is still in place in the NE corner of the main barn. A stairs to the hayloft is built into the granary.

**CAMERA DIRECTION:** First floor, South lean-to, looking NE at milk cow stanchions still in place.

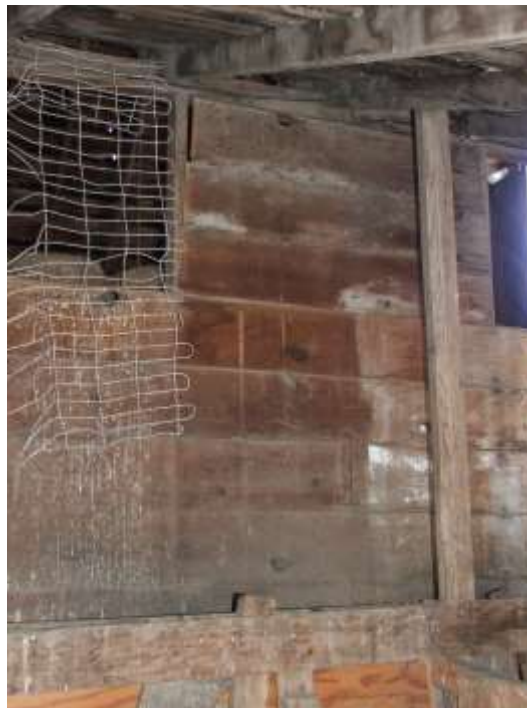
**ROLL NUMBER:** \_\_\_\_\_  
**PHOTO NUMBER:** 6

OTHER NOTES: 2X4 stud walls with 1x10 shiplap applied diagonally and 1/2" x 6" cedar lap siding on all four exterior walls. The South wall of the main barn is 2x4 studs with 1x10 shiplap applied horizontally. Windows are 9"x 12" four light. No evidence of a cupola ever being in the hayloft. The South lean-to appears to have been built at the same time as the barn. 2x4 rafters in the hayloft, but 2x6 rafters in the South lean-to.

**CAMERA DIRECTION:** First floor, looking NE, South wall of the main barn, 1x10 shiplap applied horizontally.

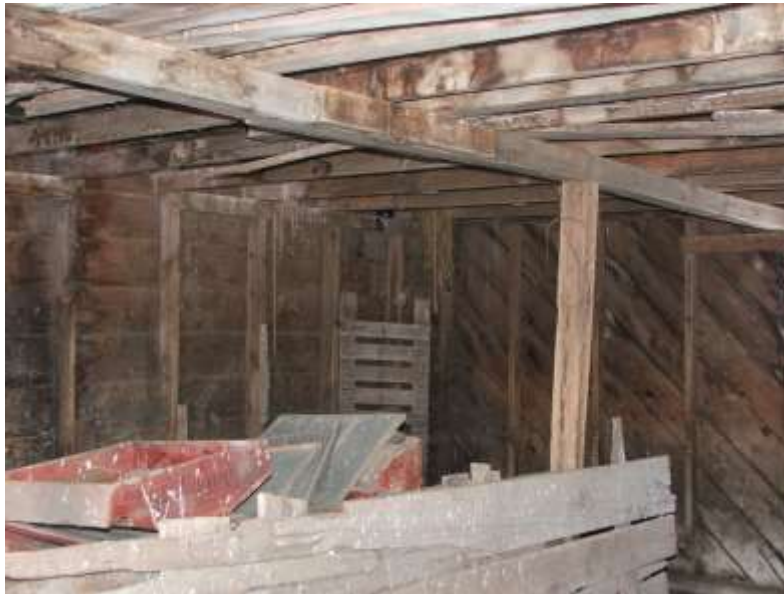
**ROLL NUMBER:** \_\_\_\_\_  
**PHOTO NUMBER:** 7

**First floor, main barn, looking SW, 4x6 posts, 4x4 beam and 2x4 floor joists. Note diagonal sheathing on West wall and horizontal sheathing on the South wall.**

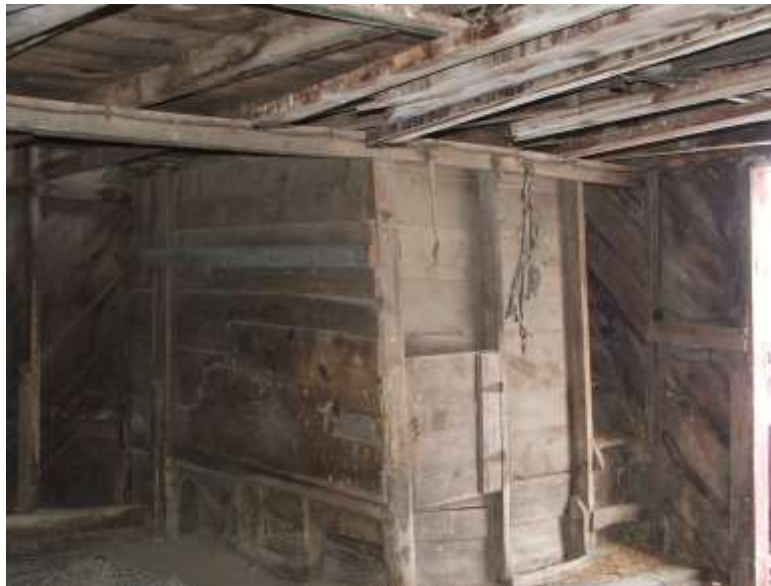
**ROLL NUMBER:** \_\_\_\_\_  
**PHOTO NUMBER:** 8

**First floor, main barn, looking NE, granary in the NE corner and stairs built into granary.**

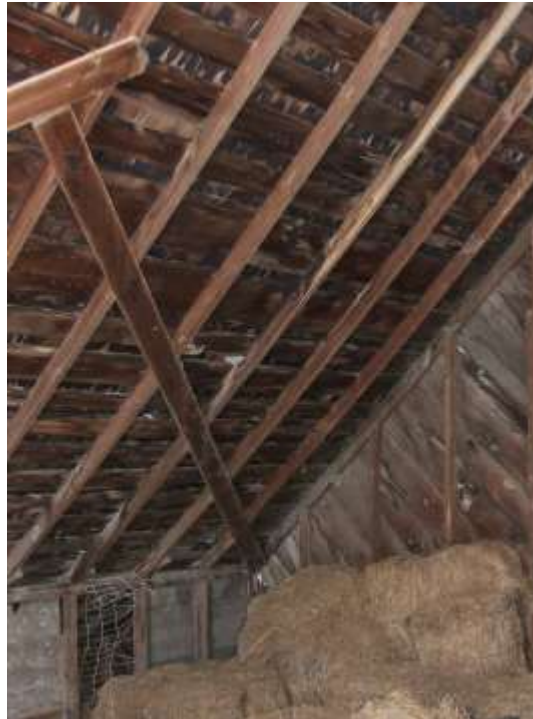
ROLL NUMBER: \_\_\_\_\_  
PHOTO NUMBER: 9

Hayloft, looking SW, 2x4  
rafters, note difference in  
sheathing on the two  
walls.

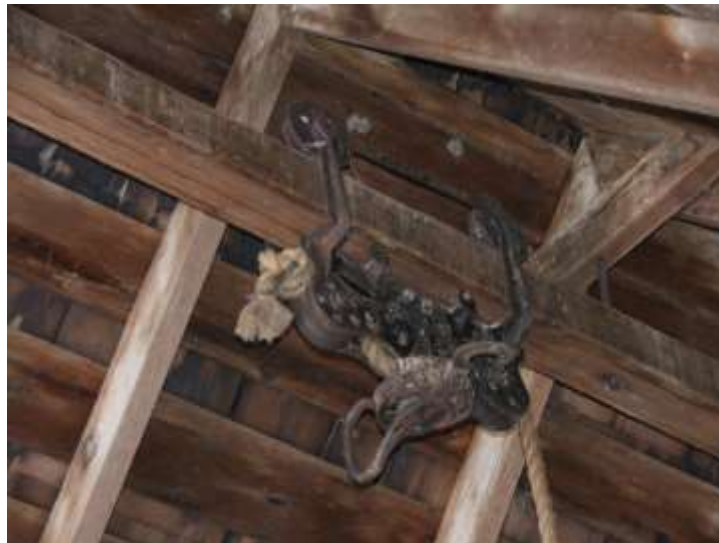
ROLL NUMBER: \_\_\_\_\_  
PHOTO NUMBER: 10

Hayloft, looking SW,  
special trolley for a 4x4  
hay track.
