**SOUTH DAKOTA STATE HISTORIC PRESERVATION OFFICE
HISTORIC SITES SURVEY STRUCTURE FORM**

*SURVEY DATE: July 23, 2013 *ADDRESS: 45619 306th Street
*SURVEYOR: Jim Stone *COUNTY: Clay
*CITY: Wakonda

CURRENT FUNCTION: <u>Goats and sheep barn</u>	FOUNDATION: <u>Poured concrete</u>
CURRENT SUBFUNCTION: <u>Storage</u>	ROOF MATERIAL: <u>Steel roofing over cedar shingles</u>
HISTORIC FUNCTION: <u>Livestock barn</u>	ROOF SHAPE: <u>Gambrel roof</u>
HISTORIC SUBFUNCTION: <u>Hay storage</u>	STRUCTURAL SYSTEM: <u>Balloon framing</u>
OCCUPIED: <u>Yes</u>	STYLE: <u>Gambrel roof barn</u>
ACCESSIBLE: <u>Yes with permission</u>	TYPE: <u>Livestock barn</u> <u>2x6 studs, 1x8 #106 drop siding and 1/2"x6" cedar lap siding</u>
STORIES: <u>3</u>	WALLS: _____
*DATE OF CONSTRUCTION: <u>1910 to 1920</u>	SIGNIFICANT PERSON: <u>Rasmus Anderson</u>
	CULTURAL AFFILIATION: <u>Danish</u>

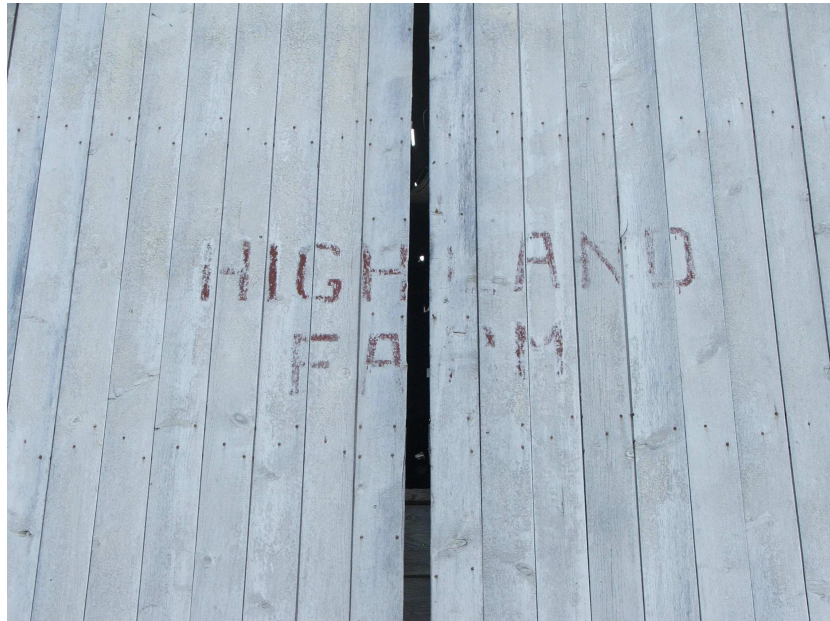
ROLL NUMBER: _____
PHOTO NUMBER: 5

CAMERA DIRECTION: Looking up and South, "High Land Farm" painted on the North hayloft doors

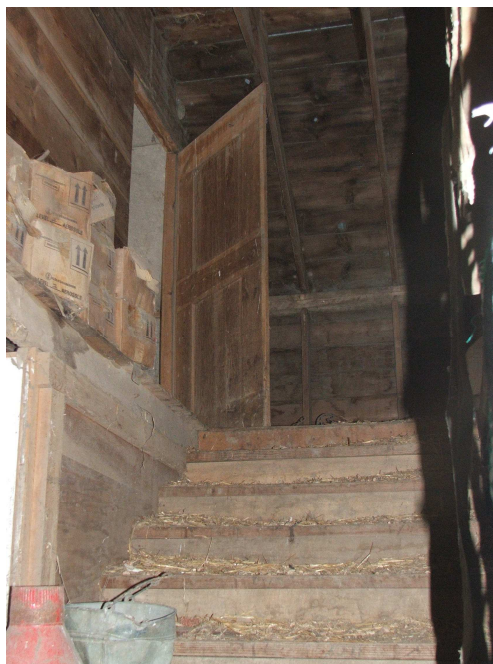
ROLL NUMBER: _____
PHOTO NUMBER: 6

CAMERA DIRECTION: First floor, looking West up stairs to second floor, note door into second floor.

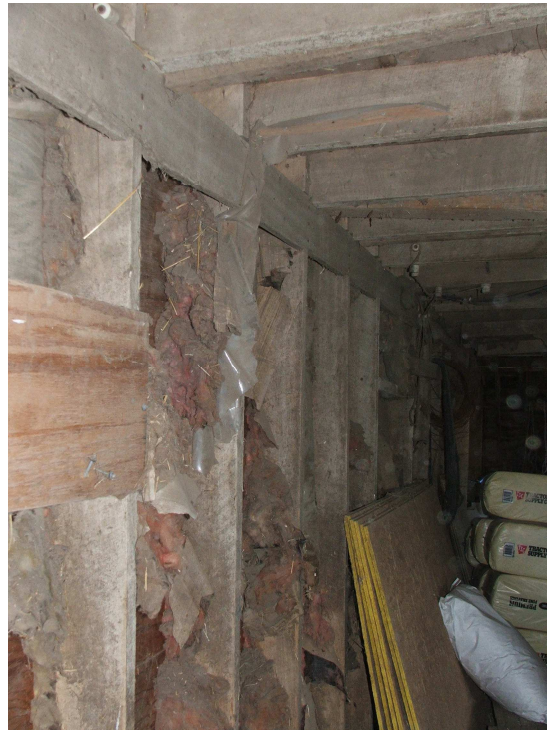
ROLL NUMBER: _____
PHOTO NUMBER: 7

CAMERA DIRECTION: First floor, looking NW,
solid 2x6 stud wall
dividing West 12' of
barn.

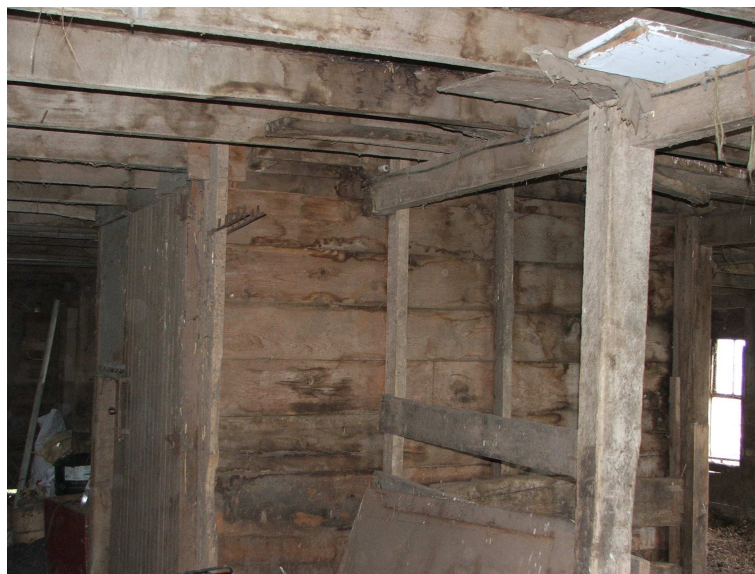
ROLL NUMBER: _____
PHOTO NUMBER: 8

CAMERA DIRECTION: First floor, 8' x 8' room in
the center of barn, note
4x6 posts and 4x6 beam.

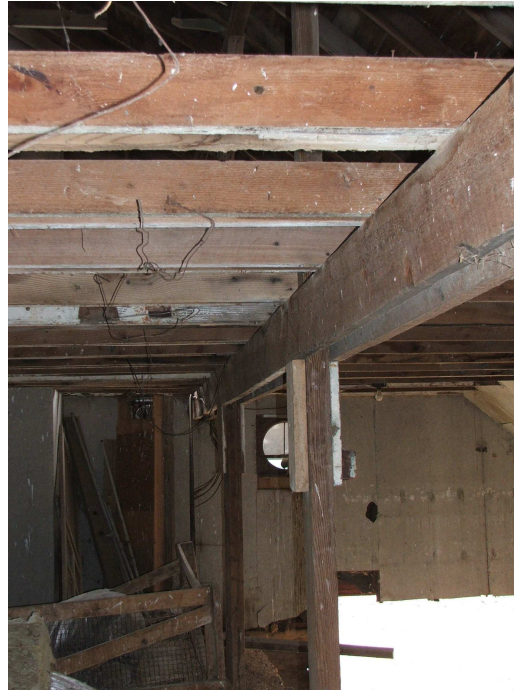
ROLL NUMBER: _____
PHOTO NUMBER: 9

**Second floor, two 2x12's
on 4x6 posts, supporting
doubled 2x8's for hayloft
floor.**

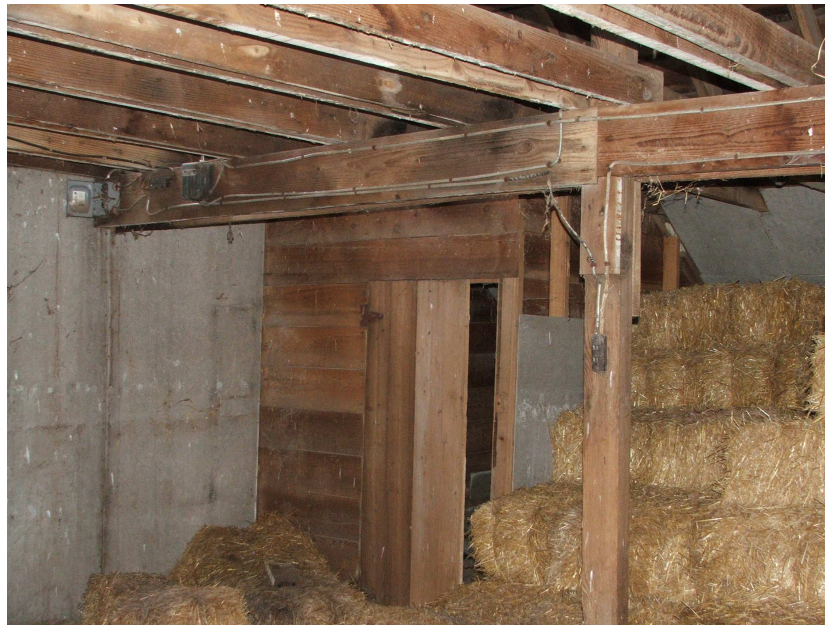
ROLL NUMBER: _____
PHOTO NUMBER: 10

**Second floor, looking
NE, 6' x 10' room in the
NE corner.**

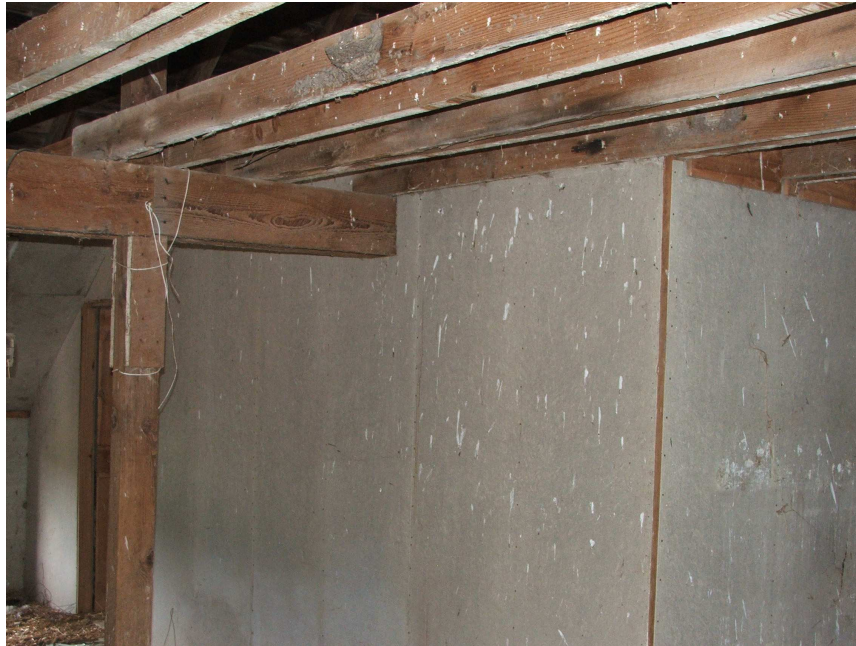
ROLL NUMBER: _____
PHOTO NUMBER: 11

CAMERA DIRECTION: Second floor, wall enclosing stairs to second floor,

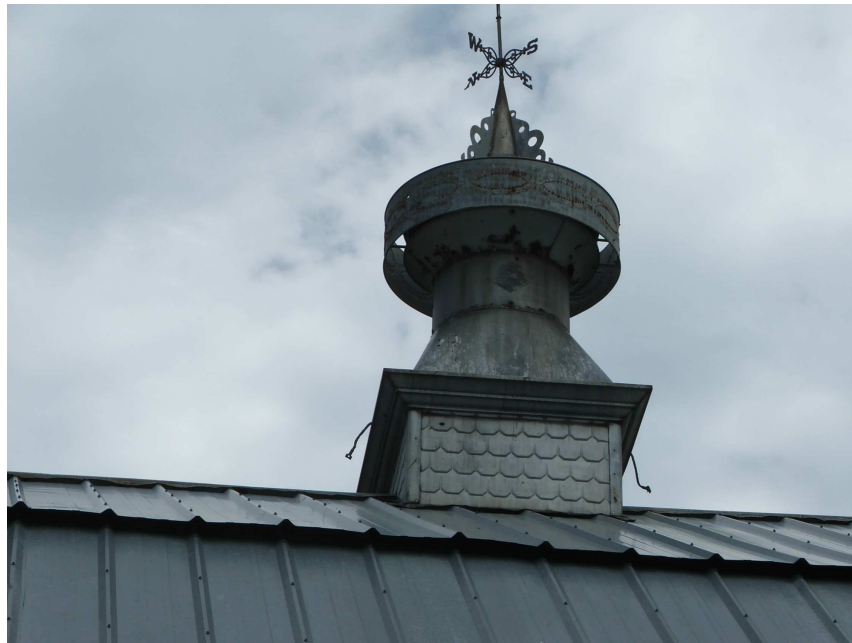
ROLL NUMBER: _____
PHOTO NUMBER: 12

CAMERA DIRECTION: Looking up and East, very ornate cupola, from the 19-teens.
