""SITE INFORMATION				
*SURVEY DATE: July 27, 2	2013 *ADDRESS: 45850 306 th Street			
*SURVEYOR: Jim Ston				
	*CITY: Wakonda			
LOCATION DESCRIPTION: From Vermillion, intersection of South Dakota Highway 50 bi-pass and				
South Dakota Highway 19, North about11 miles to 306th Street, turn left (West) about 3-1/2 miles, on the				
right, (North) side.				
LEGAL DESCRIPTION: W 350' of S 840' Exc H-1 & H-2 in SW 1/4, 18 – 94 – 52 Pleasant Valley Twp				
*QUARTER 1: SW 1/4	OWNER NAME: Nickolas Schwebach			
*QUARTER 2:	OWNER ADDRESS: 45850 306 th Street			
*TOWNSHIP: Pleasant Valley	OWNER CITY: Wakonda			
*RANGE: 52	OWNER STATE: South Dakota			
*SECTION:18	OWNER ZIP: <u>57073</u>			
ACRES: <u>6.71</u>	QUAD NAME:			
OWNER CODE 1: P				
OWNER CODE 2:				
OWNER CODE 3:				
HISTORIC SIGNIFICANCE				
*DOE:	REGISTER NAME:			
*DOE DATE:	MULTIPLE PROPERTY NAME.			
REASON INELIGIBLE:				
	CATEGORY:			
NOMINATION STATUS:	SIGNIFICANCE LEVEL 1: N S L

STRUCTURE DETAILS

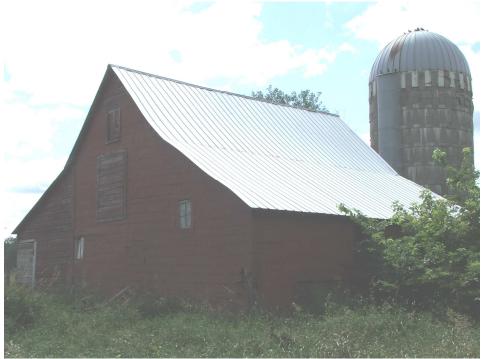
PHOTOGRAPHER: Jim Stone ROLL NUMBER: DATE OF PHOTO: July 26, 2013 PHOTO NUMBER: 4

CAMERA DIRECTION: Looking SE, NW corner

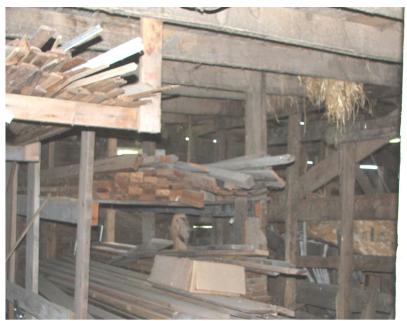
First floor, looking NE, in center barn, parts of 4x4 posts and 4x4 beam, CAMERA DIRECTION: racks for lumber storage

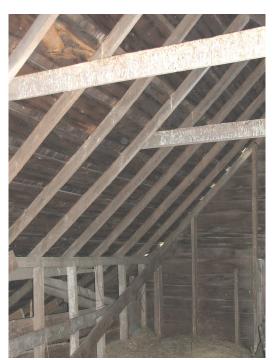
Hayloft, looking NW, 2x4 rafters, open 2x4 stud

CAMERA DIRECTION: walls in hayloft.

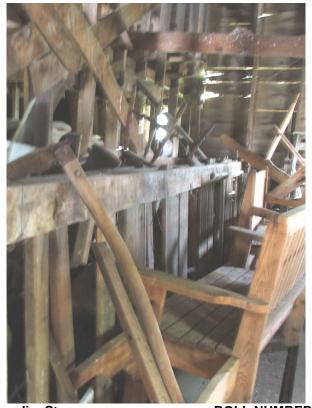
First floor, looking NW, (7) milk cow stanchions still in place in East lean-

CAMERA DIRECTION: to.
