**SOUTH DAKOTA STATE HISTORIC PRESERVATION OFFICE  
HISTORIC SITES SURVEY STRUCTURE FORM**

\*SURVEY DATE: July 9, 2012 \*ADDRESS: 31751 455<sup>th</sup> Ave.  
\*SURVEYOR: Jim Stone \*COUNTY: Clay  
\*CITY: Vermillion

CURRENT FUNCTION:	<u>Tractor and auto garage</u>	FOUNDATION:	<u>Poured concrete Steel over cedar shingles</u>
CURRENT SUBFUNCTION:	<u>Storage</u>	ROOF MATERIAL:	<u>shingles</u>
HISTORIC FUNCTION:	<u>Livestock barn</u>	ROOF SHAPE:	<u>Gable</u>
HISTORIC SUBFUNCTION:	<u>Hay storage</u>	STRUCTURAL SYSTEM:	<u>Balloon framing</u>
		STYLE:	<u>Gable roof barn</u>
OCCUPIED:	<u>Yes</u>	TYPE:	<u>Livestock barn</u>
	<u>Yes with</u>		<u>2x6, 1x6 106 drop</u>
ACCESSIBLE:	<u>permission</u>	WALLS:	<u>siding</u>

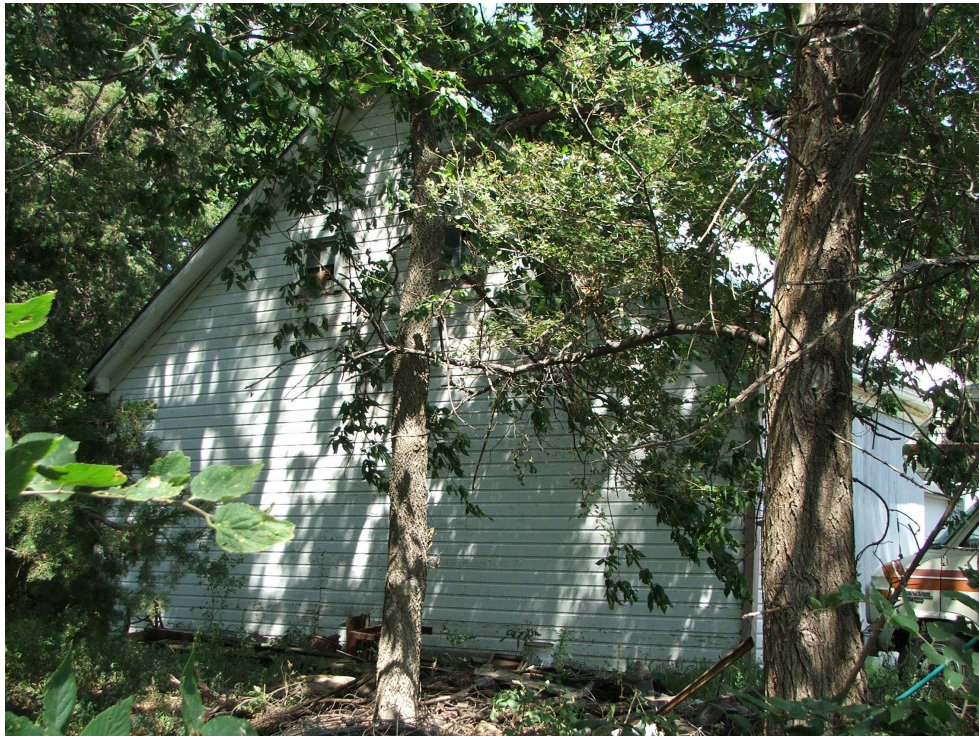
**ROLL NUMBER:** \_\_\_\_\_  
**PHOTO NUMBER:** 1  
**CAMERA DIRECTION:** Looking NE, SW corner

**\*PHYSICAL NOTES:** Barn is in good condition.

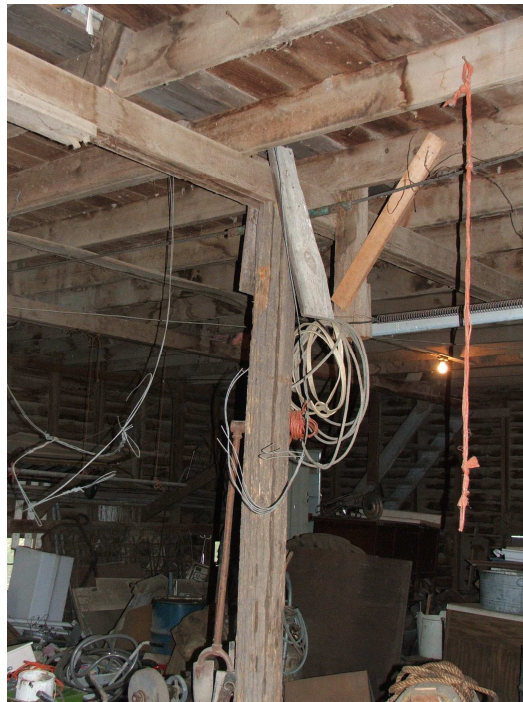
**INTERIOR NOTES:** Has 8" round posts and (3) 2x6's for beams to support hayloft floor. Joists are 2x8.

ROLL NUMBER: \_\_\_\_\_  
PHOTO NUMBER: 4  
CAMERA DIRECTION: First floor, looking NE,  
post and beam and floor  
joists

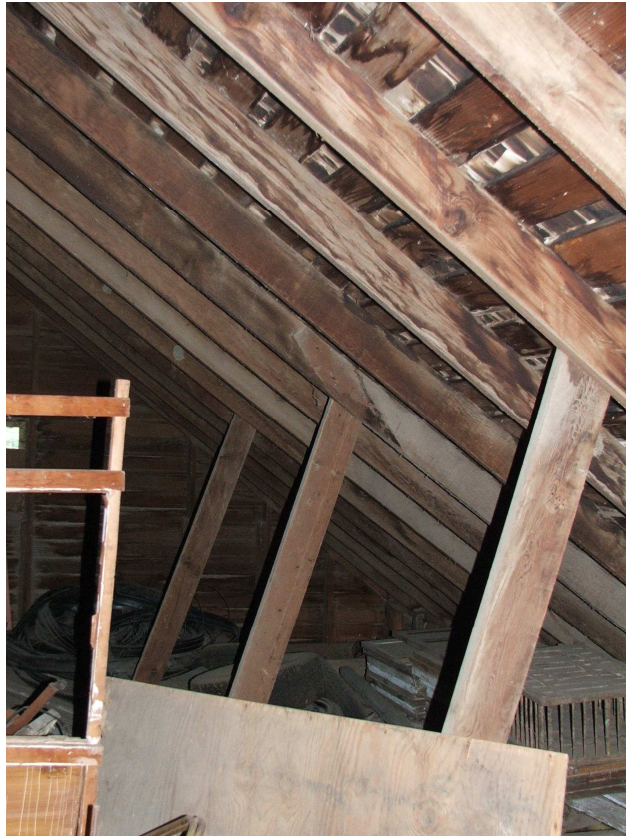
**OTHER NOTES:** Windows were 8"x10" four light. 2x6 stud wall 10' high with 1x6 #106 drop siding. Rafters are 2x6 with 2x6 brace from the center of the rafter down to the hayloft floor. The brace most likely rested on the beams that supported the hayloft floor, but beams have been moved.

**CAMERA DIRECTION:** Hayloft, looking West,  
rafter and center support  
brace
