**SOUTH DAKOTA STATE HISTORIC PRESERVATION OFFICE
HISTORIC SITES SURVEY STRUCTURE FORM**

*SURVEY DATE: April 15, 2013 *ADDRESS: 46891 299th Street
*SURVEYOR: Jim Stone *COUNTY: Clay
*CITY: Beresford

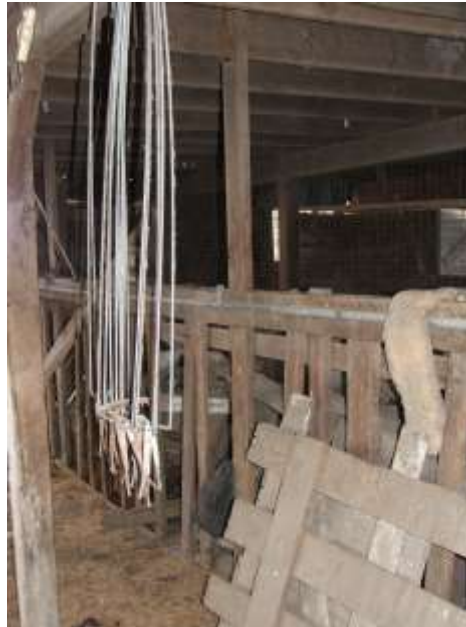
ROLL NUMBER: _____
PHOTO NUMBER: 5

INTERIOR NOTES: The original barn had two rows of (3) 2x6 posts and (3) 2x8's for a beam and one row of 4x6 posts with (3) 2x8's for a beam. Floor joists are 2x8's for the hayloft floor. (9) milk cow stanchions are still in place on the East side. (4) double horse stalls are still on the West side. The mangers are removed in (2) stalls. (2) pens in the NE corner appear to have been added or replaced.

**First floor, looking SW
on East side, (9) milk
cow stanchions still in
place.**

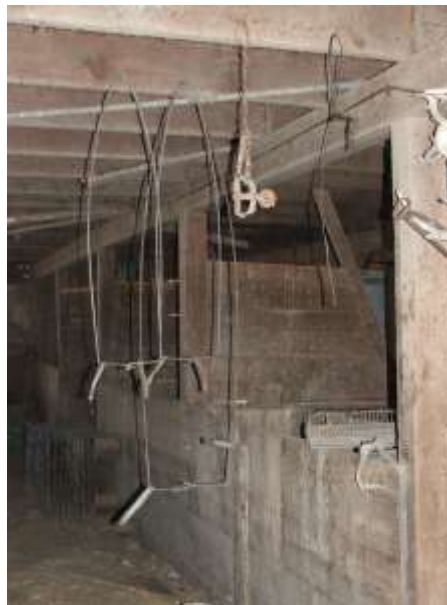
ROLL NUMBER: _____
PHOTO NUMBER: 6

**First floor, looking SW
from in the center feed
alley, (4) double horse
stalls on the West side.**

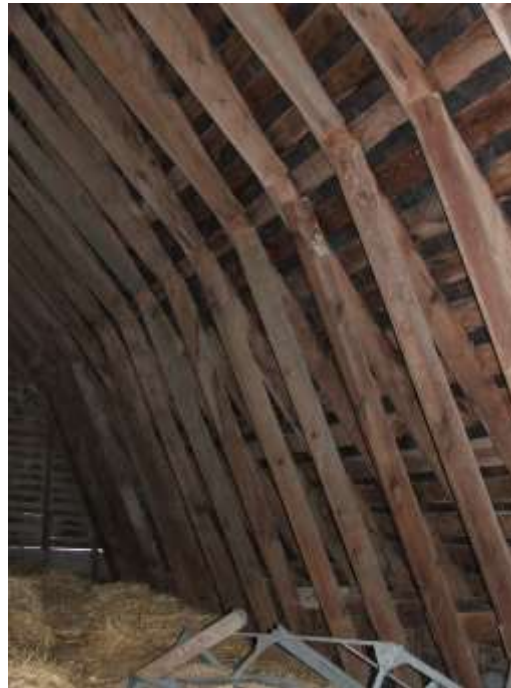
ROLL NUMBER: _____
PHOTO NUMBER: 7

OTHER NOTES: 2x6 stud walls with 1x8 sheathing and 1/2"x6" cedar lap siding with steel roofing on the East wall. Rafters are 2x6's with 2x6 bracing 24" O. C. at the hip and from the center of lower rafters down to the floor. Interesting note on the rafter bracing, 6' O. C., a 1x6 brace was substituted for the 2x6 Brace. A 1x8 brace from hip out to hip bracing and a 2x6brace on 2x6 bracing or 1x6 brace on 1x6 bracing from the bottom of the lower rafters out to the lower brace. Windows are 4"x24" four light. Two metal cupola's still in place.

Hayloft, looking SW,
lower rafter bracing, note
1x6 bracing 6' O. C.

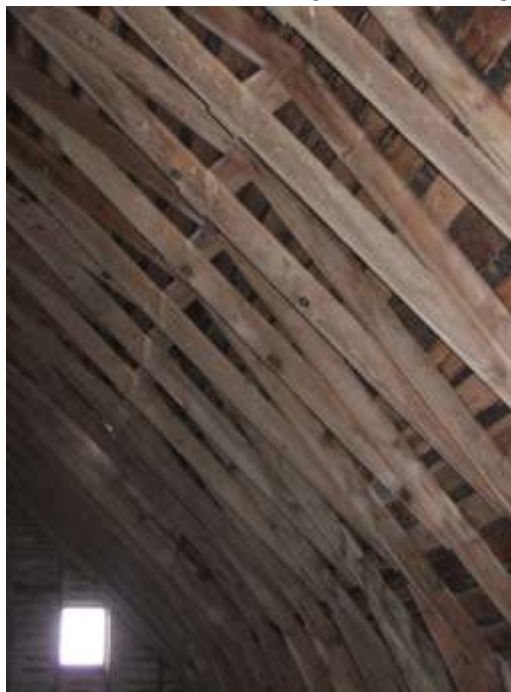
ROLL NUMBER: _____
PHOTO NUMBER: 8

Hayloft, looking NE,
upper rafter bracing,
note 1x6 bracing 6' O. C.

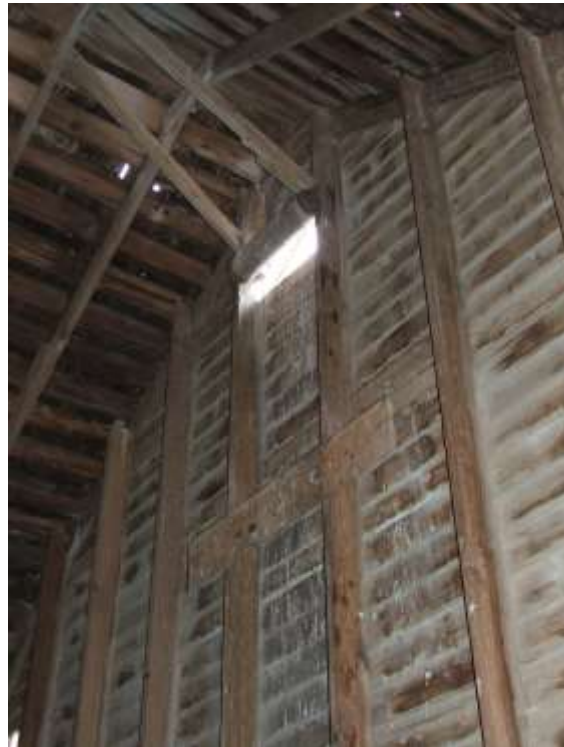
ROLL NUMBER: _____
PHOTO NUMBER: 9

CAMERA DIRECTION: Hayloft, looking up and SE, wooden roller for the hay track rope, this is the first one I have seen, usually this is a wooden block pulley.
