**SOUTH DAKOTA STATE HISTORIC PRESERVATION OFFICE
HISTORIC SITES SURVEY STRUCTURE FORM**

*SURVEY DATE: June 25, 2012 *ADDRESS: 31483 454th Ave.
*SURVEYOR: Jim Stone *COUNTY: Clay
*CITY: Gayville

CURRENT FUNCTION: <u>Shop</u>	FOUNDATION: <u>Poured concrete</u>
CURRENT SUBFUNCTION: <u>Farm machinery storage</u>	ROOF MATERIAL: <u>Steel over cedar shingles</u>
HISTORIC FUNCTION: <u>Livestock barn</u>	ROOF SHAPE: <u>Gambrel</u>
HISTORIC SUBFUNCTION: <u>Hay and grain storage</u>	STRUCTURAL SYSTEM: <u>Balloon framing</u>
OCCUPIED: <u>Yes</u>	STYLE: <u>Gambrel roof barn</u>
ACCESSIBLE: <u>Yes with permission</u>	TYPE: <u>Livestock barn</u>
	WALLS: <u>2x6, sheathing & 1/2" x 6" cedar lap siding</u>
STORIES: <u>2</u>	SIGNIFICANT PERSON: <u>S. G. Myron</u>
*DATE OF CONSTRUCTION: <u>?</u>	CULTURAL AFFILIATION: <u>Norwegian</u>

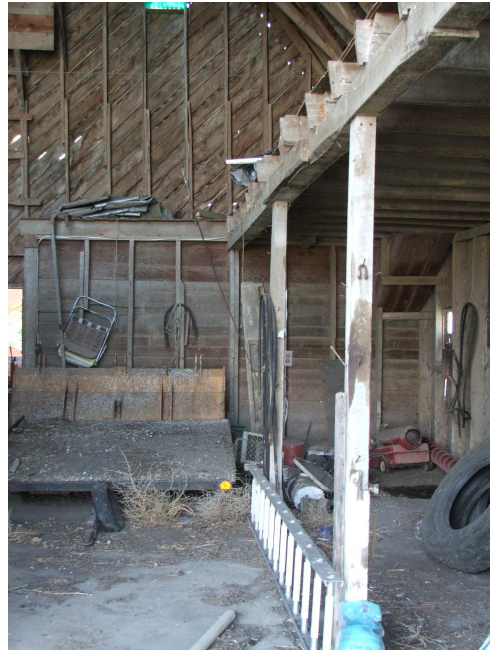
ROLL NUMBER: _____
PHOTO NUMBER: 5

CAMERA DIRECTION: First floor, looking West,
posts and beam,
granaries in NW corner.

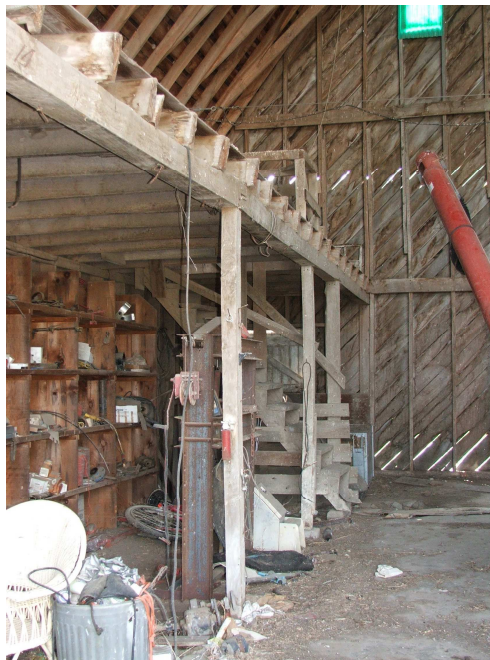
ROLL NUMBER: _____
PHOTO NUMBER: 6

CAMERA DIRECTION: First floor, looking West,
posts, beam and stairs
on the South wall

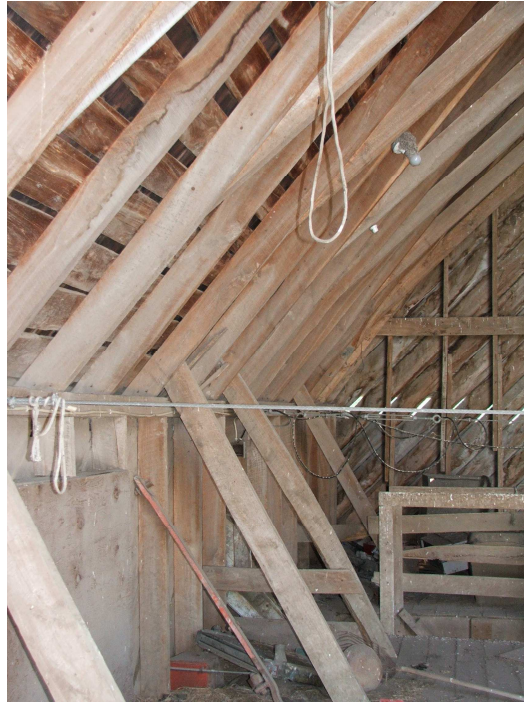
ROLL NUMBER: _____
PHOTO NUMBER: 7

**Hayloft, looking West,
lower rafter and wall
bracing.**

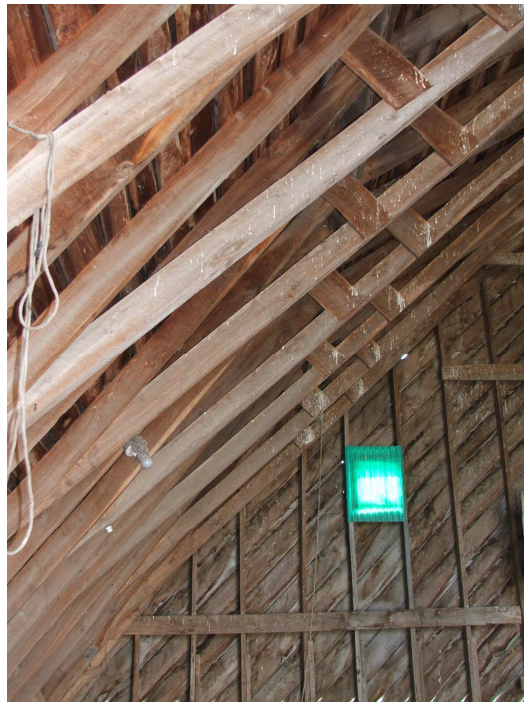
ROLL NUMBER: _____
PHOTO NUMBER: 8

**Hayloft, looking West,
upper rafter bracing.**
