**SOUTH DAKOTA STATE HISTORIC PRESERVATION OFFICE
HISTORIC SITES SURVEY STRUCTURE FORM**

*SURVEY DATE: May 7, 2013 *ADDRESS: 29831 University Road
*SURVEYOR: Jim Stone *COUNTY: Clay
*CITY: Centerville

CURRENT FUNCTION: Vacant FOUNDATION: Poured concrete
 CURRENT SUBFUNCTION: Vacant ROOF MATERIAL: Steel over cedar shingles
 HISTORIC FUNCTION: Livestock barn ROOF SHAPE: Gable
 HISTORIC SUBFUNCTION: Hay and grain storage STRUCTURAL SYSTEM: Balloon framing
 OCCUPIED: Yes STYLE: Gable roof barn
Yes with TYPE: Livestock barn
 ACCESSIBLE: permission WALLS: 2x6 studs, 1x6 #106 drop siding

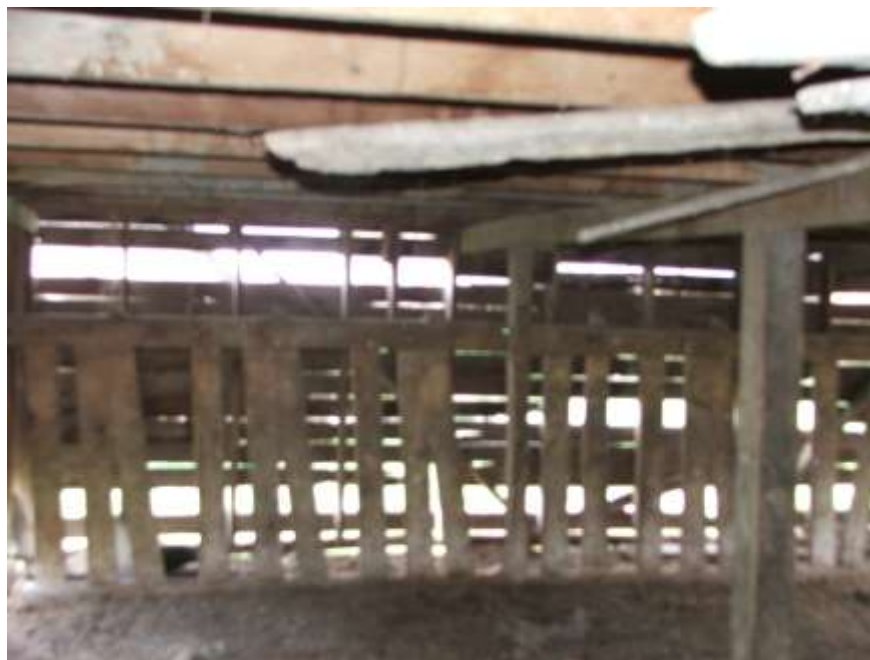
ROLL NUMBER: _____
PHOTO NUMBER: 5

CAMERA DIRECTION: First floor, looking East.
(9) milk cow stanchions
on East wall

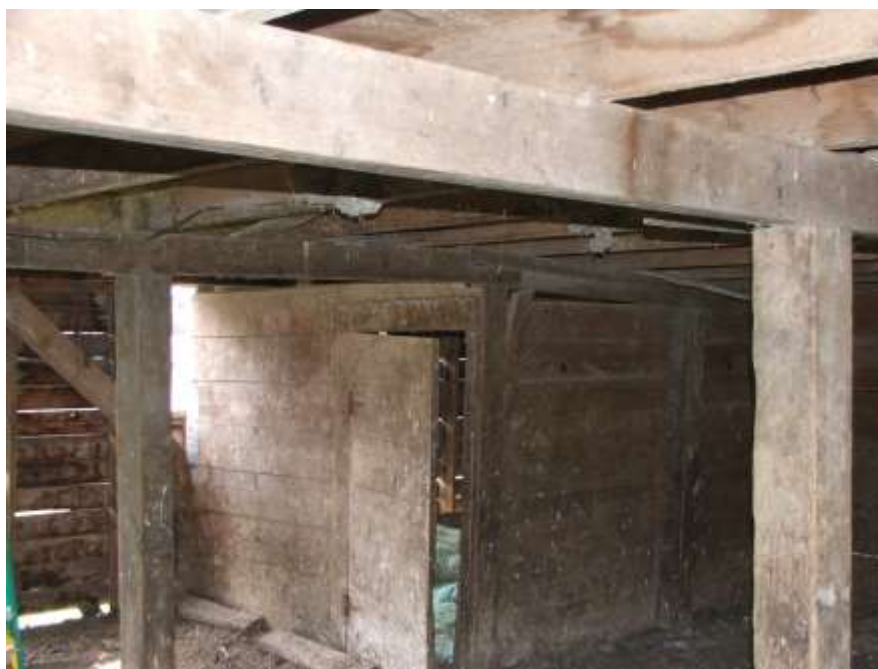
ROLL NUMBER: _____
PHOTO NUMBER: 6

CAMERA DIRECTION: First floor, looking SW, 8'
x 8' granary on south
wall.

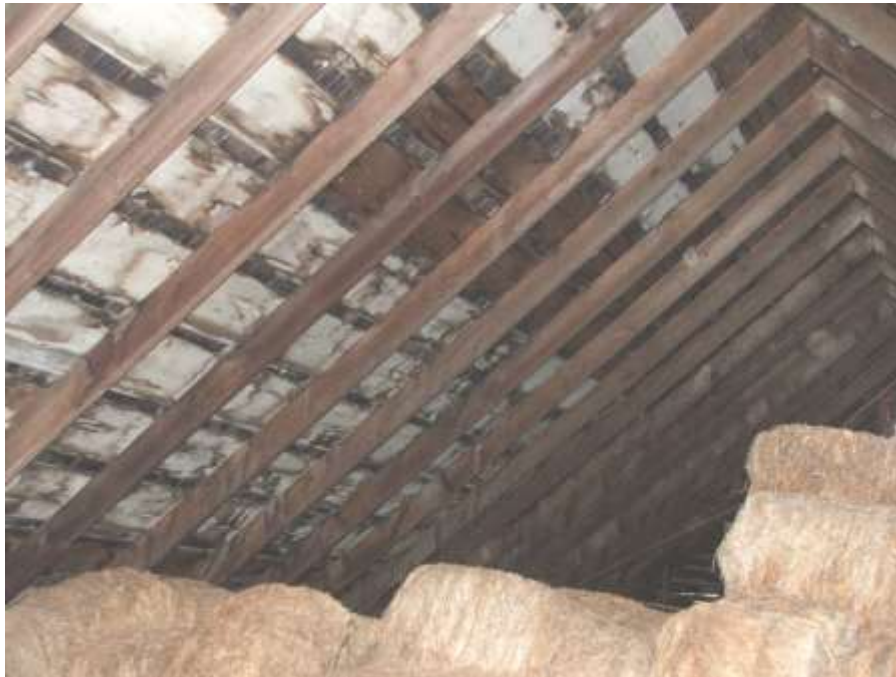
ROLL NUMBER: _____
PHOTO NUMBER: 7
CAMERA DIRECTION: Hayloft, looking SW, 2x6 rafters with no bracing.

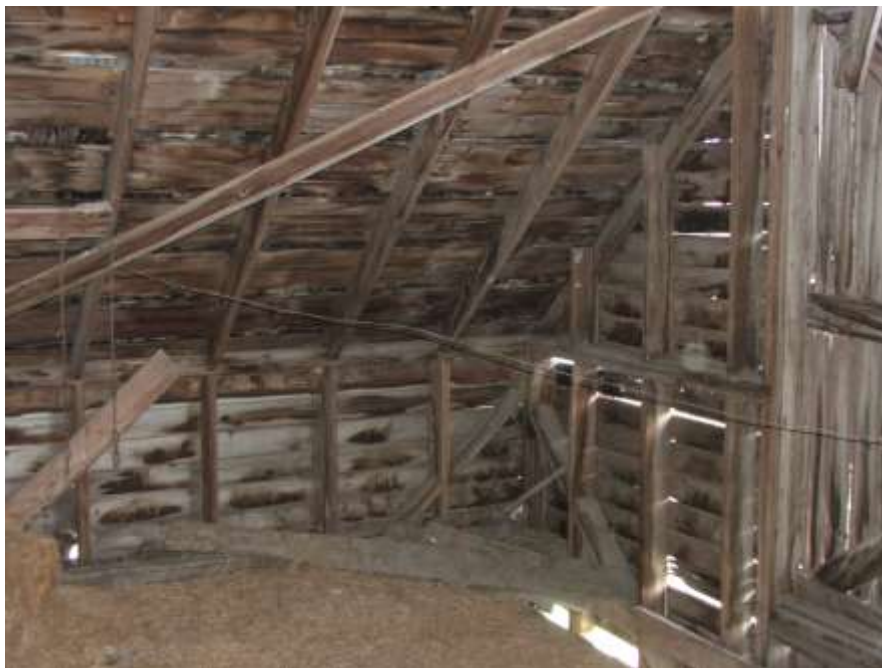
ROLL NUMBER: _____
PHOTO NUMBER: 8
CAMERA DIRECTION: Hayloft, looking NE, note diagonal bracing in walls and one diagonal brace on bottom of rafters.
