**SOUTH DAKOTA STATE HISTORIC PRESERVATION OFFICE
HISTORIC SITES SURVEY STRUCTURE FORM**

*SURVEY DATE: May 7, 2013 *ADDRESS: 29831 University Road
*SURVEYOR: Jim Stone *COUNTY: Clay
*CITY: Centerville

CURRENT FUNCTION: Vacant FOUNDATION: Poured concrete
 CURRENT SUBFUNCTION: Storage ROOF MATERIAL: Cedar shingles
 HISTORIC FUNCTION: Livestock barn ROOF SHAPE: Gable
 HISTORIC SUBFUNCTION: Hay storage STRUCTURAL SYSTEM: Balloon framing
 STYLE: Gable roof barn
 OCCUPIED: Yes TYPE: Western feeder barn
 Yes with 2x4& 2x6 studs, 1x6
 ACCESSIBLE: permission permission WALLS: #106 drop siding

STORIES: 2 SIGNIFICANT PERSON: Swen Victor Peterson
 *DATE OF CONSTRUCTION: 1920's CULTURAL AFFILIATION: Swedish

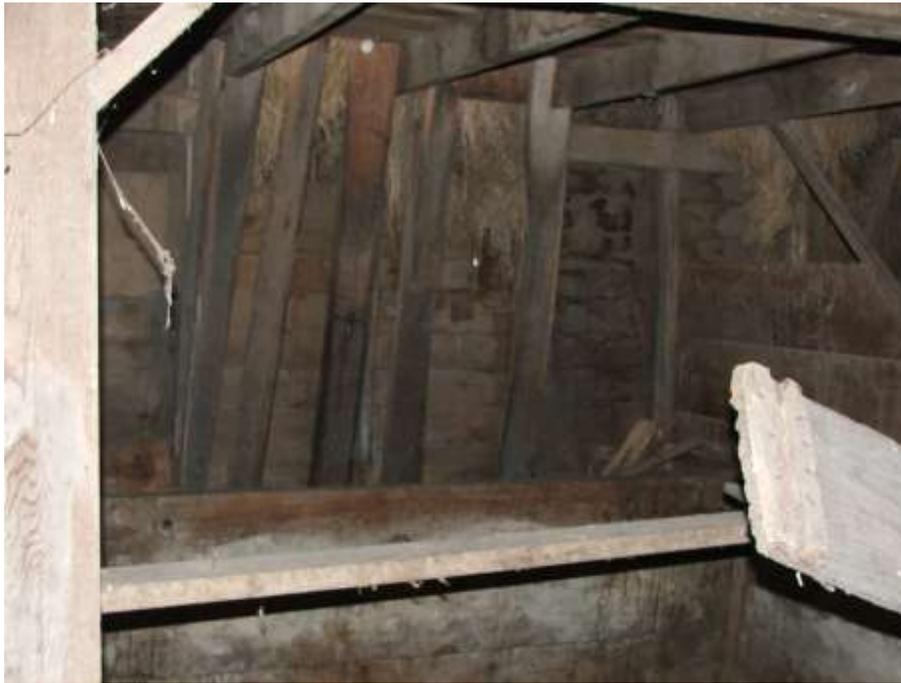
ROLL NUMBER: _____
PHOTO NUMBER: 5

First floor, looking South, double horse stall on South wall.

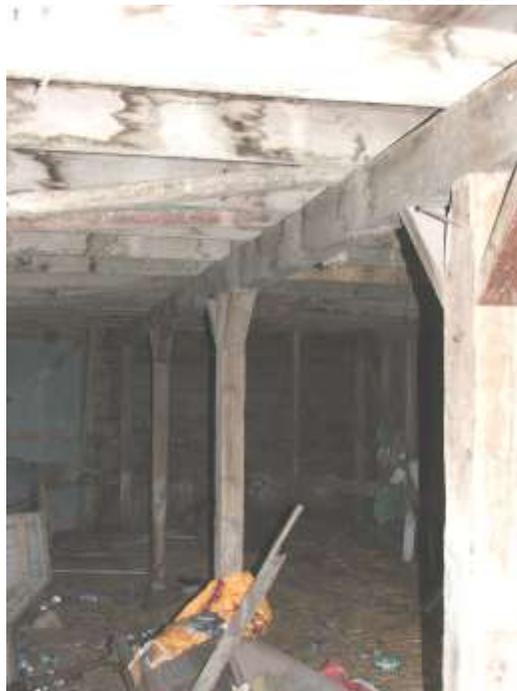
ROLL NUMBER: _____
PHOTO NUMBER: 6

First floor, looking NW, 4x6 posts, 4x6 beam and 2x6 floor joists

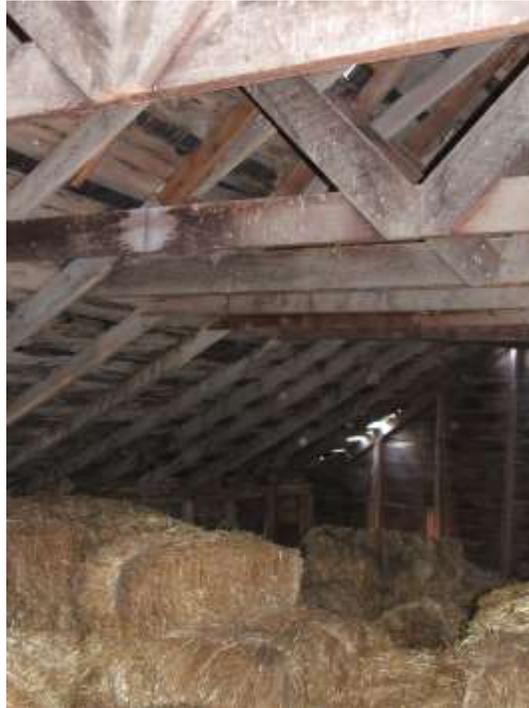
ROLL NUMBER: _____
PHOTO NUMBER: 7

**Hayloft, looking SW, 2x4
rafters and bracing at the
peak**

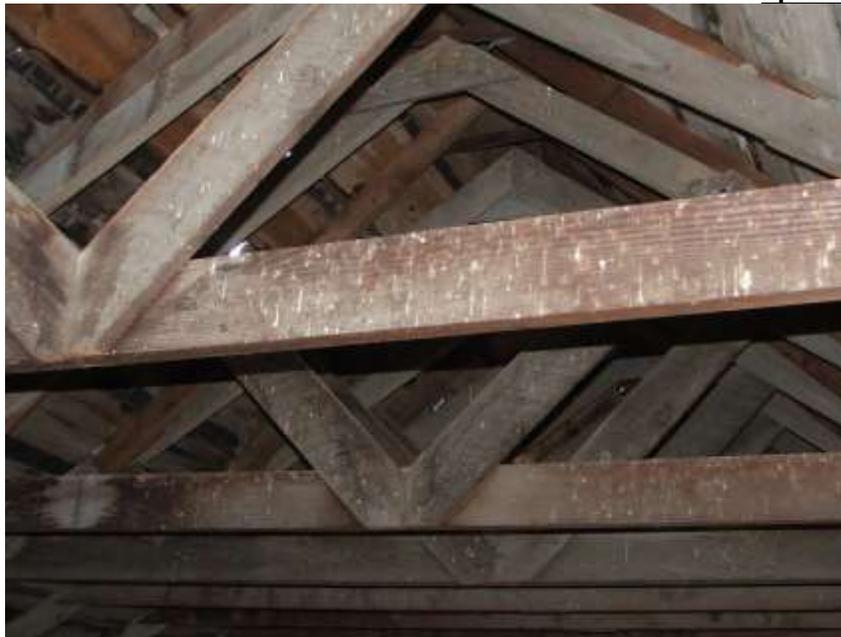
ROLL NUMBER: _____
PHOTO NUMBER: 8

**Hayloft, looking West,
2x6 bracing 4' O. C., with
(2) 1x6's truss bracing at
the peak.**
