SITE INFORMATION

*SURVEY DATE:	May 7, 20	13	*ADDRESS:	29831	29831 University Road						
*SURVEYOR: Jim Stone			*COUNTY:	′: Clay							
			*CITY:	Cente	ervil	le					
LOCATION DESCRIPTION:	From Ver	million, interse	ction of South [Dakota I	High	way	50 b	i-pas	s an	d	
University Road, North 19-3/4	miles, pa	st 299 th Street,	on the right (Ea	st) side) .						
LEGAL DESCRIPTION: NW	1/4, 8 – 9	95 – 51 Glenwo	od Twp.								
*QUARTER 1: NE 1/4		c	Susan & Robert P. Walsh								
*QUARTER 2:				RESS: 47844 County road 1 B					,,,,		
*TOWNSHIP: Glenwoo	nd	01111	Elk Point								
*RANGE: 51		0	South Dakota								
*SECTION: 8		_	57025								
ACRES: 157.89	_		QUAD NAME:								
OWNER CODE 1: P											
OWNER CODE 2:											
OWNER CODE 3:											
HISTORIC SIGNIFICANCI	E										
*DOF:	_		REGISTER NA	ME-							
*DOE: *DOE DATE:											
*DOE DATE: REASON INELIGIBLE:				O. L.			_

STRUCTURE DETAILS

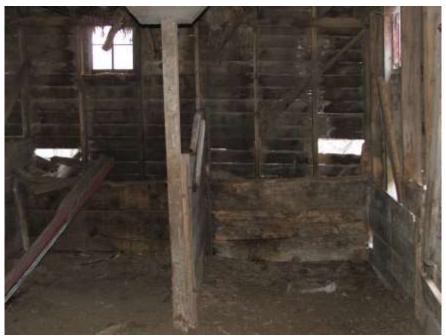
First floor, looking South, stalls on South wall, may have been for

CAMERA DIRECTION: young horses or mules.

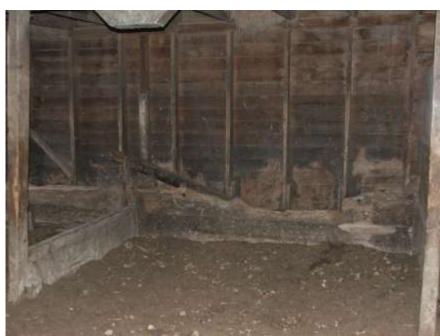
First floor, looking North, double horse stall on

CAMERA DIRECTION: North wall

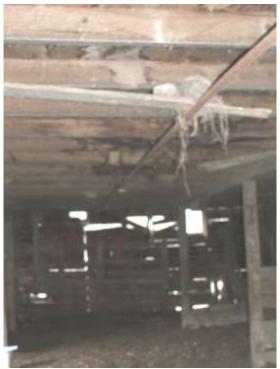
First floor, looking West, track rail for manure

CAMERA DIRECTION: bucket

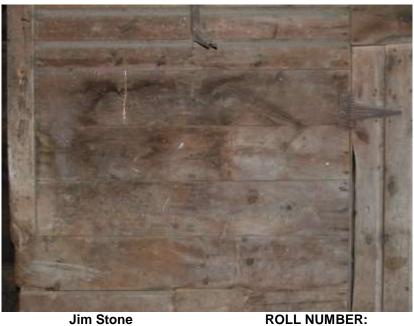
First floor, looking North, initials carved in the wall

CAMERA DIRECTION: of the granary.

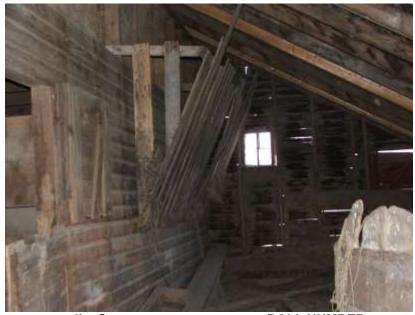
Looking SW in North lean-to, note hay feed rack & 1x6 drop siding on North wall of original

CAMERA DIRECTION: barn

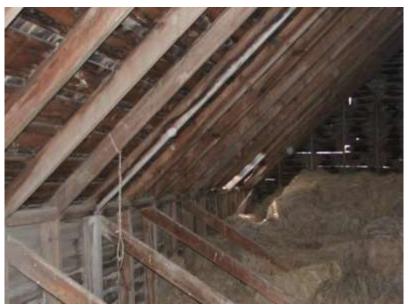
10

Hayloft, looking SW, 2x6 rafters and 2x6 brace 4' O. C. from top of wall

CAMERA DIRECTION: down to floor.

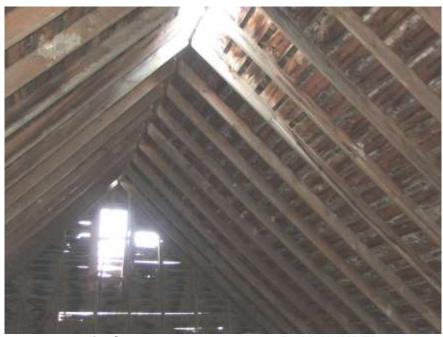
Hayloft, looking West, 2x6 rafters and hole

CAMERA DIRECTION: where cupola was.
