#### **```SITE INFORMATION**

<u>May 29, 2013</u> Jim Stone \*ADDRESS: <u>30904 460<sup>th</sup> Ave.</u> \*COUNTY: <u>Clay</u> \*CITY: <u>Vermillion</u>

SHPO ID:				
*PROPERTY NAME:				
OTHER NAME:				
CURRENT FUNCTION:	Vacant	FOUNDA	TION:	Poured concrete
CURRENT SUBFUNCTION:	Storage	ROOF MATE	RIAL:	Steel roofing over cedar shingles
HISTORIC FUNCTION:	Livestock barn	ROOF SH	IAPE:	Gambrel roof
HISTORIC SUBFUNCTION:	Hay and grain storage	je STRUCTURAL SYS	STEM:	Balloon framing
		S	TYLE:	Gambrel roof barn
OCCUPIED:	Yes	-	TYPE:	Livestock barn
ACCESSIBLE:	Yes with permission	WALLS:		2x6 studs, 1x6 #106 drop siding
STORIES:	2	SIGNIFICANT PERSON:	Sa	amuel Peterson
*DATE OF CONSTRUCTION:	Early 1900's	CULTURAL AFFILIATION:		Norwegian

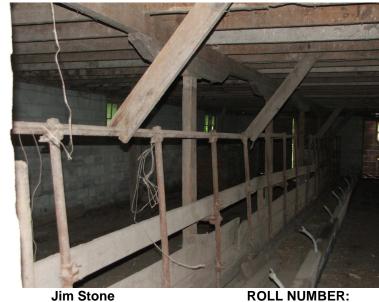
First floor in South addition, looking SE, concrete feed trough and framing for milk cow stanchions on East side.
