**SOUTH DAKOTA STATE HISTORIC PRESERVATION OFFICE  
HISTORIC SITES SURVEY STRUCTURE FORM**

\*SURVEY DATE: August 29, 2013 \*ADDRESS: 31245 466<sup>th</sup> Ave.  
\*SURVEYOR: Jim Stone \*COUNTY: Clay  
\*CITY: Vermillion

CURRENT FUNCTION: Sheep barn FOUNDATION: Poured concrete  
Steel roofing over

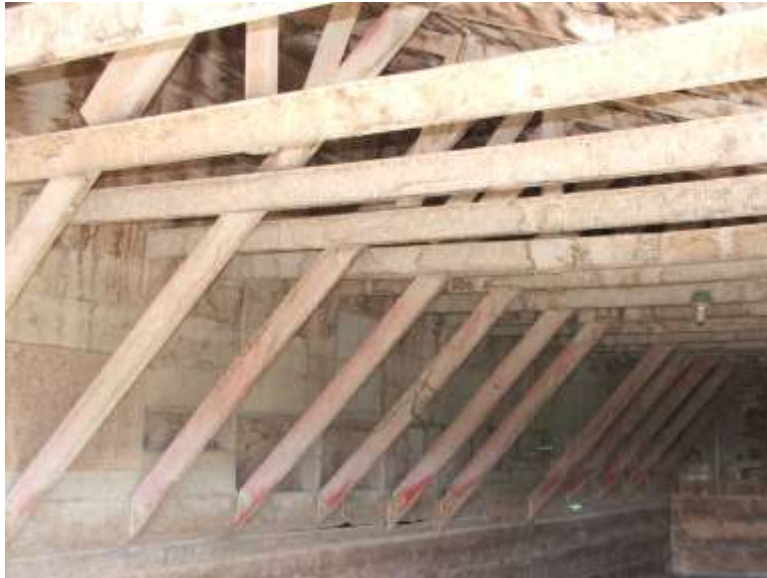
**ROLL NUMBER:** \_\_\_\_\_  
**PHOTO NUMBER:** 5

**CAMERA DIRECTION:** South lean-to, looking NE, 2x6 rafters, 2x6 ceiling joists. 2x6 bracing added to support the center of rafters.

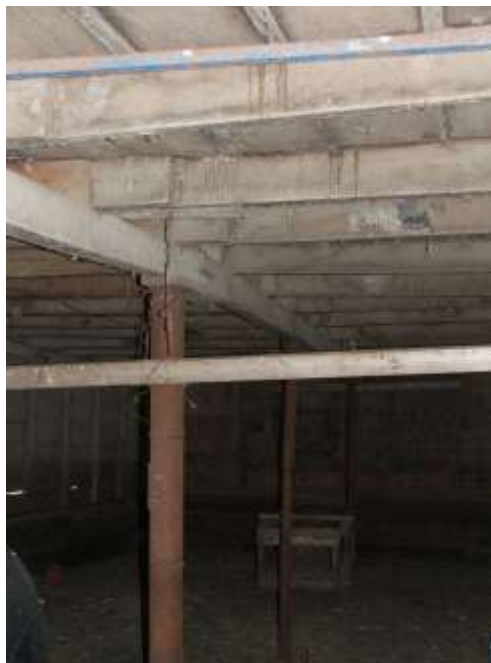
**ROLL NUMBER:** \_\_\_\_\_  
**PHOTO NUMBER:** 6

**INTERIOR NOTES:** One row of steel pipe posts with 4x6's for beam support 2x6 joists for hayloft floor. 11' x 8' gravity feed granary still in the NE corner of hayloft. 2x6 floor joists are doubled in this area. 2x6 rafters with 2x6 bracing horizontal bracing added later, 8' up and 2' O. C.

**CAMERA DIRECTION:** First floor, looking SW, steel pipe posts, 4x6 beam, 2x6 floor joists.

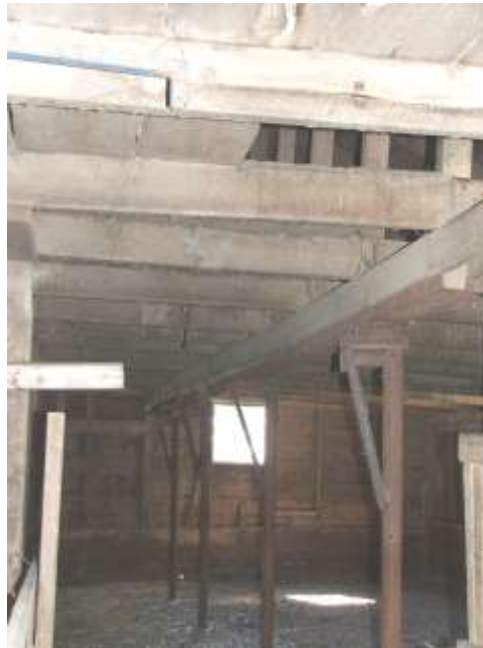
**ROLL NUMBER:** \_\_\_\_\_  
**PHOTO NUMBER:** 7

**ALTERED/MOVED NOTES:** Original site. Roof covered with steel roofing over cedar shingles. All evidence of milk cow stanchions and horse stalls has been removed. North wall of center barn has the bottom 8' of the open 2x4 wall removed with steel pipe posts and channel iron supporting wall and hayloft above. 2x6 bracing added in the South lean-to to support the center of rafters. Exterior walls covered with steel roofing applied horizontally. Posts under 4x6 beam in the center of the barn have been replaced with steel pipe posts. 2x6 bracing added in South lean-to to support center of rafters 2' O. C.

**First floor, looking NW,  
bottom 8' of open 2x4  
wall removed, steel pipe  
posts and channel iron  
support wall and North  
side of hayloft.**

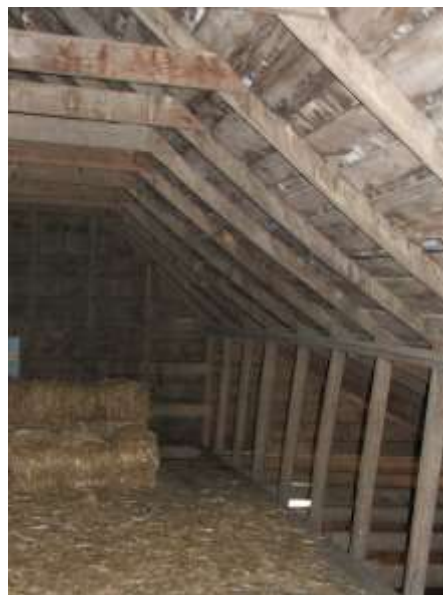
**ROLL NUMBER:** \_\_\_\_\_  
**PHOTO NUMBER:** 8

**Hayloft, looking NW, 2x6  
rafters and 2x6 bracing  
for rafters, open 2x4 wall.**

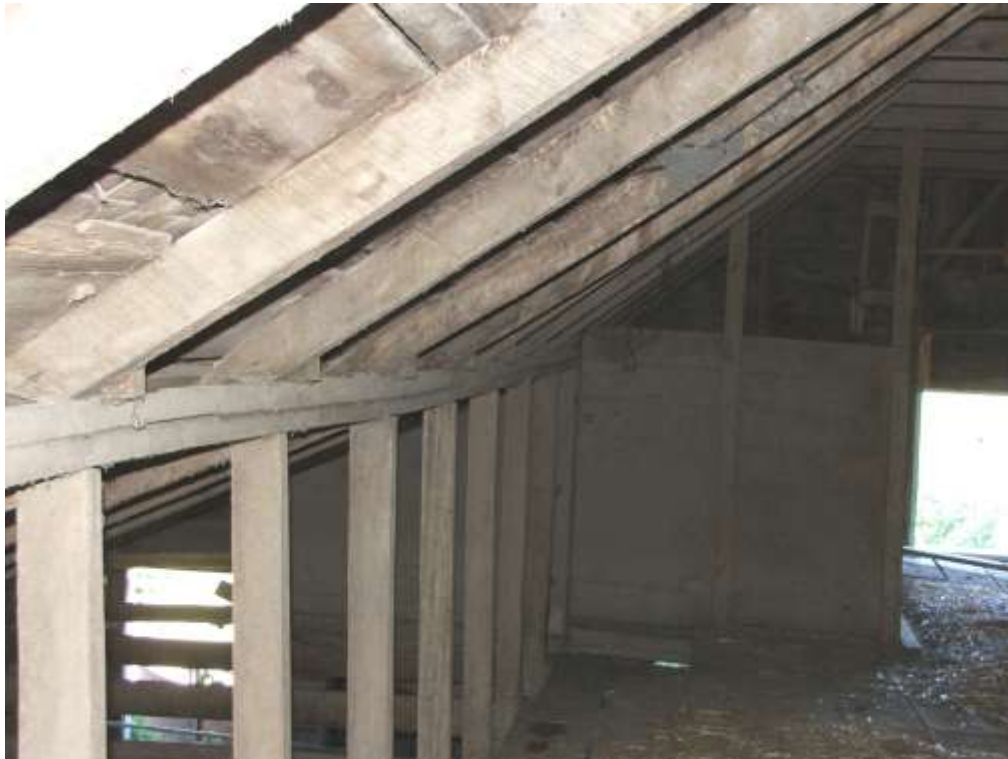
**ROLL NUMBER:** \_\_\_\_\_  
**PHOTO NUMBER:** 9

**CAMERA DIRECTION:** Hayloft, looking NE, 2x6  
rafters and 11' x 8'  
gravity feed granary in  
the NE corner of hayloft,
