SITE INFORMATION

STRUCTURE DETAILS

SHPO ID:								
*PROPERTY NAME:								
OTHER NAME:								
CURRENT FUNCTION:	Livestock barn	FOUNDATION	: Poured concrete					
CURRENT SUBFUNCTION:	Hay storage	ROOF MATERIAL	: Cedar shingles					
HISTORIC FUNCTION:	Draft horse barn	ROOF SHAPE	: Gable					
HISTORIC SUBFUNCTION:	Hay storage	STRUCTURAL SYSTEM						
		CTVI F	Gable roof barn,					
OCCUPIED.	Voc		: Italianate					
OCCUPIED:	res	ITPE	: Draft horse barn 6x6 & 3x6 posts,					
			diagonal 2x4					
400500IDL 5	Yes with		nailers & 1x12					
ACCESSIBLE:	permission	WALLS	: vertical siding					
		Sole	oman & Margaret					
STORIES:	2	SIGNIFICANT PERSON: And						
*DATE OF CONSTRUCTION:		CULTURAL AFFILIATION:	Swedish					
ALTERED/MOVED NOTES:	Original site. A	all 19 single horse stalls and harnes	room still place					
INTERIOR NOTES: Has two	rows 6x6 nosts a	nd 6x8 beam in 7' from East and We	st walls, and two more					
rows of 6x8 posts and 10x10 beams in 13'-6" from the East and West walls to support hayloft floor. The center drive alley is 17' wide. All posts on the first floor and bottom of 10x10 beams are chamfered.

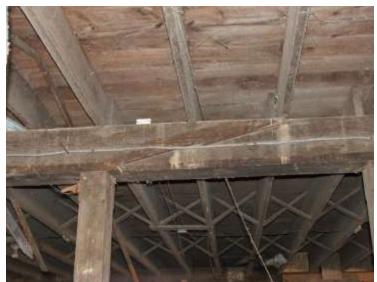
7

First floor, looking West, scarf joint on massive10x10 beam, note chamfer edges

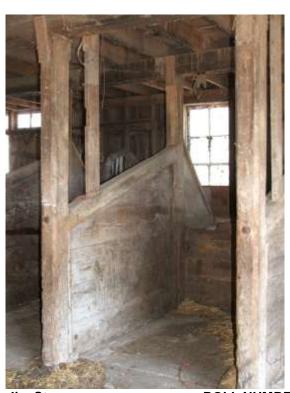
First floor, looking East, single horse stall from

CAMERA DIRECTION: center alley

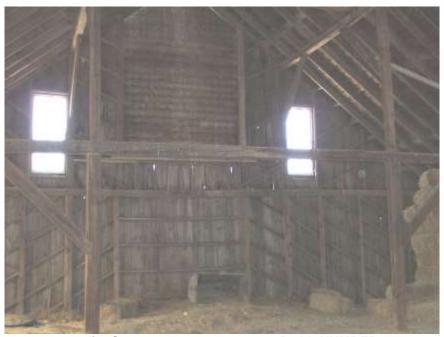
CAMERA DIRECTION: heavy posts and beams

Hayloft, looking North,

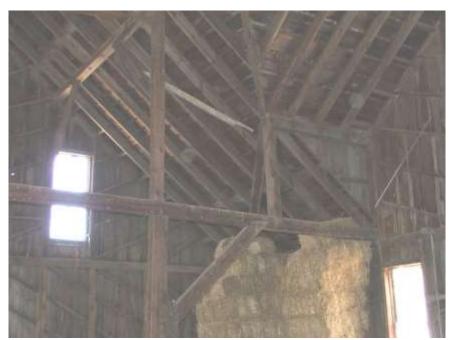
10

Hayloft, looking North, posts and beams, note 6x6 post on 6x8 beam to

CAMERA DIRECTION: support valley rafter

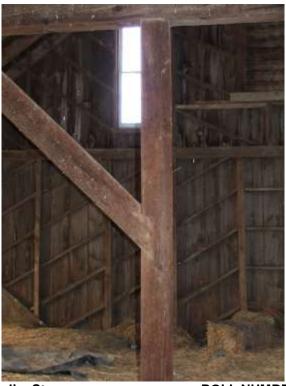
Hayloft, mortised 3x8 brace for 6x8 post up to

CAMERA DIRECTION: 6x8 beam

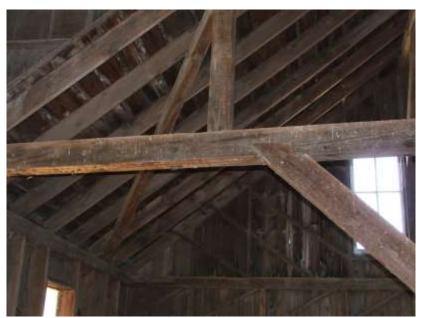
Hayloft, top of 3x8 CAMERA DIRECTION: mortised into 6x8 beam

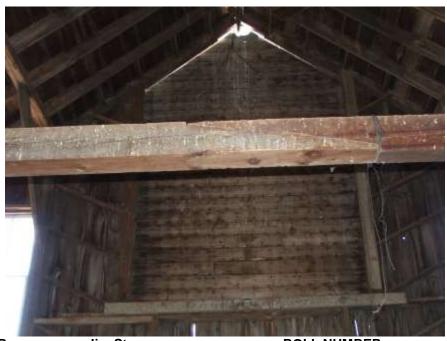
Hayloft, unique scarf joint in 6x8 beam with no CAMERA DIRECTION: post to support splice.

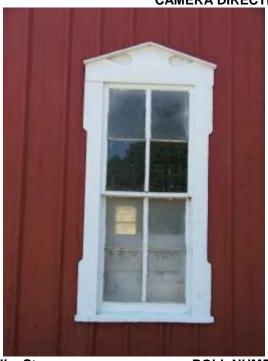
CAMERA DIRECTION: all windows

Ornate window trim on

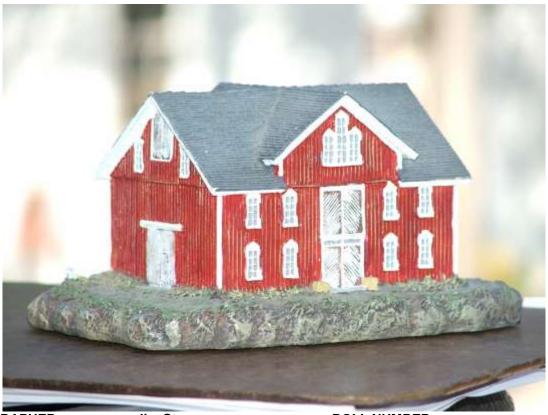
15

Model of this barn cast by Ertl Company 1979. Number 8 of 12 Historical **American Rural Barns**
