SITE INFORMATION

STRUCTURE DETAILS				
SHPO ID:				
*PROPERTY NAME:				
OTHER NAME:				
3111 <u>21111</u> 31112.				
CURRENT FUNCTION:	Farm machinery shop	FOUNDATION:	Poured concrete	
CURRENT SUBFUNCTION:	Auto repair	ROOF MATERIAL:	Asphalt over cedar shingles	
HISTORIC FUNCTION:	Livestock barn	ROOF SHAPE:	Gambrel	
HISTORIC SUBFUNCTION:	Hay and grain storage	STRUCTURAL SYSTEM:	Balloon framing	
		STYLE:	Gambrel roof barn	
OCCUPIED:	Yes		Livestock barn	
	Yes with		2x6, 1x6 #106 drop	
ACCESSIBLE:	permission	WALLS:	siding	
STORIES:	: 2 S	SIGNIFICANT PERSON:	Sophia Demann	
*DATE OF CONSTRUCTION:		LTURAL AFFILIATION:	German	
ALTERED/MOVED NOTES: Original site. Hayloft floor raised to 14'. All stanchions, horse stalls and				
granary have been removed. Walls and Ceiling have been insulated and lined. 16'x12' overhead door				
installed in the North wall. 32' x 32' addition added to the South side with a gable roof. South wall of

SKETCH MAP

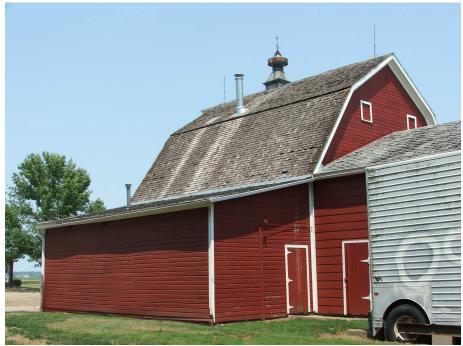
CAMERA DIRECTION: Looking NE, SW corner

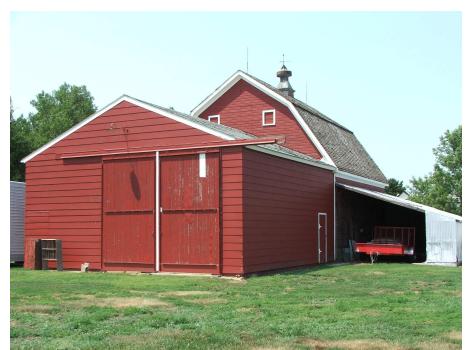
Looking NW, SE corner,

32'x32' addition on the

CAMERA DIRECTION: South

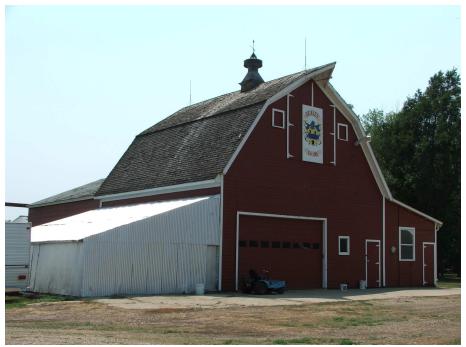
PHOTOGRAPHER: Jim Stone ROLL NUMBER: DATE OF PHOTO: July 2, 2012 PHOTO NUMBER: 3

CAMERA DIRECTION: Looking SW, NE corner

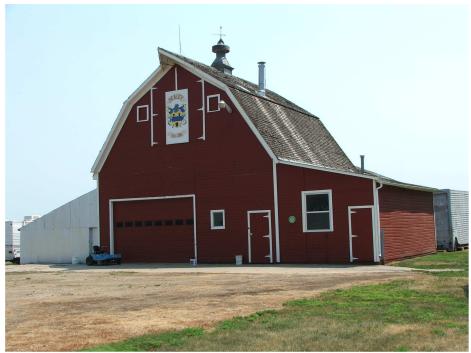
PHOTOGRAPHER: Jim Stone ROLL NUMBER: DATE OF PHOTO: July 2, 2012 PHOTO NUMBER: 4

CAMERA DIRECTION: Looking SE, NW corner

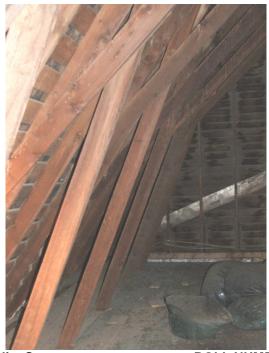
Hayloft, looking South,

CAMERA DIRECTION: lower rafter bracing

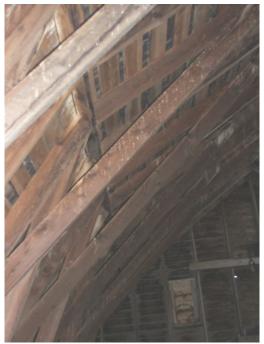
CAMERA DIRECTION: upper/ hip rafter bracing

Hayloft, looking South,
