SITE INFORMATION

*SURVEY DATE: November 4, 2012

*ADDRESS: 46824 Burbank Road

SHPO ID:			
*PROPERTY NAME:			
OTHER NAME:			
CURRENT FUNCTION:	Storage	FOUNDATION:	Poured concrete foundation
CURRENT SUBFUNCTION:	Storage	ROOF MATERIAL:	Steel roofing over cedar shingles
HISTORIC FUNCTION:		ROOF SHAPE:	
HISTORIC SUBFUNCTION:	Hay storage	STRUCTURAL SYSTEM:	Balloon framing
		STYLE:	Gambrel roof barn
OCCUPIED:	Yes	TYPE:	Livestock barn
ACCESSIBLE:	Yes with permission	WALLS:	2x6 stud with 1x6 #106 drop siding
STORIES:	2	SIGNIFICANT PERSON: <u>Star</u>	nley J. Ketchem
*DATE OF CONSTRUCTION:	About 1900 to 1910	CULTURAL AFFILIATION:	?

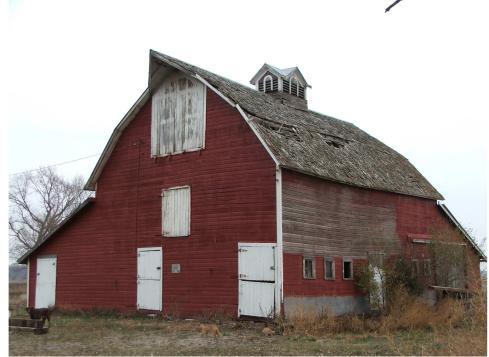
1

Looking NE, SW corner

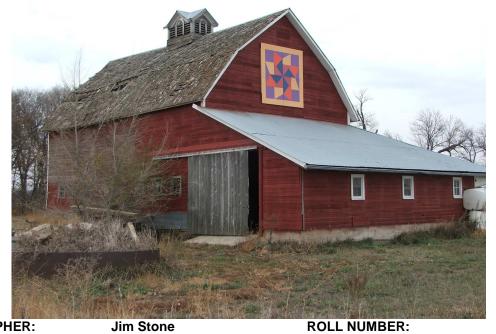
ROLL NUMBER: PHOTO NUMBER: 2 CAMERA DIRECTION: Looking NW, SE corner

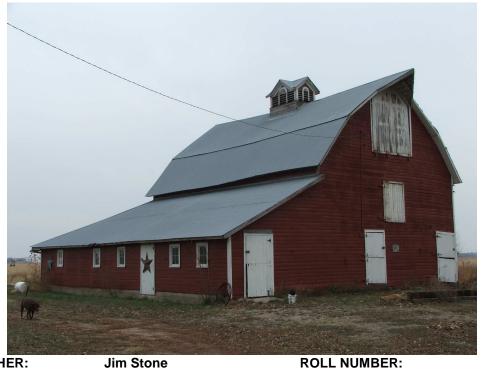
ROLL NUMBER: PHOTO NUMBER: 4 CAMERA DIRECTION: Looking SE, NW corner

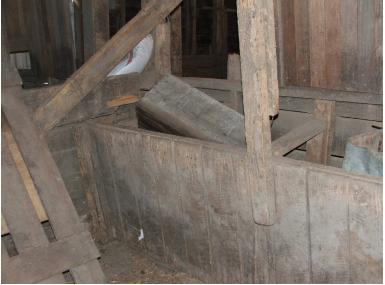
7 First floor, original barn, looking NW, double horse stall

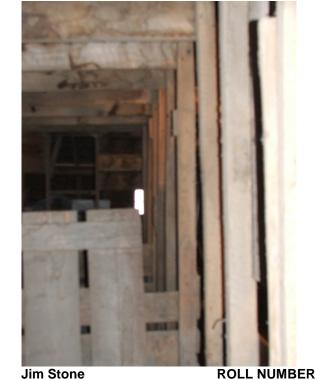
8 First floor, original barn, looking East, 2x6 stud CAMERA DIRECTION: wall in 8' from North wall

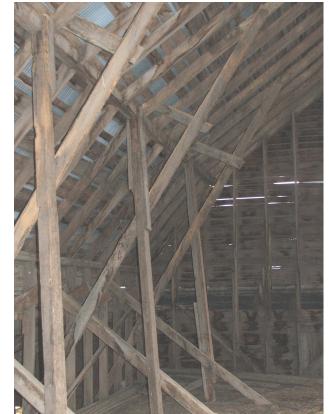
9 Hay loft, looking East, 4x6 posts and (2) 2x6's for beam to support hip CAMERA DIRECTION: and 2x6 bracing 8' O.C.
