SITE INFORMATION

STRUCTURE DETAILS			
SHPO ID:			
*PROPERTY NAME:	Stephen Oleson barn		
OTHER NAME:			
CURRENT FUNCTION:	Storage	FOUNDATION:	Poured concrete
CURRENT SUBFUNCTION:		ROOF MATERIAL:	Cedar shingles
HISTORIC FUNCTION:	Livestock barn & dairy barn	ROOF SHAPE:	Gable
HISTORIC SUBFUNCTION:	Hay storage	STRUCTURAL SYSTEM:	
HISTORIC SUBFUNCTION.	nay storage	STRUCTURAL STSTEM. STYLE:	
		SITLE.	English Livestock
OCCUPIED:	Yes	TYPE:	_
			2x6 with 1x6 #106
ACCESSIBLE:	Yes	WALLS:	drop siding
ATAP: = 4	•	OLONIELO ANT DEDOCAL CO	
STORIES:	2 Early	SIGNIFICANT PERSON: Stepl	nen Oleson
*DATE OF CONSTRUCTION:		CULTURAL AFFILIATION: No	orwegian
ALTERED/MOVED NOTES:	Original site. Original	y had a rock foundation with 6x0	S sill. Foundation

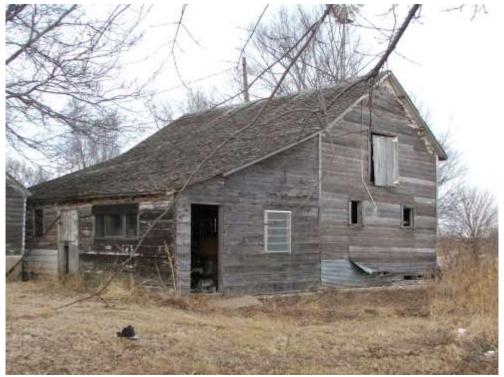
DATE OF PHOTO: February 2, 2012 PHOTO NUMBER: 1

CAMERA DIRECTION: Looking NE, SW corner

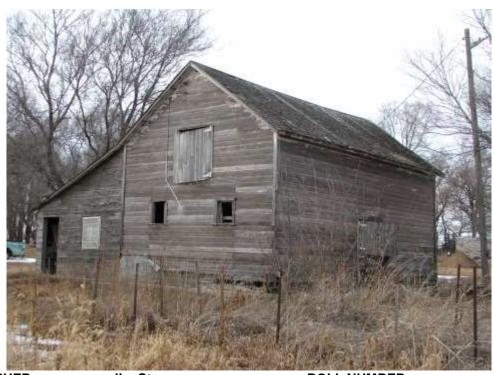
PHOTOGRAPHER: Jim Stone ROLL NUMBER: DATE OF PHOTO: February 2, 2012 PHOTO NUMBER: 2
CAMERA DIRECTION: Looking NW, SE corner

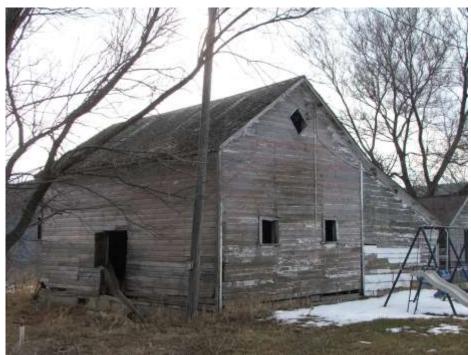
CAMERA DIRECTION: Looking SW, NE corner

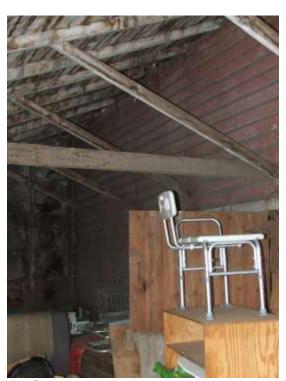
CAMERA DIRECTION: In lean to, looking NE

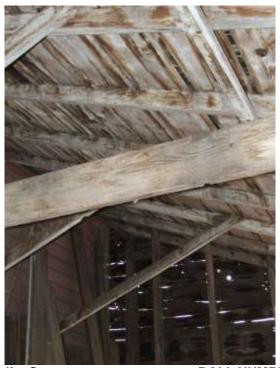
CAMERA DIRECTION: In lean to, looking SE

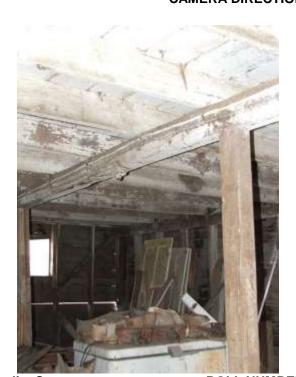
CAMERA DIRECTION: First floor, looking NE

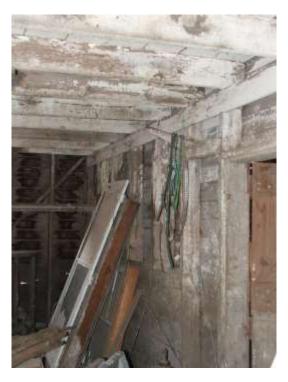
DATE OF PHOTO: February 2, 2012 PHOTO NUMBER: 7

CAMERA DIRECTION: First floor, looking SW

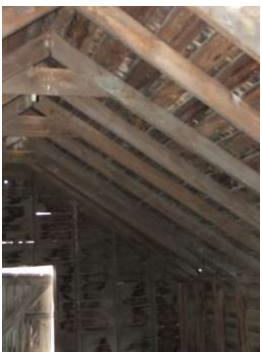
PHOTOGRAPHER: Jim Stone ROLL NUMBER: BHOTO NUMBER: B CAMERA DIRECTION: Hayloft, looking North

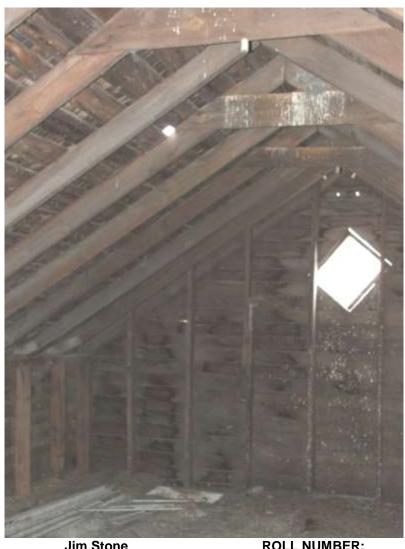
CAMERA DIRECTION: Hayloft, looking North
