**SOUTH DAKOTA STATE HISTORIC PRESERVATION OFFICE
HISTORIC SITES SURVEY STRUCTURE FORM**

*SURVEY DATE: March 7, 2013 *ADDRESS: 31015 470th Ave.
*SURVEYOR: Jim Stone *COUNTY: Clay
*CITY: Beresford

CURRENT FUNCTION:	<u>Horse shelter</u>	FOUNDATION:	<u>Poured concrete</u>
CURRENT SUBFUNCTION:	<u>Vacant</u>	ROOF MATERIAL:	<u>Steel roofing over cedar shingles</u>
HISTORIC FUNCTION:	<u>Livestock barn</u>	ROOF SHAPE:	<u>Gable</u>
HISTORIC SUBFUNCTION:	<u>Hay storage</u>	STRUCTURAL SYSTEM:	<u>Balloon framing</u> <u>Western feeder</u>
		STYLE:	<u>barn</u>
OCCUPIED:	<u>Yes</u>	TYPE:	<u>Livestock barn</u> <u>2x4 & 2x6 studs,</u> <u>1x6 #106 drop</u> <u>siding</u>
ACCESSIBLE:	<u>Yes with permission</u>	WALLS:

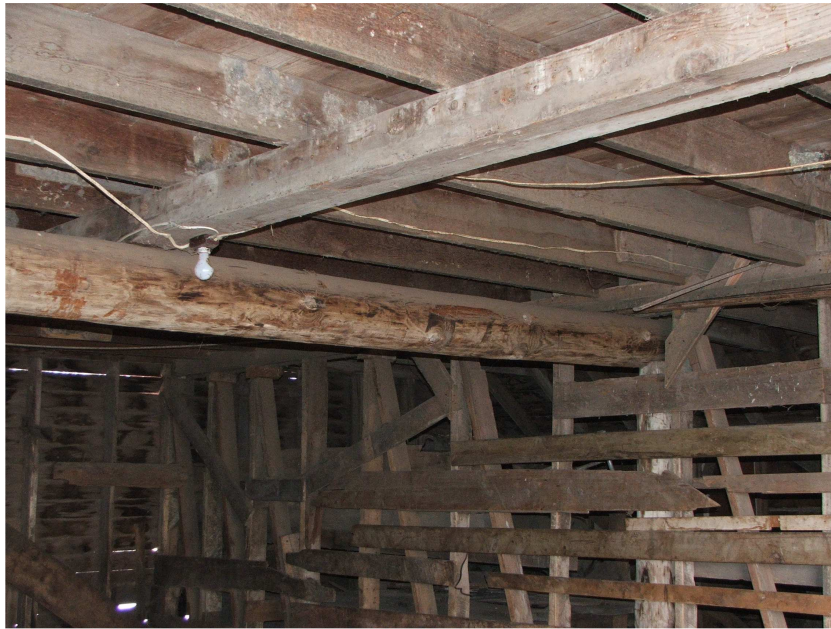
ROLL NUMBER: _____
PHOTO NUMBER: 5

INTERIOR NOTES: Double 4x6's have been added in the center part of the barn to support the center of the floor joists. A 10" pole has been added perpendicular under the double 4x6's. This pole is supported on each end with 10" poles in the wall on each side of the center part of the barn. The floor joists for the hayloft floor are 2x8's.

CAMERA DIRECTION: First floor, looking NW, double 4x6's and 10" beam supporting the center of the 4x6's.

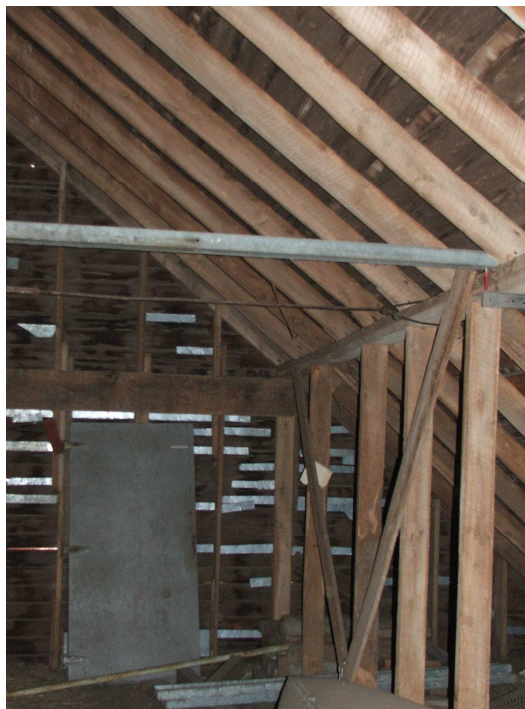
ROLL NUMBER: _____
PHOTO NUMBER: 6

CAMERA DIRECTION: Hayloft, looking NW, 93" high, 2x6 wall in hayloft.

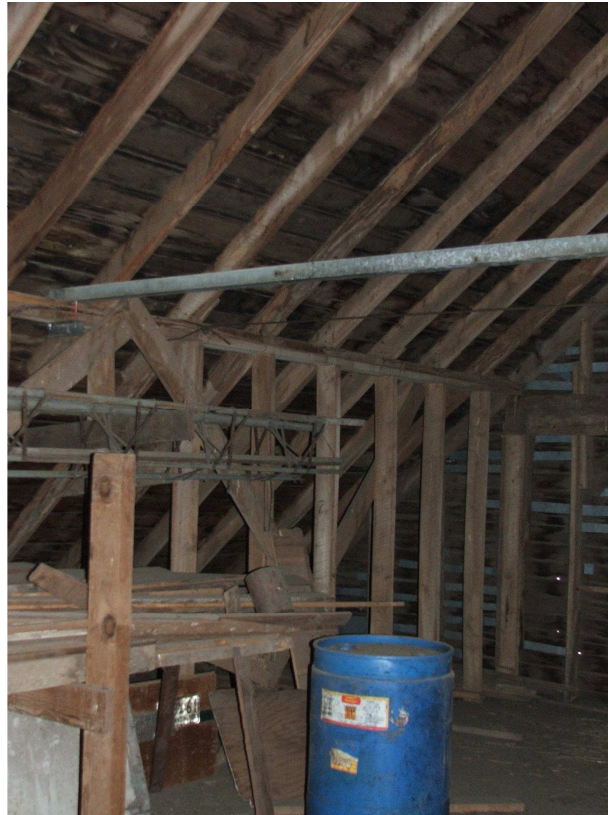
ROLL NUMBER: _____
PHOTO NUMBER: 7

CAMERA DIRECTION: Hayloft, looking SW,
South 93" stud wall in
hayloft .
