SITE INFORMATION

*SURVEY DATE: January 18, 2013

*ADDRESS: 46562 312th Street

SHPO ID:			
*PROPERTY NAME:			
OTHER NAME:			
CURRENT FUNCTION:	Machinery storage	FOUNDATION:	Poured concrete foundation
CURRENT SUBFUNCTION:	Machinery storage	ROOF MATERIAL:	Asphalt shingles over cedar shingles
HISTORIC FUNCTION:	Livestock barn	ROOF SHAPE:	Gable
HISTORIC SUBFUNCTION:	Hay storage	STRUCTURAL SYSTEM:	Balloon framing
		STYLE:	Western feeder barn
OCCUPIED:	Yes	TYPE:	Livestock barn
ACCESSIBLE:	Yes with permission	WALLS:	2x6 & 2x4 studs, sheathing & ½"x6" cedar lap siding
			· · · · · · · · · · · · · · · · · · ·
STORIES:	2	SIGNIFICANT PERSON:	Theo Anker
*DATE OF CONSTRUCTION:	1910 to 1920	CULTURAL AFFILIATION:	?

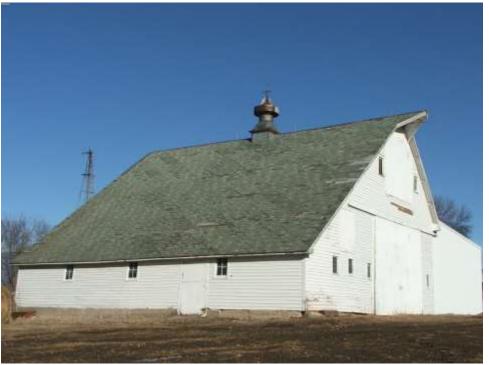
1

CAMERA DIRECTION: Looking NE, SW corner

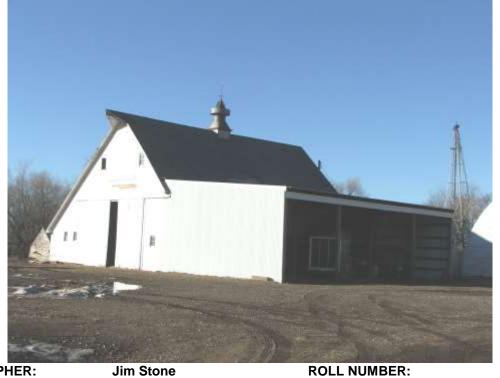
2 **PHOTO NUMBER:** CAMERA DIRECTION: Looking NW, SE corner

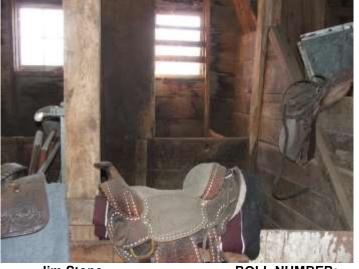
5 First floor, West lean-to, looking South, one of the single horse stalls on

CAMERA DIRECTION: South wall.

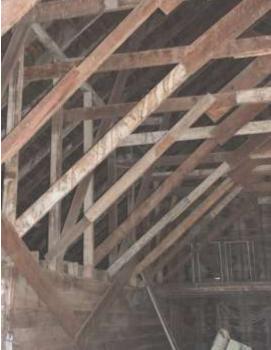
PHOTO NUMBER: 6 First floor, looking up, double 2x6 studs on the West wall of center of barn and 2x6 original bracing and 2x8 added CAMERA DIRECTION: bracing.

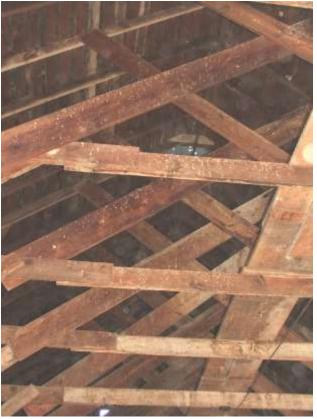
7

First floor, looking up, 2x8 cross bracing to reenforce rafters after removing havloft floor.
