""SITE INFORMATION

OHE IN ORMATION										
*SURVEY DATE: De	ecember 18, 2013	*ADDRESS: _30717 University Road								
*SURVEYOR: Jir	m Stone	*COUNTY:								
		*CITY:	Vermillio	n						
LOCATION DESCRIPTION: Fr	om Vermillion, South	Dakota Highwa	y 50 East a	bout 4 n	niles to	o 469) th Ave	е.,		
turn left (North) about 1/2 mile to 317 th Street, turn right (East) about ½ mile on the left (North) side.

STRUCTURE DETAILS

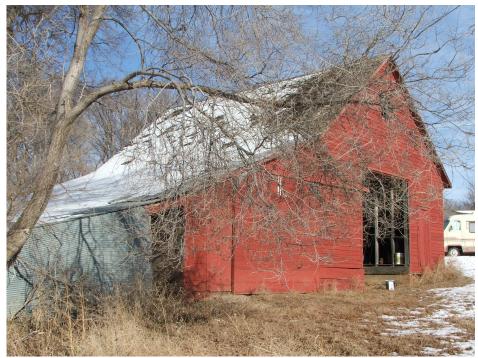
CAMERA DIRECTION: Looking NE, SW corner

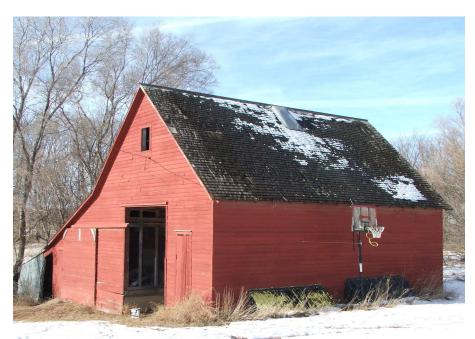
CAMERA DIRECTION: Looking NW, SE corner

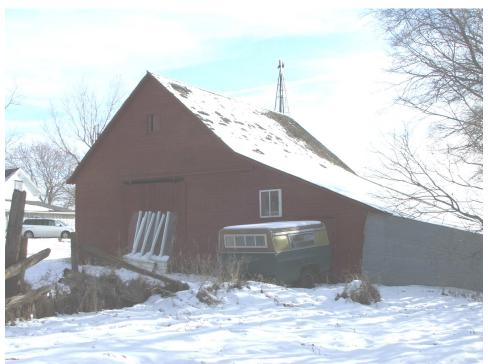
PHOTOGRAPHER: Jim Stone ROLL NUMBER: DATE OF PHOTO: December 18, 2013 PHOTO NUMBER: 4

CAMERA DIRECTION: Looking SE, NW corner
