**SOUTH DAKOTA STATE HISTORIC PRESERVATION OFFICE
HISTORIC SITES SURVEY STRUCTURE FORM**

*SURVEY DATE: August 10, 2013 *ADDRESS: 45344 306th Street
*SURVEYOR: Jim Stone *COUNTY: Clay
*CITY: Volin

CURRENT FUNCTION: Calving barn FOUNDATION: Native stone and poured concrete
 CURRENT SUBFUNCTION: Storage ROOF MATERIAL: Steel roofing over cedar shingles
 HISTORIC FUNCTION: Livestock barn ROOF SHAPE: Gambrel roof
 HISTORIC SUBFUNCTION: Hay & grain storage STRUCTURAL SYSTEM: Balloon framing
 OCCUPIED: No STYLE: Gambrel roof barn
 TYPE: Livestock barn
 ACCESSIBLE: Yes with permission WALLS: 2x6 studs, 1x10 shiplap & 1/2"x6" cedar lap siding

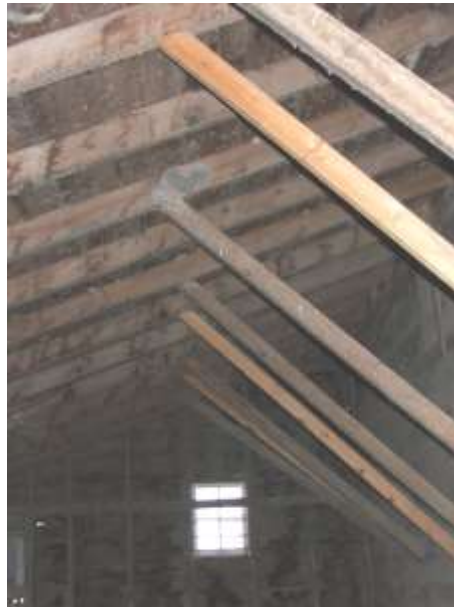
ROLL NUMBER: _____
PHOTO NUMBER: 5

CAMERA DIRECTION: Looking South & up, in East lean-to, 2x6 rafters with 2x6 bracing for support.

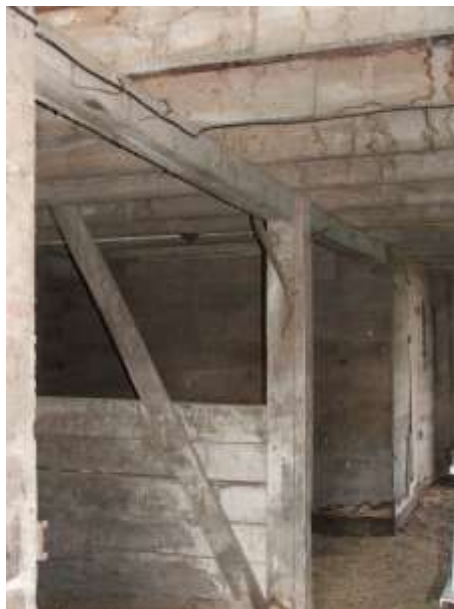
ROLL NUMBER: _____
PHOTO NUMBER: 6

CAMERA DIRECTION: First floor, looking NW, 6x6 posts, (3) 2x6's for a beam, 2x8 floor joists, horse stalls were between posts, granary in the NW corner.

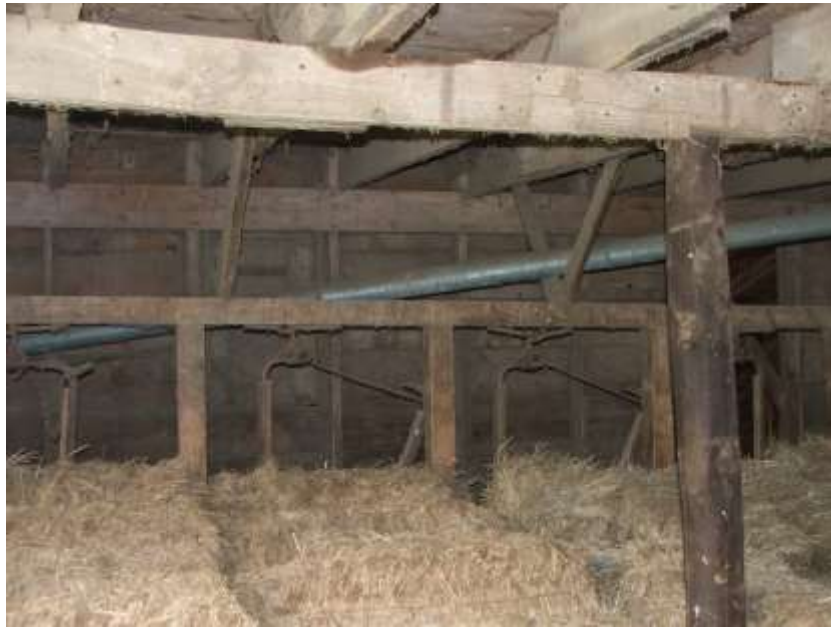
ROLL NUMBER: _____
PHOTO NUMBER: 7

**First floor, looking East,
four milk cow stanchions
still in place, almost
hidden by straw bales.**

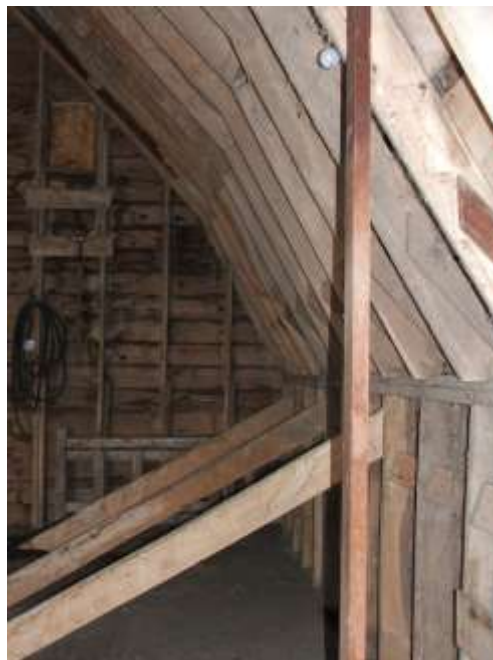
ROLL NUMBER: _____
PHOTO NUMBER: 8

**Hayloft, looking NE, 2x6
rafters, 2x6 bracing from
top of wall down to floor.
6' O. C.**

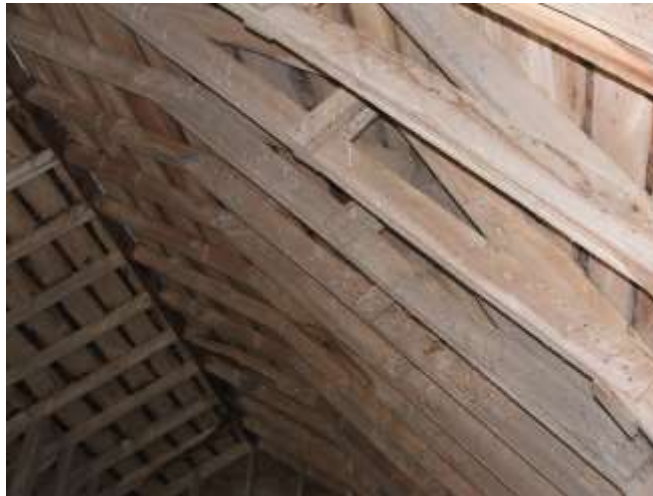
ROLL NUMBER: _____
PHOTO NUMBER: 9

**Hayloft, looking NW, (2)
1x6's bracing rafters at
roof hip.**

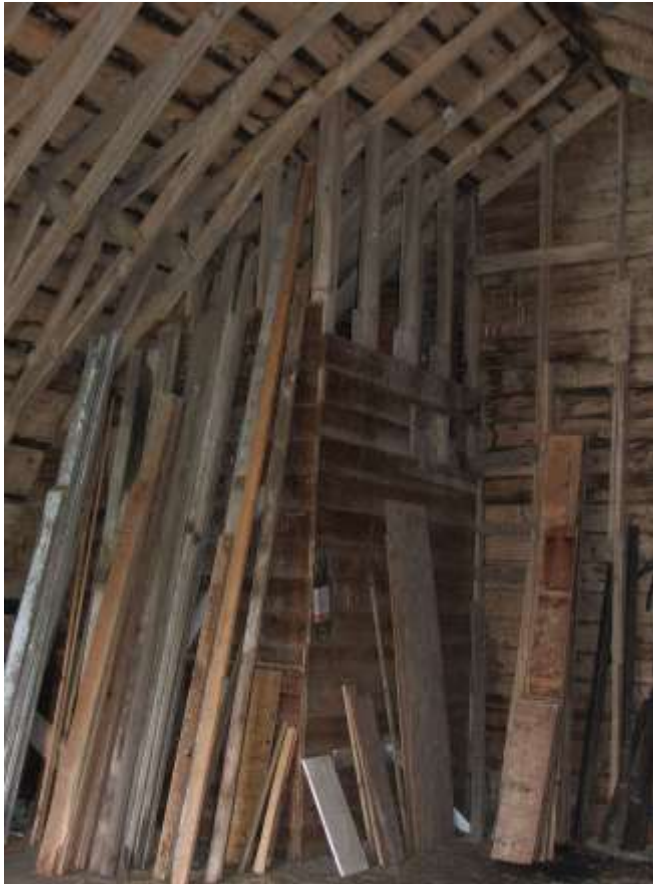
ROLL NUMBER: _____
PHOTO NUMBER: 10

**Hayloft, looking NW, tall
8' x 10' granary in the
NW corner of hayloft.**
