**SOUTH DAKOTA STATE HISTORIC PRESERVATION OFFICE
HISTORIC SITES SURVEY STRUCTURE FORM**

*SURVEY DATE: January 8, 2013 *ADDRESS: 46913 303rd Street
*SURVEYOR: Jim Stone *COUNTY: Clay
*CITY: Beresford

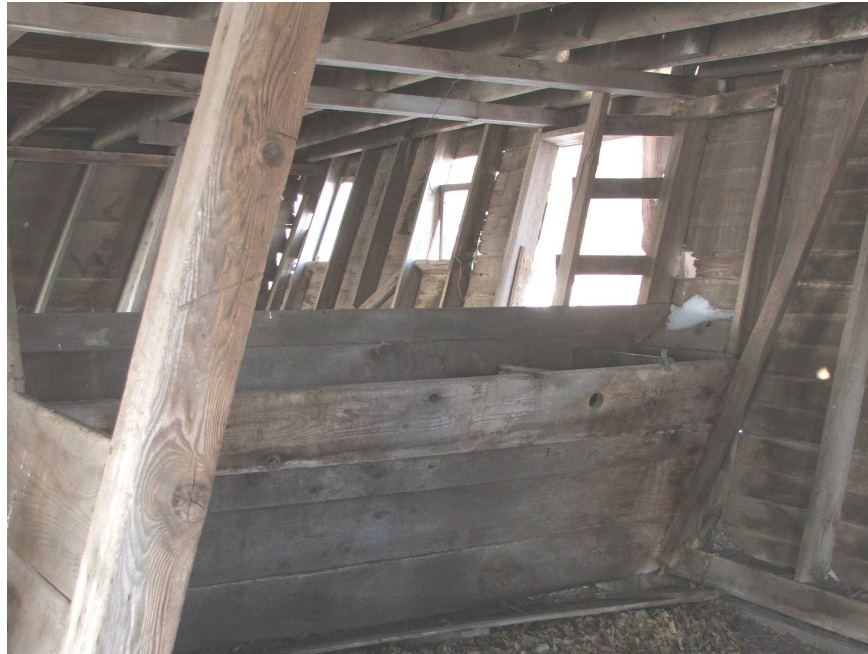
ROLL NUMBER: _____
PHOTO NUMBER: 5

CAMERA DIRECTION: First floor, looking NW,
double horse stall on
East side.

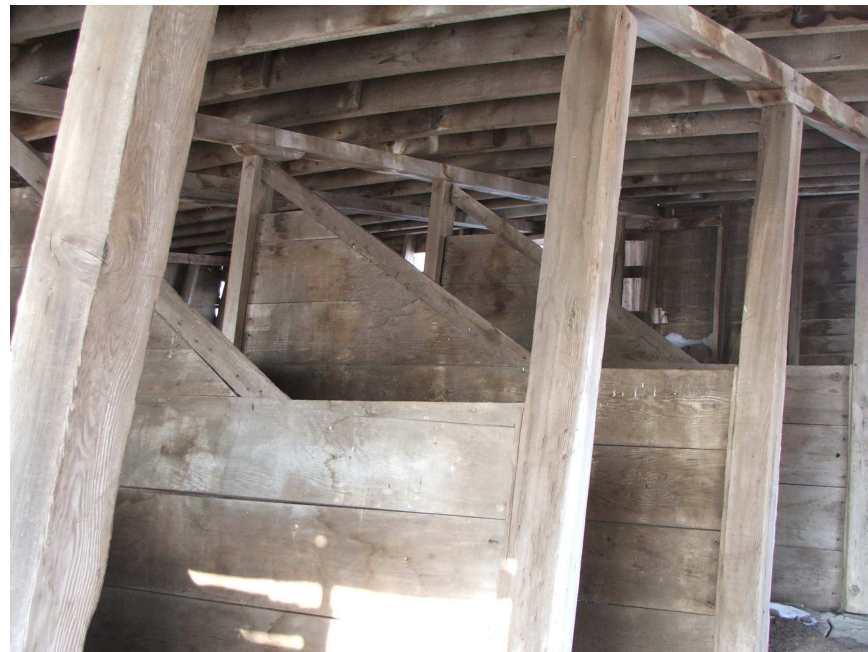
ROLL NUMBER: _____
PHOTO NUMBER: 6

CAMERA DIRECTION: First floor, looking NW,
single horse stall on the
East side.

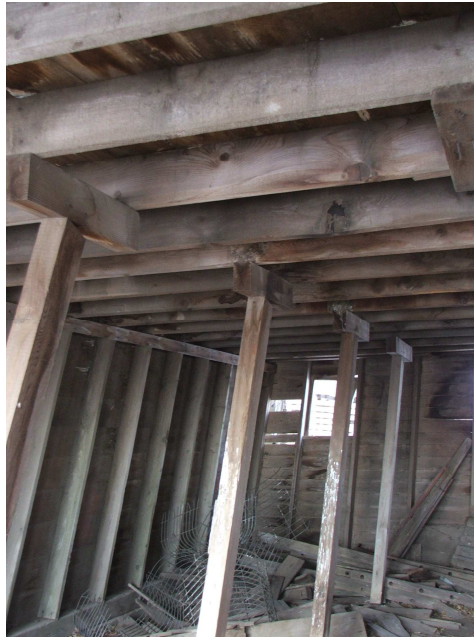
ROLL NUMBER: _____
PHOTO NUMBER: 7

ALTERED/MOVED NOTES: Original site. Any evidence of milk cow stanchions has been removed. 12' x 32' lean-to on the West side appears to have been added on a long time ago. Two rows of 4x6 post and beams have been removed on the West side and replaced with same 4x6 posts and short pieces of 4x6 beams. Two rows of 4x6 posts with a 4x6 beam support the center of the rafters in the hayloft.

**First floor, looking NW.
posts and beam
removed, shorts pieces
of beam and posts
replaced.**

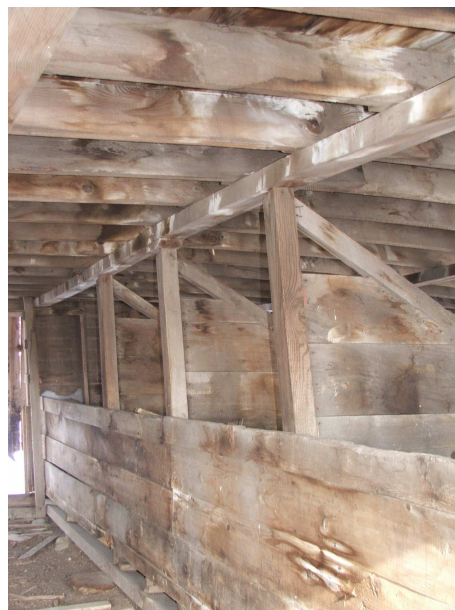
ROLL NUMBER: _____
PHOTO NUMBER: 8

**First floor, looking NE,
center feed alley, horse
stalls on the right**
