**SOUTH DAKOTA STATE HISTORIC PRESERVATION OFFICE
HISTORIC SITES SURVEY STRUCTURE FORM**

*SURVEY DATE: November 19, 2012 *ADDRESS: 28 Center Street
*SURVEYOR: Jim Stone *COUNTY: Clay
*CITY: Vermillion

CURRENT FUNCTION:	<u>Renting, three store's</u>	FOUNDATION:	<u>Poured concrete foundation</u>
CURRENT SUBFUNCTION:	<u>Storage</u>	ROOF MATERIAL:	<u>Asphalt roofing over cedar shingles</u>
HISTORIC FUNCTION:	<u>Livery barn</u>	ROOF SHAPE:	<u>Hip with flat top</u>
HISTORIC SUBFUNCTION:	<u>Hay storage</u>	STRUCTURAL SYSTEM:	<u>Masonry walls with brick facing</u>
OCCUPIED:	<u>Yes</u>	STYLE:	<u>Livery barn</u>
	<u>Yes with permission</u>	TYPE:	<u>Livestock barn</u>
ACCESSIBLE:	<u>permission</u>	WALLS:	<u>Clay tile and brick walls</u>
STORIES:	<u>2</u>	SIGNIFICANT PERSON:	<u>D. L. Caine - proprietor</u>
*DATE OF CONSTRUCTION:	<u>1902 or 1903</u>	CULTURAL AFFILIATION:	<u>?</u>

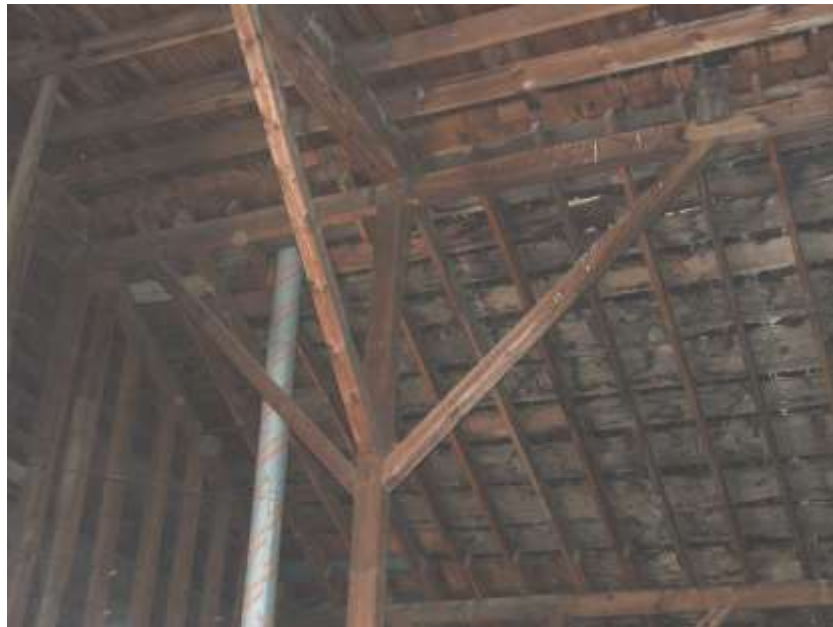
ROLL NUMBER: _____
PHOTO NUMBER: 5

Hayloft, looking SE, 4x6 post, bracing 6x6 beam and 5 ply 2/12 beam

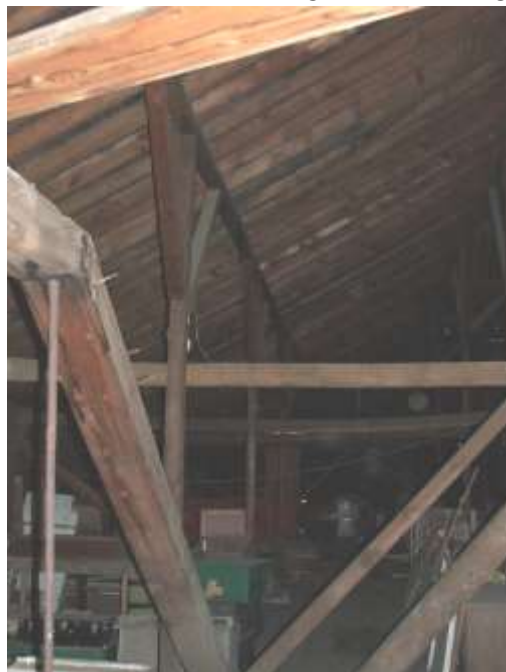
ROLL NUMBER: _____
PHOTO NUMBER: 6

Hayloft, looking West, 4x6 posts and beam support for center of rafters

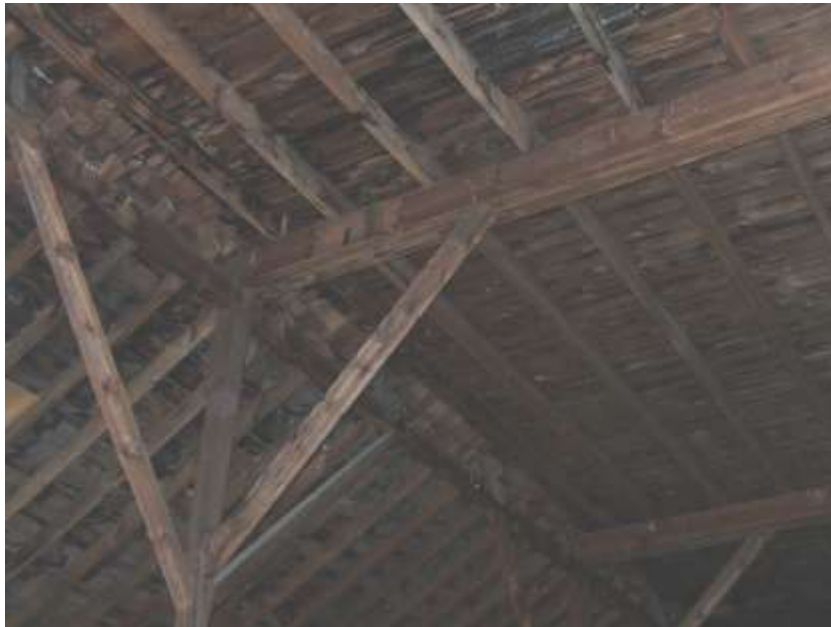
ROLL NUMBER: _____
PHOTO NUMBER: 7

CAMERA DIRECTION: Hayloft, looking SE, 4x6 posts, bracing, 6x6 beam and 5 ply 2x12 beam.

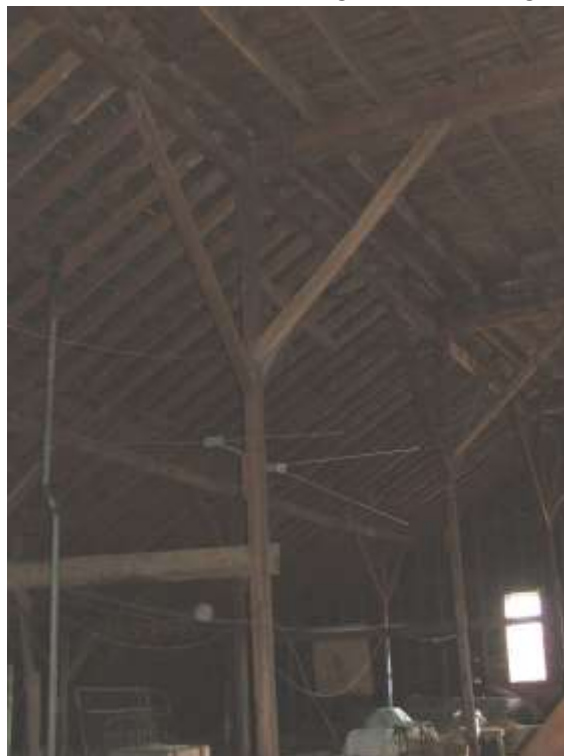
ROLL NUMBER: _____
PHOTO NUMBER: 8

CAMERA DIRECTION: Hayloft, looking NE, 4x6 posts, bracing, 6x6 beam and 5ply 2x12 beam.

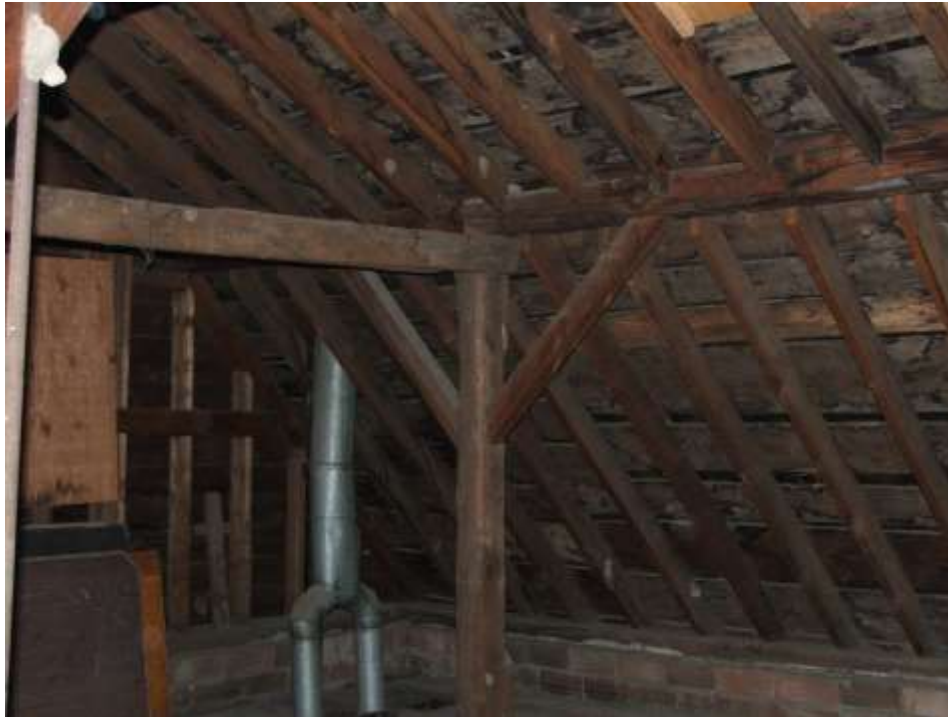
ROLL NUMBER: _____
PHOTO NUMBER: 9

CAMERA DIRECTION: Hayloft, looking SE, 6x6 short post, 6x6 beam and rafters in SE corner.

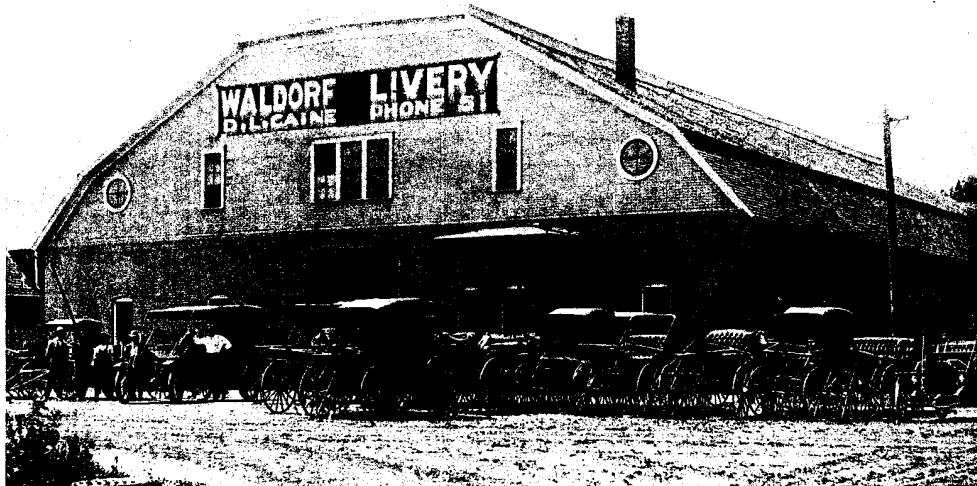
ROLL NUMBER: _____
PHOTO NUMBER: 10
CAMERA DIRECTION: Looking West, East side

Picture #10 in this survey shows the Waldorf Livery in the early 1900's as the new meets the old. Horse drawn carriages and Model T's lined up in front of the livery.
