SITE INFORMATION

| *SURVEY D | ATE: Octol | 2012 | *ADDRESS: 46852 Burbank Road | | | | | | | | | |

STRUCTURE DETAILS

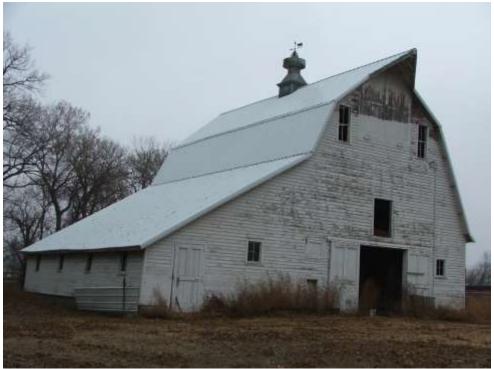
PHOTO NUMBER: CAMERA DIRECTION: Looking NE, SW corner

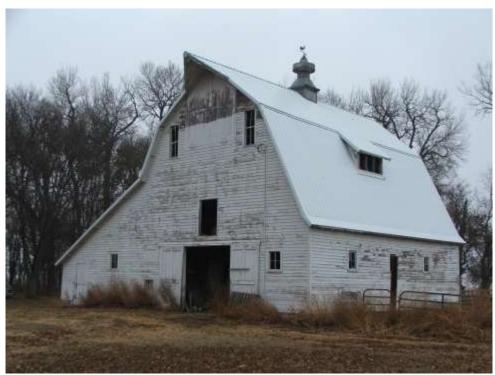
CAMERA DIRECTION: Looking NW, SE corner

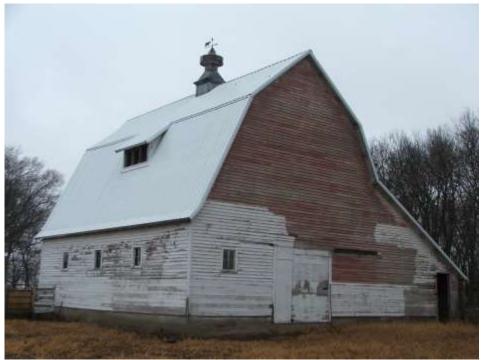
PHOTOGRAPHER: Jim Stone ROLL NUMBER:
DATE OF PHOTO: October 24, 2012 PHOTO NUMBER: 3
CAMERA DIRECTION: Looking SW, NE corner

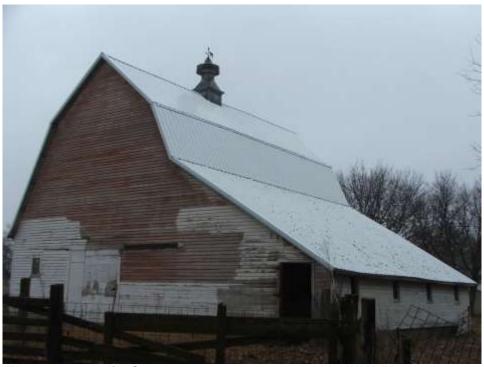
CAMERA DIRECTION: Looking SE, NW corner
