**SOUTH DAKOTA STATE HISTORIC PRESERVATION OFFICE
HISTORIC SITES SURVEY STRUCTURE FORM**

*SURVEY DATE: June 26, 2013 *ADDRESS: 45640 301st Street
*SURVEYOR: Jim Stone *COUNTY: Clay
*CITY: Wakonda

CURRENT FUNCTION: <u>Calving barn</u>	FOUNDATION: <u>Native stone, sand and lime mortar</u>
CURRENT SUBFUNCTION: <u>Storage</u>	ROOF MATERIAL: <u>Cedar shingles</u>
HISTORIC FUNCTION: <u>Livestock barn</u>	ROOF SHAPE: <u>Gable roof</u>
HISTORIC SUBFUNCTION: <u>Hay storage</u>	STRUCTURAL SYSTEM: <u>Balloon framing</u>
	STYLE: <u>Gable roof bank barn</u>
OCCUPIED: Yes	TYPE: <u>Livestock barn</u>
	<u>2x6 studs, 1x8 #106 drop siding</u>
ACCESSIBLE: Yes with permission	WALLS: _____
STORIES: <u>2</u>	SIGNIFICANT PERSON: <u>William F. Mayer</u>
*DATE OF CONSTRUCTION: <u>1880's</u>	CULTURAL AFFILIATION: <u>?</u>

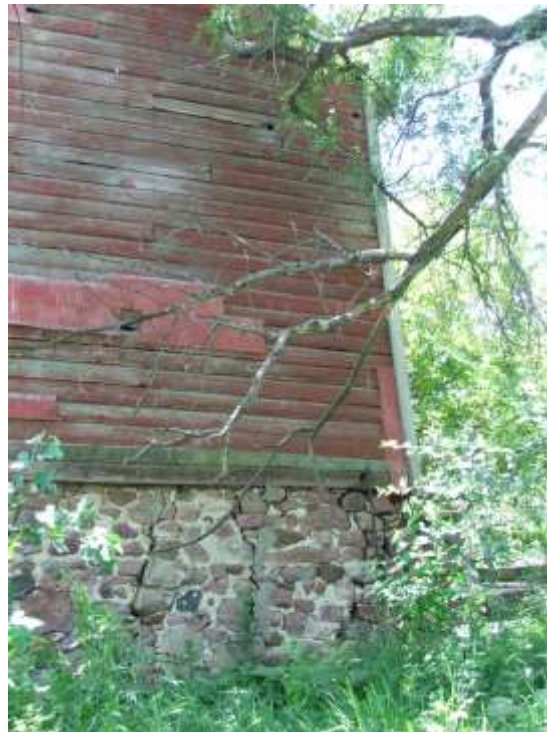
ROLL NUMBER: _____
PHOTO NUMBER: 5

CAMERA DIRECTION: Looking South, NW corner and North stone wall.

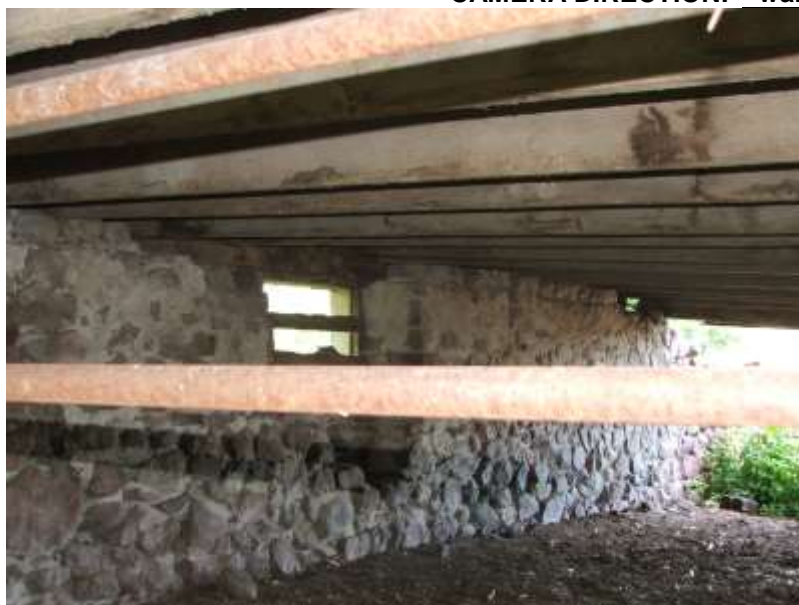
ROLL NUMBER: _____
PHOTO NUMBER: 6

CAMERA DIRECTION: First floor, looking NE, in side looking at the North stone wall.

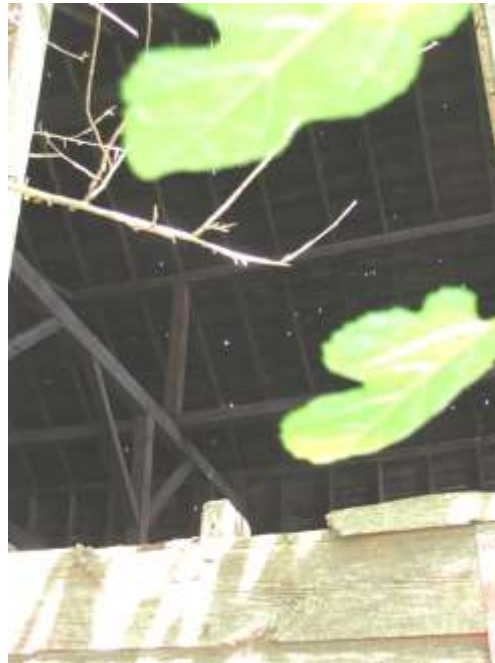
ROLL NUMBER: _____
PHOTO NUMBER: 7

INTERIOR NOTES: One row of 6x6 posts, and 6x6 beam and one 2x4 solid stud wall support the 2x12 joists for the hayloft floor. The second floor is all hayloft with 13' – 6" sides and 28' 6" to peak. 6x6 posts and 6x6 beams support the center of rafters. 4x4 angle bracing help support posts and beams.

CAMERA DIRECTION: Hayloft, looking NE, 6x6 posts, 6x6 beams and 4x4 diagonal bracing.

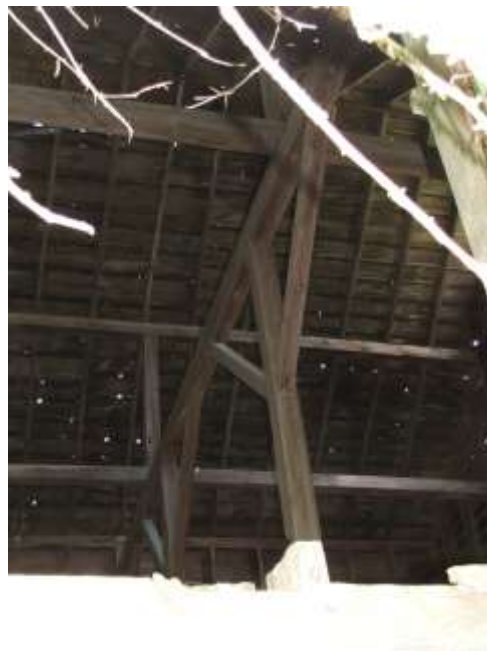
ROLL NUMBER: _____
PHOTO NUMBER: 8

CAMERA DIRECTION: Hayloft, looking SE, 6x6 posts, 6x6 beams and 4x4 diagonal bracing.
