"SITE INFORMATION													
*SURVEY DATE:	June 26, 2	2013	45640 301st Street										
*SURVEYOR:	Jim Stone		*COUNTY:	Clay									
			*CITY:	Wako	Wakonda

STRUCTURE DETAILS

SHPO ID:		<u>_</u>									
*PROPERTY NAME:											
OTHER NAME:											
CURRENT FUNCTION:	Calving barn	FOUNDATION:	Poured concrete								
		_	Asphalt shingles over								
CURRENT SUBFUNCTION:	Storage	ROOF MATERIAL:	cedar shingles								
HISTORIC FUNCTION:	Livestock barn	_ ROOF SHAPE:	Gambrel roof								
HISTORIC SUBFUNCTION:	Hay storage	STRUCTURAL SYSTEM:	Balloon framing								
		STYLE:	Gambrel roof barn								
OCCUPIED:	Yes	TYPE:	Livestock barn								
	Yes with		2x6 studs, 1x6 #106								
ACCESSIBLE:	permission	WALLS:	drop siding								
STORIES:	2	SIGNIFICANT PERSON:	William F. Mayer								
*DATE OF CONSTRUCTION:	1920's Cl	JLTURAL AFFILIATION:	?								
ALTERED/MOVED NOTES: Original site. All evidence of horse stalls and or milk cow stanchions has											
been removed. Asphalt shingles have been installed over cedar shingles on the roof. Cupola is gone.

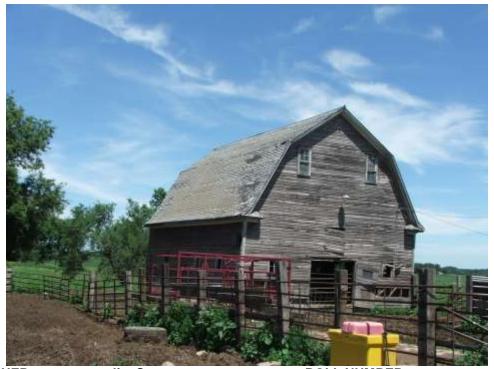
CAMERA DIRECTION: Looking NE, SW corner

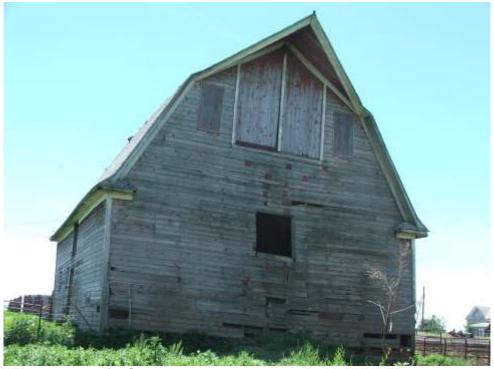
CAMERA DIRECTION: Looking NW, SE corner

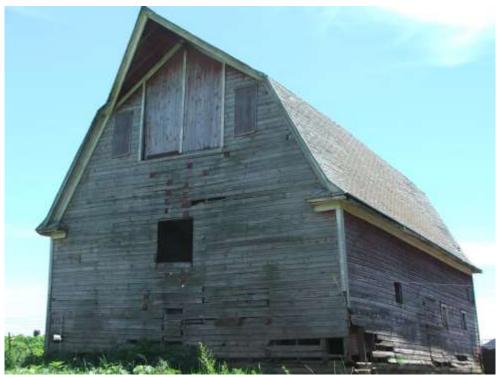
PHOTOGRAPHER: Jim Stone ROLL NUMBER: DATE OF PHOTO: June 26, 2013 PHOTO NUMBER: 3

CAMERA DIRECTION: Looking SW, NE corner

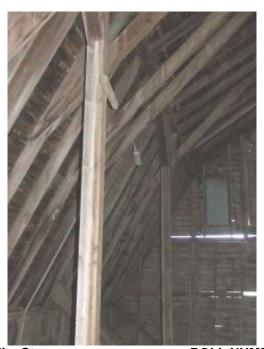
First floor, looking NW, 6x6 post, 6x6 beam, 2x10 joists, some evidence of

CAMERA DIRECTION: horse stalls.

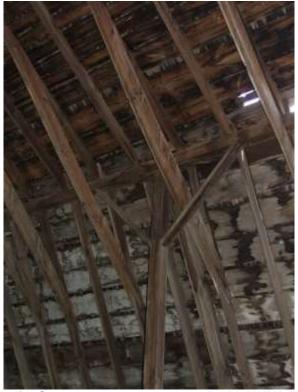
Hayloft, looking NW, 6x6 posts and 6x6 beam

CAMERA DIRECTION: supporting hip.
