STRUCTURE DETAILS

SHPO ID:											
*PROPERTY NAME:											
OTHER NAME:											
CURRENT FUNCTION:	Cow calf barn	FOUNDATION:	Poured concrete								
			Steel over cedar								
CURRENT SUBFUNCTION:	Storage	ROOF MATERIAL:	shingles								
HISTORIC FUNCTION:	Livestock barn	ROOF SHAPE:	-								
HISTORIC SUBFUNCTION:	Hay storage	STRUCTURAL SYSTEM:	Balloon framing								
		STYLE:	Western feeder barn								
OCCUPIED:	Yes	TYPE:	Livestock barn								
ACCECCIDI E.	Yes with	WALL C.	2x4 and 2x6 studs,								
ACCESSIBLE:	permission	WALLS:	1x6 #106 drop siding								
STORIES:	2	SIGNIFICANT PERSON:									
*DATE OF CONSTRUCTION:		CULTURAL AFFILIATION:	?								
DATE OF CONSTRUCTION.	Larry 1900 S	COLTONAL ATTILIATION.	i								
ALTERED/MOVED NOTES:	Original site Mo	ost evidence of horse stalls and or mil	k cow stanchions has

*PHYSICAL NOTES: Barn is	s in fair condition										
0.0/12 110 120. Daili 1	z idii Gondidioni										
*LITM 70NC		*DECTRICTED: V -	M								
		*RESTRICTED: Y o	r N								
*UTM EASTING:											
*UTM NORTHING:

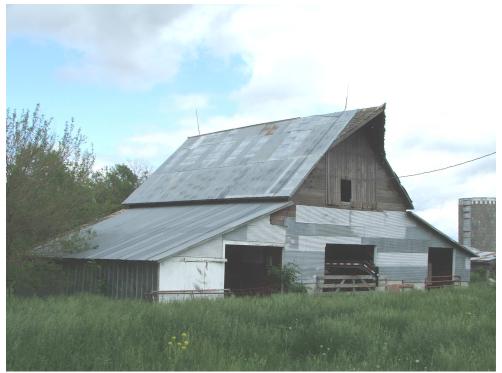
CAMERA DIRECTION: Looking NE, SW corner

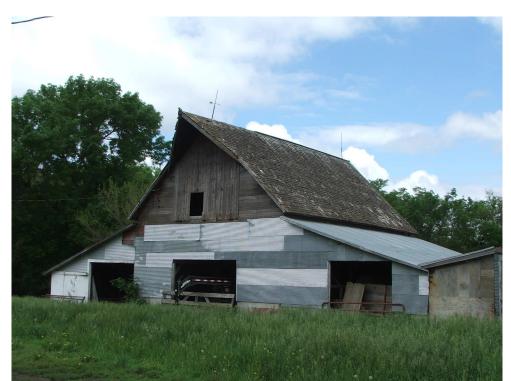
CAMERA DIRECTION: Looking NW, SE corner

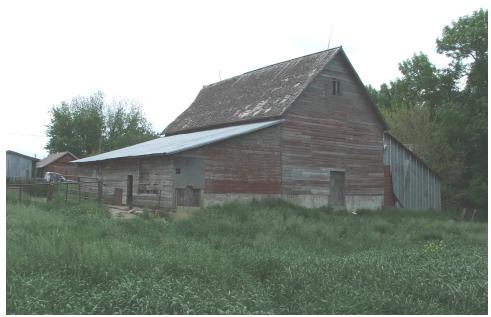
PHOTOGRAPHER: Jim Stone ROLL NUMBER: DATE OF PHOTO: June 5, 2013 PHOTO NUMBER: 3
CAMERA DIRECTION: Looking SW, NE corner

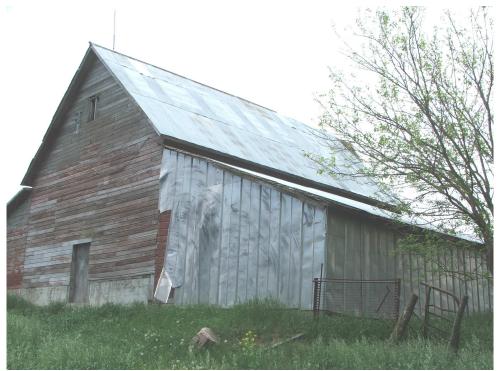
PHOTOGRAPHER: Jim Stone ROLL NUMBER: DATE OF PHOTO: June 5, 2013 PHOTO NUMBER: 4
CAMERA DIRECTION: Looking SE, NW corner

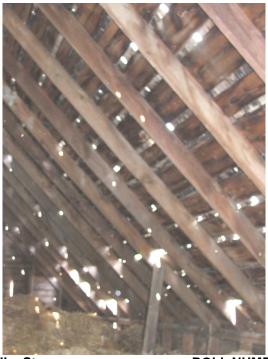
Hayloft, looking NE, 2x6

CAMERA DIRECTION: _rafters.

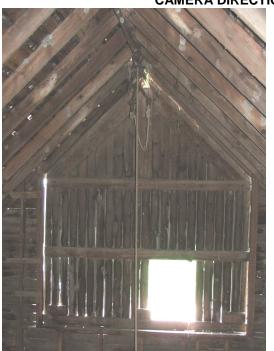
Hayloft, looking South, 2x6 rafters and hayloft

CAMERA DIRECTION: door on the South wall.
