**SOUTH DAKOTA STATE HISTORIC PRESERVATION OFFICE
HISTORIC SITES SURVEY STRUCTURE FORM**

*SURVEY DATE: August 21, 2013 *ADDRESS: 30318 456th Ave.
*SURVEYOR: Jim Stone *COUNTY: Clay
*CITY: Wakonda

CURRENT FUNCTION: Storage FOUNDATION: Poured concrete
 CURRENT SUBFUNCTION: Storage ROOF MATERIAL: Steel roofing over cedar shingles
 HISTORIC FUNCTION: Livestock barn ROOF SHAPE: Gambrel roof
 HISTORIC SUBFUNCTION: Hay & grain storage STRUCTURAL SYSTEM: Balloon framing
 OCCUPIED: Yes STYLE: Gambrel roof barn
 TYPE: Livestock barn
 ACCESSIBLE: Yes with permission WALLS: 2x6 studs, 1x6 #106 drop siding & steel roofing

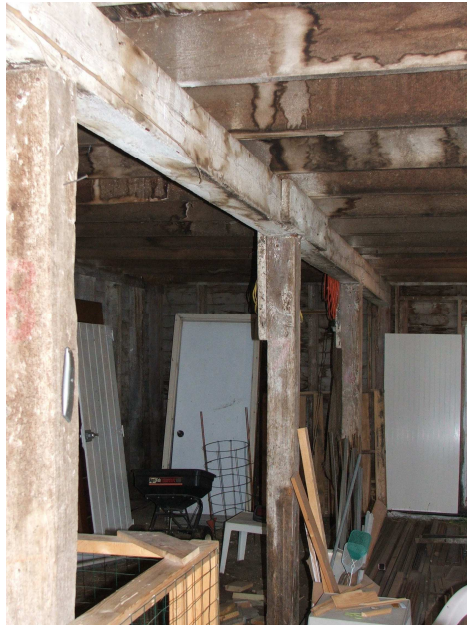
ROLL NUMBER: _____
PHOTO NUMBER: 5

**First floor, looking SW,
6x6 posts, 6x8 beam, 2x8
floor joists for hayloft
floor.**

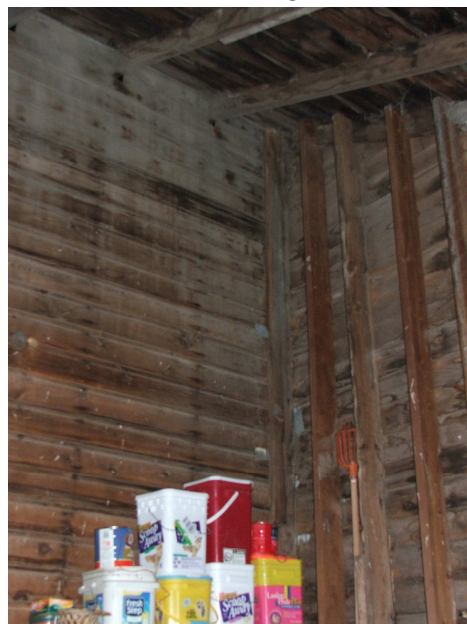
ROLL NUMBER: _____
PHOTO NUMBER: 6

**First floor, South lean-to,
looking NE, 2x6 studs
12" O. C., note condition
of drop siding on original
barn.**

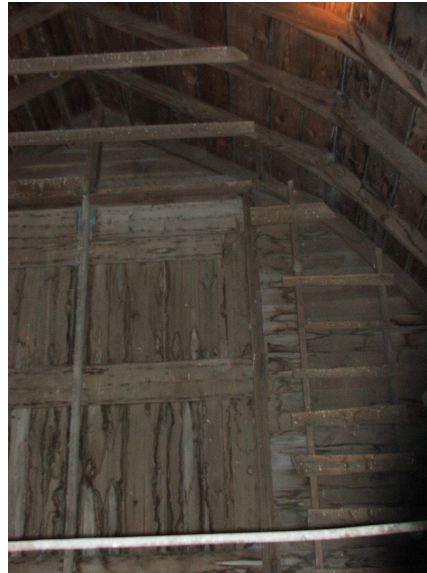
ROLL NUMBER: _____
PHOTO NUMBER: 7

Hayloft, looking SE, 2x6 rafters, note short 1x6 brace on rafters at roof hip. 1" iron rod from top of North wall to top of South wall.

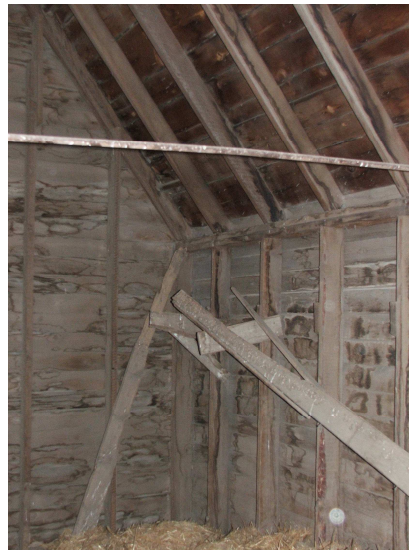
ROLL NUMBER: _____
PHOTO NUMBER: 8

Hayloft, looking SE, 2x6 rafters and 2x6 bracing for rafters, note lack of and rafter bracing, reason for 1" iron rod, 8' O. C., holding the top of walls from spreading.
